Local Development Framework
Evidence Base

Rochford Conservation Area
Appraisal and Management Plan

This document was produced by Essex County Council for Rochford District Council.

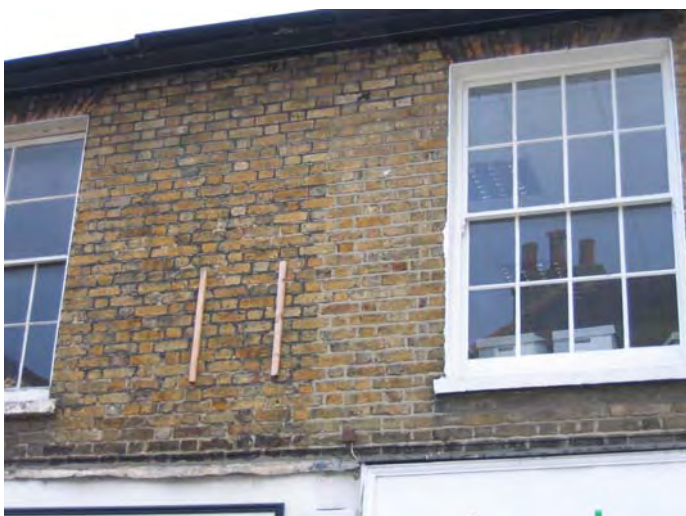
6.5 These different types of bricks present a palette of materials which were used in a variety of different ways which are not always evident today. The older red brickwork was sometimes ruddled or treated with a red wash, and in the grander houses must in some cases have been jointed with tuck pointing. Traces of this seem only to survive at no. 22 South Street. Tuck pointing was also used in some stock brick buildings (e.g. no. 21 West Street, *Fig. 12*). Penny-struck pointing must once have been common, but can only be seen in a few instances today. Most of the brick buildings have been re-pointed in the second half of the 20th century, in many cases probably unnecessarily. This has led to an erosion of the character of the original brickwork (*Fig. 12*).

Fig 12 Nos 21-23 west Street. To the left, stock brickwork with tuck pointing. To the right, unnecessary repointing has had an adverse effect on the character of the brickwork.

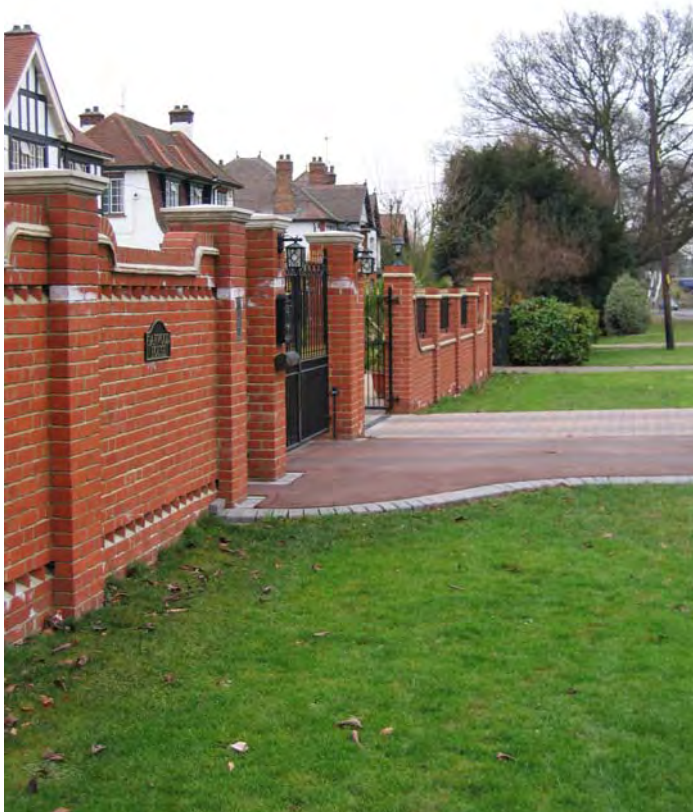
- 9.1 Until the first half of the 20th century, Hall Road was undeveloped. It still has a rural feel to it, to which the trees along it make a significant contribution, and forms an attractive approach to the town and conservation area. The large houses which have been built along Hall Road since the Second World War begin on the south side outside the conservation area and stop at Rochford Hall where the conservation area begins. The Hall and the conservation area have formed an obstacle to development on this side of the road, but the houses resume on the north side outside the conservation area boundary which is drawn along the north side of the road. It is essential to the preservation of this approach to the town, and of the setting of Rochford Hall, that further suburbanisation of the road is avoided. In particular, boundary walls in unsympathetic materials can have an effect quite disproportionate to their size on the appearance of the road (*Fig. 15*). Hedges are much more appropriate in this context.

Fig. 15 Hall Road. Boundary walls, if too elaborately designed, do not look as good in this semi-rural setting as hedges.

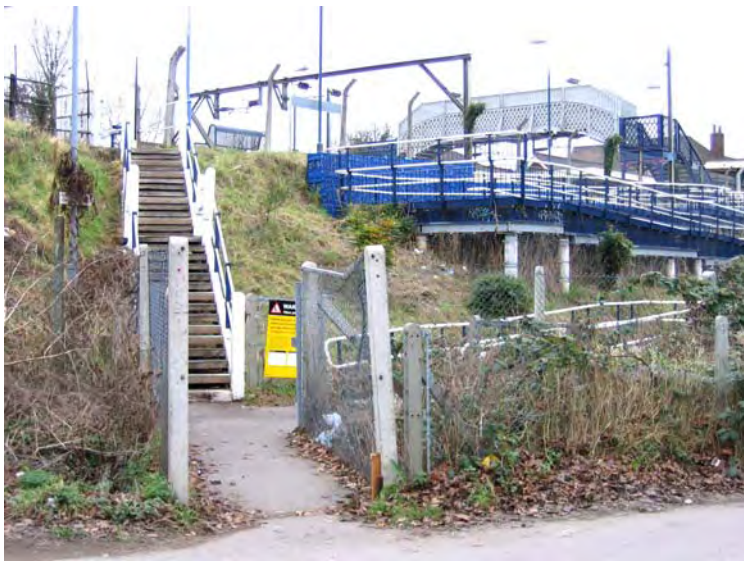
- 9.13 At the end of the cycle route, a flight of steps ascends the embankment to the west side of the station. The entrance to the steps is through a dilapidated chain link fence, whilst the posts and handrails are painted white and blue, making them excessively visible and an eyesore from a distance (*Fig. 20*). The steps are supplemented by a ramp which tacks up the side of the embankment. These too have unsightly handrails painted blue and white. These features make for an unsightly view at this end of Hall Road, not helped by the use of bright blue plastic reinforcing similar to milk crates used to revet the embankment at this point.

Fig. 20 Steps and ramp at the west access to Rochford station.

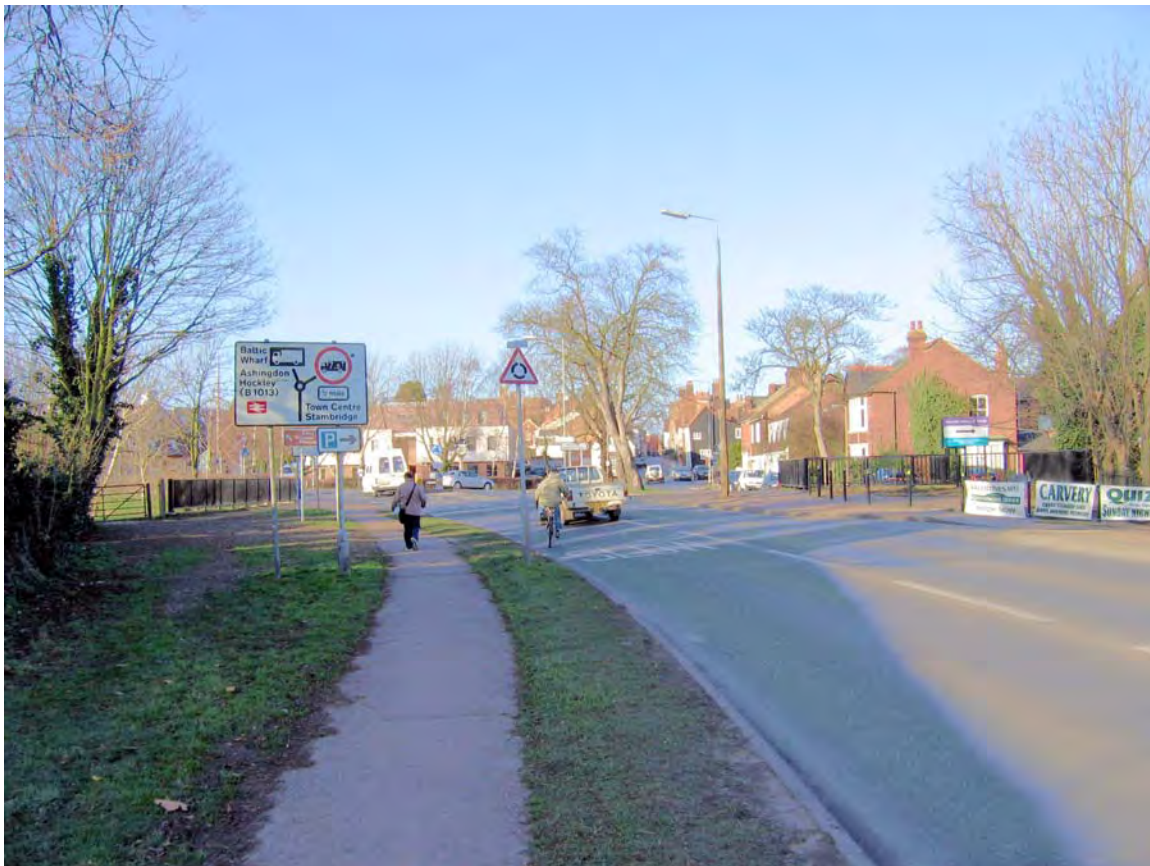
- 9.19 At the approach to the conservation area, the view glimpsed up the hill into the town along South Street contrasts with the lower lying bend round into Bradley Way, the junction between the two dominated by a modern office building, Cottis House, which although large just avoids being out of scale with its surroundings. Mature trees planted in this area contribute to this view. There is, however, an excess of road signs which could be rationalised and reduced (*Fig. 22*).

Fig. 22 The junction of Bradley Way and South Street. Street signs could be rationalised.

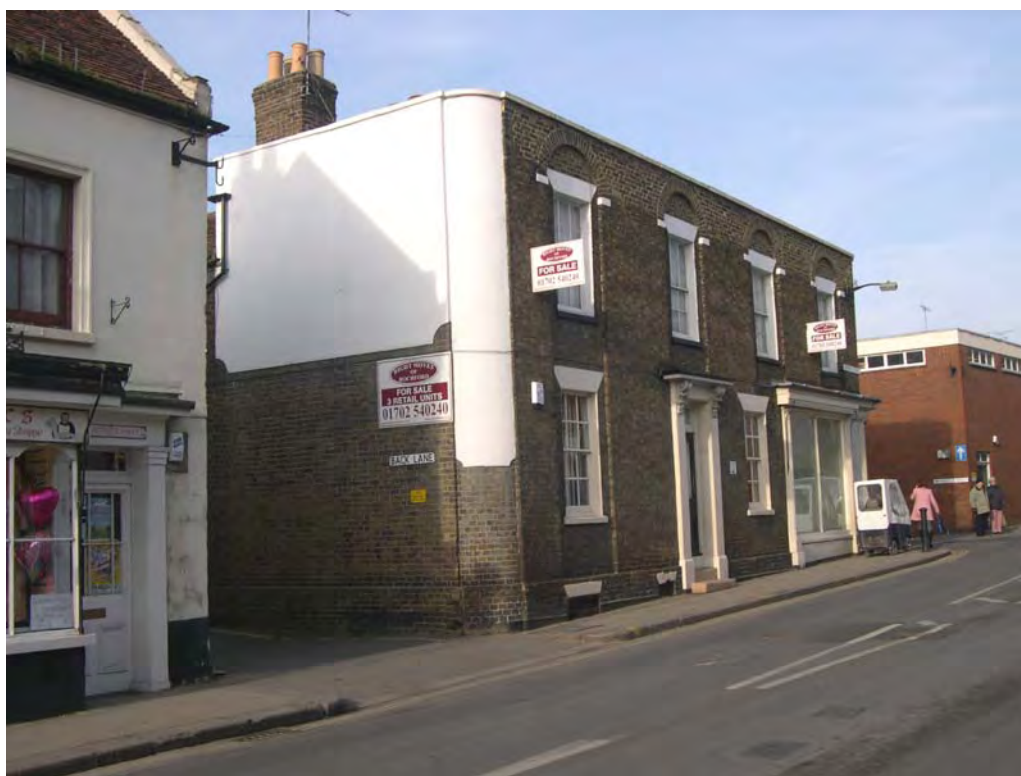
- 9.39 **No. 1** South Street, and nos 1-5 West Street, all one corner building, 19th-century, listed grade II, stock brick, windows set in full height recessed panels with arched heads (*Fig. 25*). Plain stucco doorcase with consoles to flat hood facing South Street. Elegant shop windows with half round fluted columns and cornices, but painted garish blue and yellow at 3 West Street, and bad shop signs at 3 and 5 West Street.

Fig. 25 No. 1 South Street.

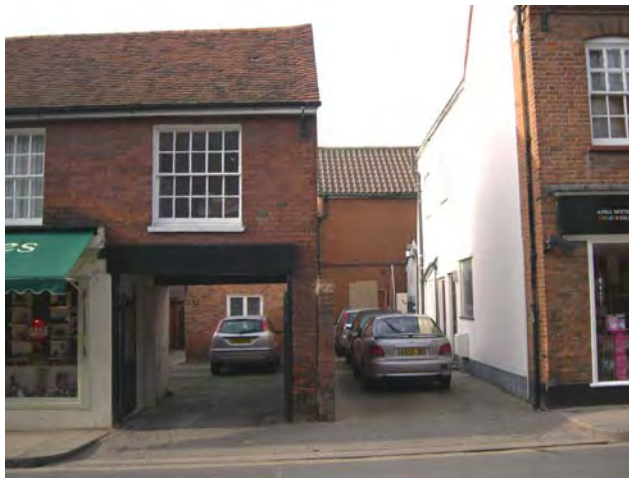
- 9.43 Rear of no. 8, the carriage arch leads through to a yard occupied by rear extensions, outbuildings and new development. Although rather crowded, this has been successfully done. **Wistaria House, no. 6**, is an attractive red brick outbuilding converted to a house. It is dated by a graffito on the brickwork: MS 1832. The windows are of rather tall narrow proportion. Two new houses, 6A and 6B, have been shoehorned in further west. The view into the carriage arch, and the space between no. 8 and no. 4, is not enhanced by parked cars (*Fig. 26*).

Fig. 26 South Street, carriage arch on the north side of no. 8.

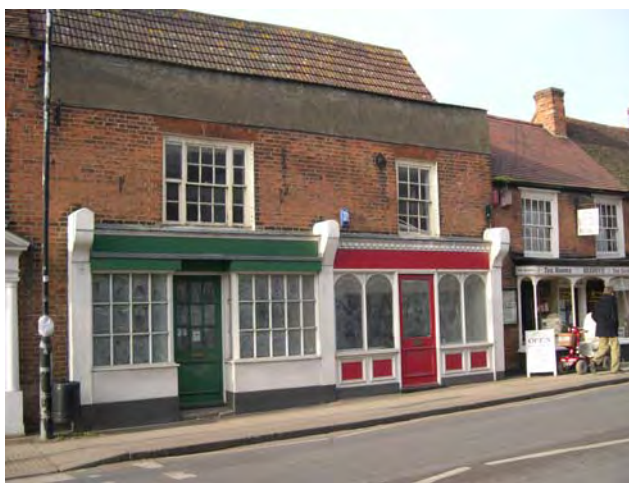
- 9.44 **Nos. 10 and 12**, two shops under one ownership and a continuous roof, though no. 12 unfortunately has machine made tiles. Beehive Tea Rooms and Records. Listed grade II, 18th-century but with older timber frame behind red brickwork. Small paned sash windows at first floor. Projecting small pane shop front to no. 10 with door with round arch. Double fronted shop front with segmental heads to no. 12 (*Fig. 27*).

Fig. 27 South Street, shop fronts at nos 14 and 16, Beehive Tea Rooms to the right.

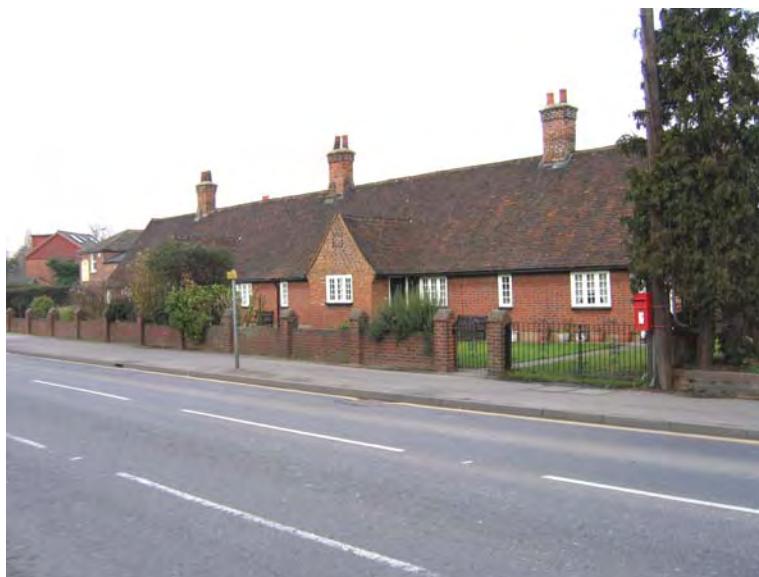
- 9.67 As already noted, this is quite different to West Street within the town centre, and indeed was formerly known as Church Street. The two sides of the road present a contrast, the north built up but without a continuous frontage, the south largely open with the Iron Well stream and the station car park. In the absence of any sense of enclosure or unifying elements in the street scene, traffic dominates.
- 9.68 At the west end, the north side starts well with **Lord Rich's almshouses** (nos 90-100), built after his death in 1567, c.1581-1617 (*Fig. 34*). Grade II listed. Picturesque row of six almshouses, each originally one room with a porch. A surprisingly large amount of the Tudor brickwork has been replaced, and what survives of it has been repointed in cement. The roofs have one or two missing tiles. The chains between the buttresses of the boundary wall are all broken.

Fig. 34 West Street, Lord Rich's almshouses.

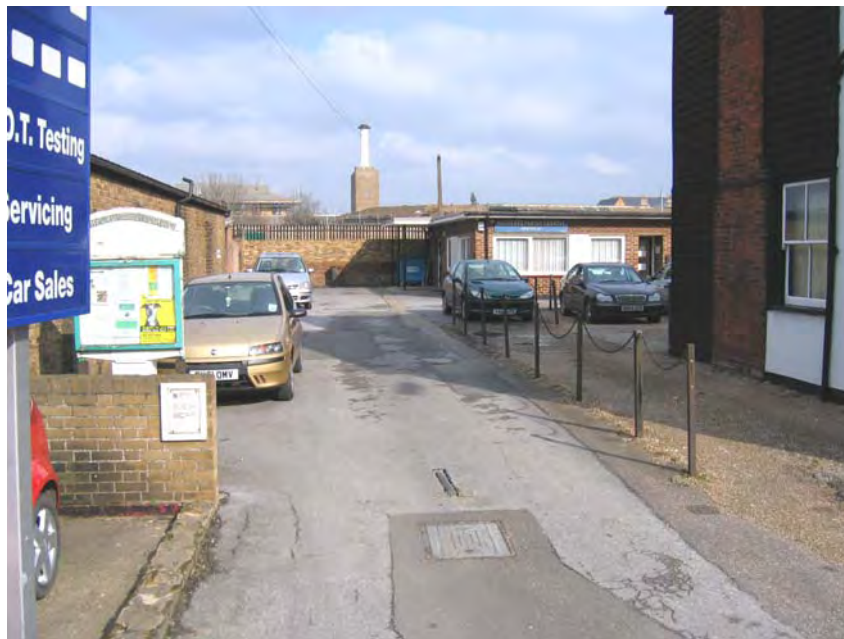
Fig. 35 West Street, depressing view between Whittingham's garage and Sovereign House to the parish council offices. In the background, the former hospital boiler house.

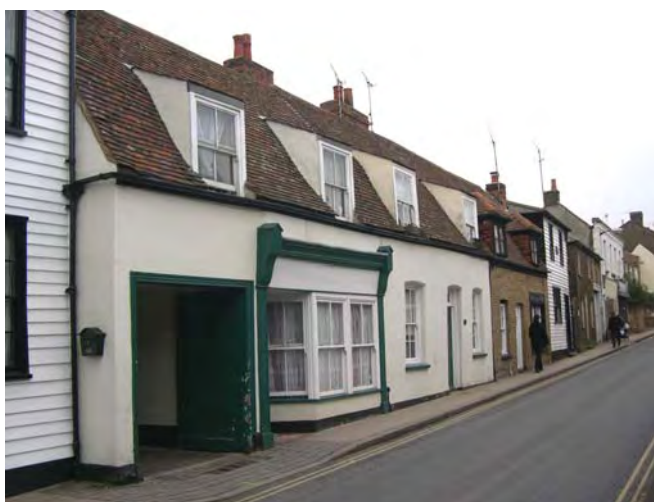
Fig. 39 West Street, north side, nos 50-62.

- 9.80 **No. 56**, identified by a plaque as 'Charterers Cottage 1810' (*Fig. 39*). Weatherboard, white to front, black to sides. Poor replacement wooden sash windows.

- 9.81 **No. 54**, boarded up and empty. Stock brickwork to street in remarkably good condition, largely unrepointed. Round arched front door; carriage arch. A potentially nice building which could make a valuable contribution to the streetscape.

- 9.82 **Nos 50-52**, a 19th-century or earlier stock brick-fronted house, its ground floor opened up to form shop fronts, most recently a Rumbelows store. Fire damaged in 1994. A report by the Morton Partnership, engineers specialised in historic buildings, concluded that the building can only be demolished, a conclusion with which it is difficult to disagree. Applications were made in 2002 to rebuild it on a like-for-like basis to the street, providing two dwellings, with three houses on the land to the rear. Development in the garden would lead to the almost total loss of the West Street backlands, making this area very densely built up and leading to a loss of character.

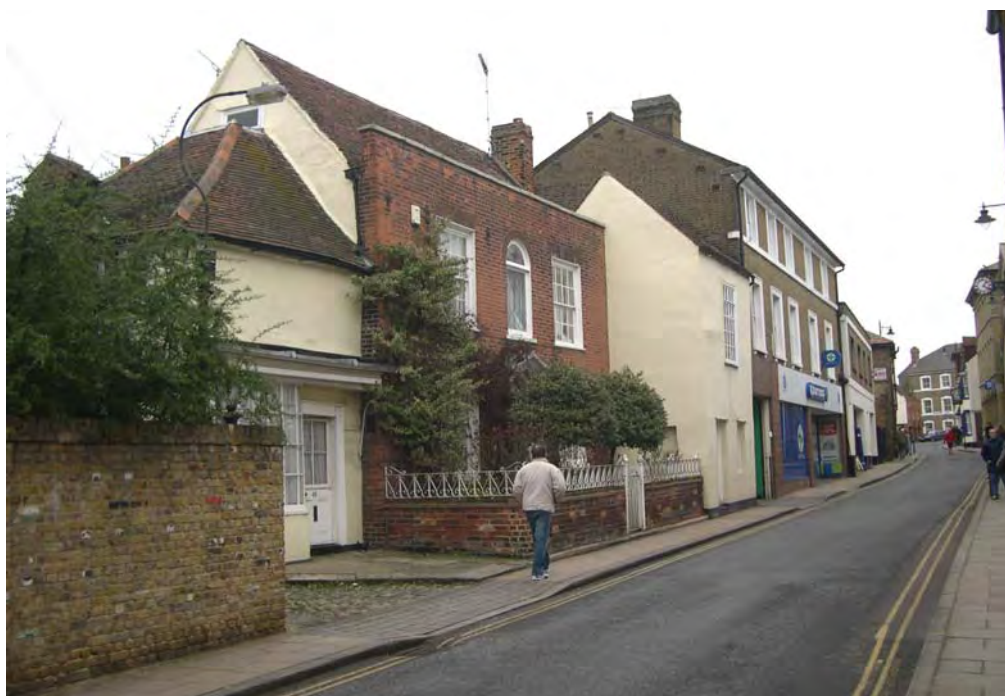
Fig. 40 West Street, nos 44-48.

- 9.84 **No. 44**, grade II listed, 18th-century, timber frame rendered and lined out to the front (*Fig. 40*). Replacement wooden windows not very good.

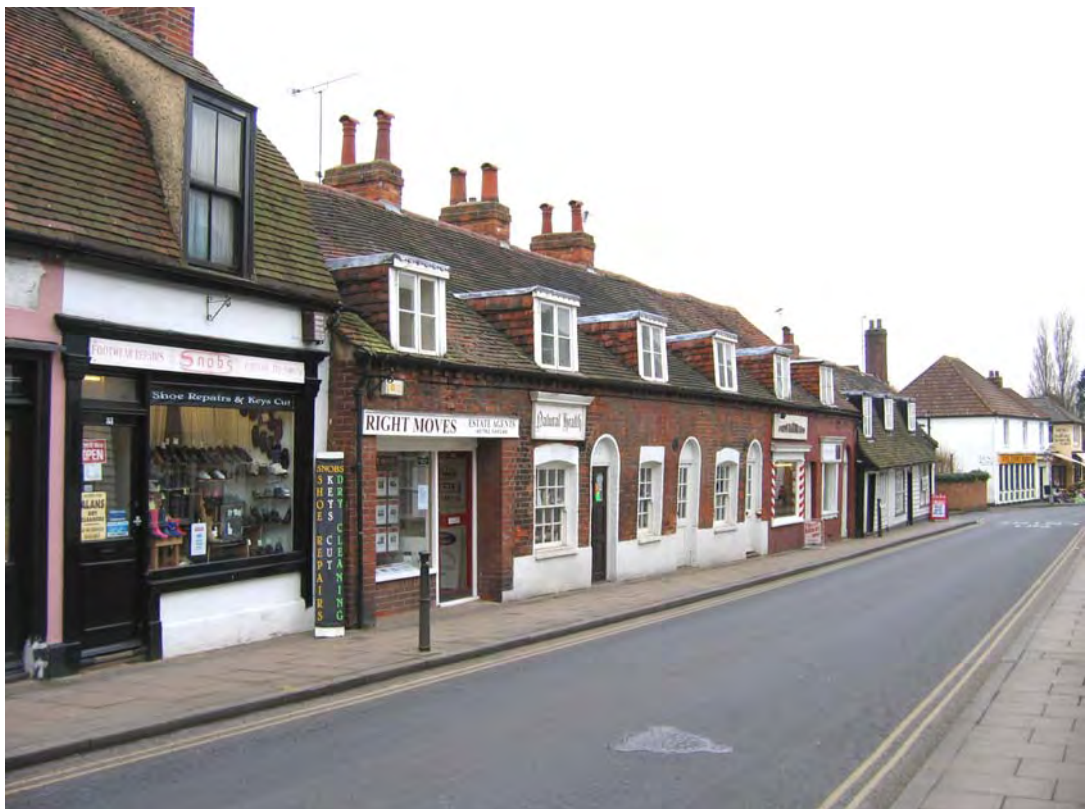
Fig. 45 West Street, cottages at west end (nos 53-69).

- 9.108 **Nos 51-53**, listed grade II, two shops, ground floor and attics in gambrel roof, probably 18th century (*Fig. 45*). The façade is painted, the left hand one, which is currently boarded up and missing tiles at the eaves, an undesirable shade of strong pink which does not fit with the rest of the street. Traditional shop fronts.
