HAWKWELL BROOK

Report on flooding issues for the Flood Forum following a site visit on 21/7/2021.

**Flood Advisory Group
Hawkwell Brook Report 2**

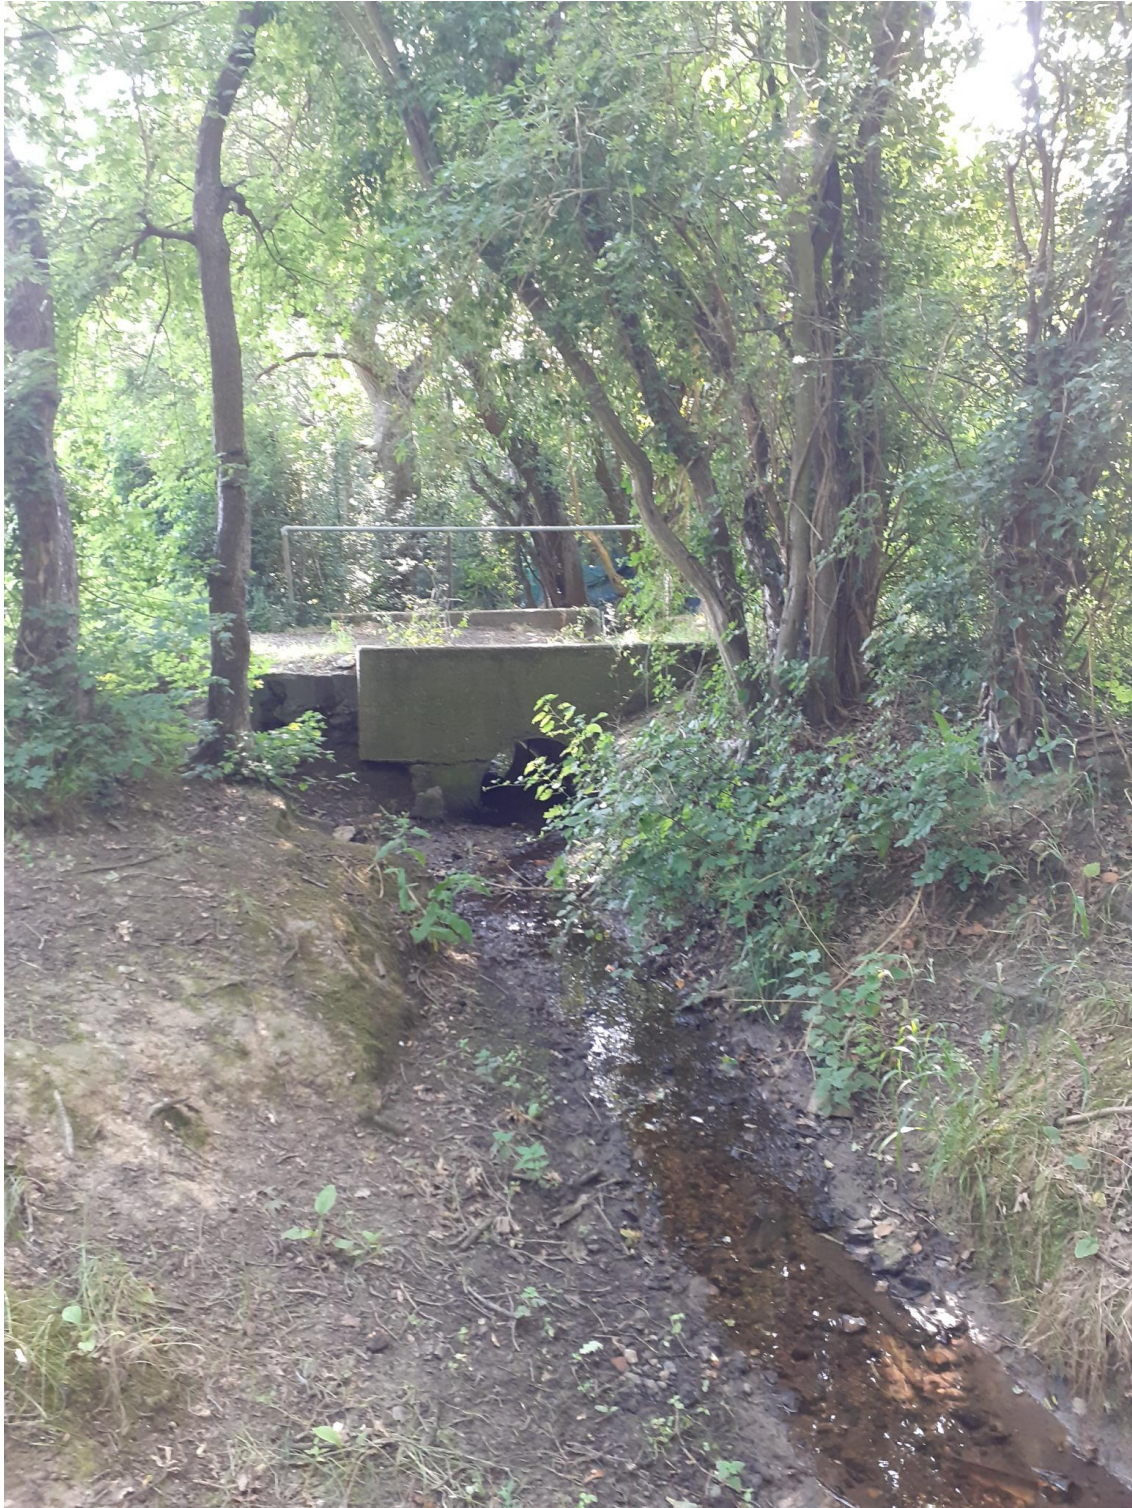
3 BELCHAMS SCOUT CAMP

The brook runs through the campsite and early in the year has been flooding. This appears to down to the volume of water during heavy rain. The brook is kept clear by the site owners, but there may be potential to increase the capacity.

To discuss on increasing capacity in Belchamps.

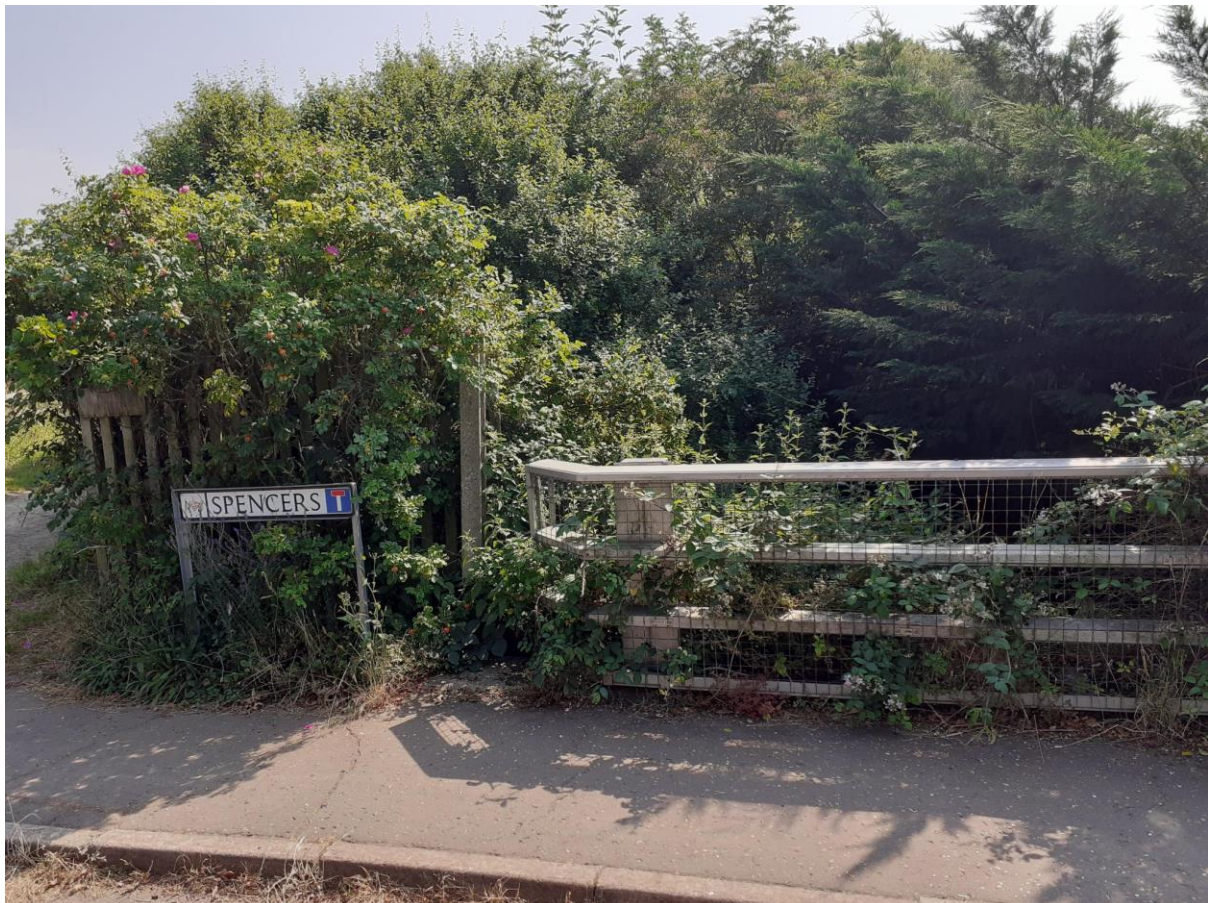
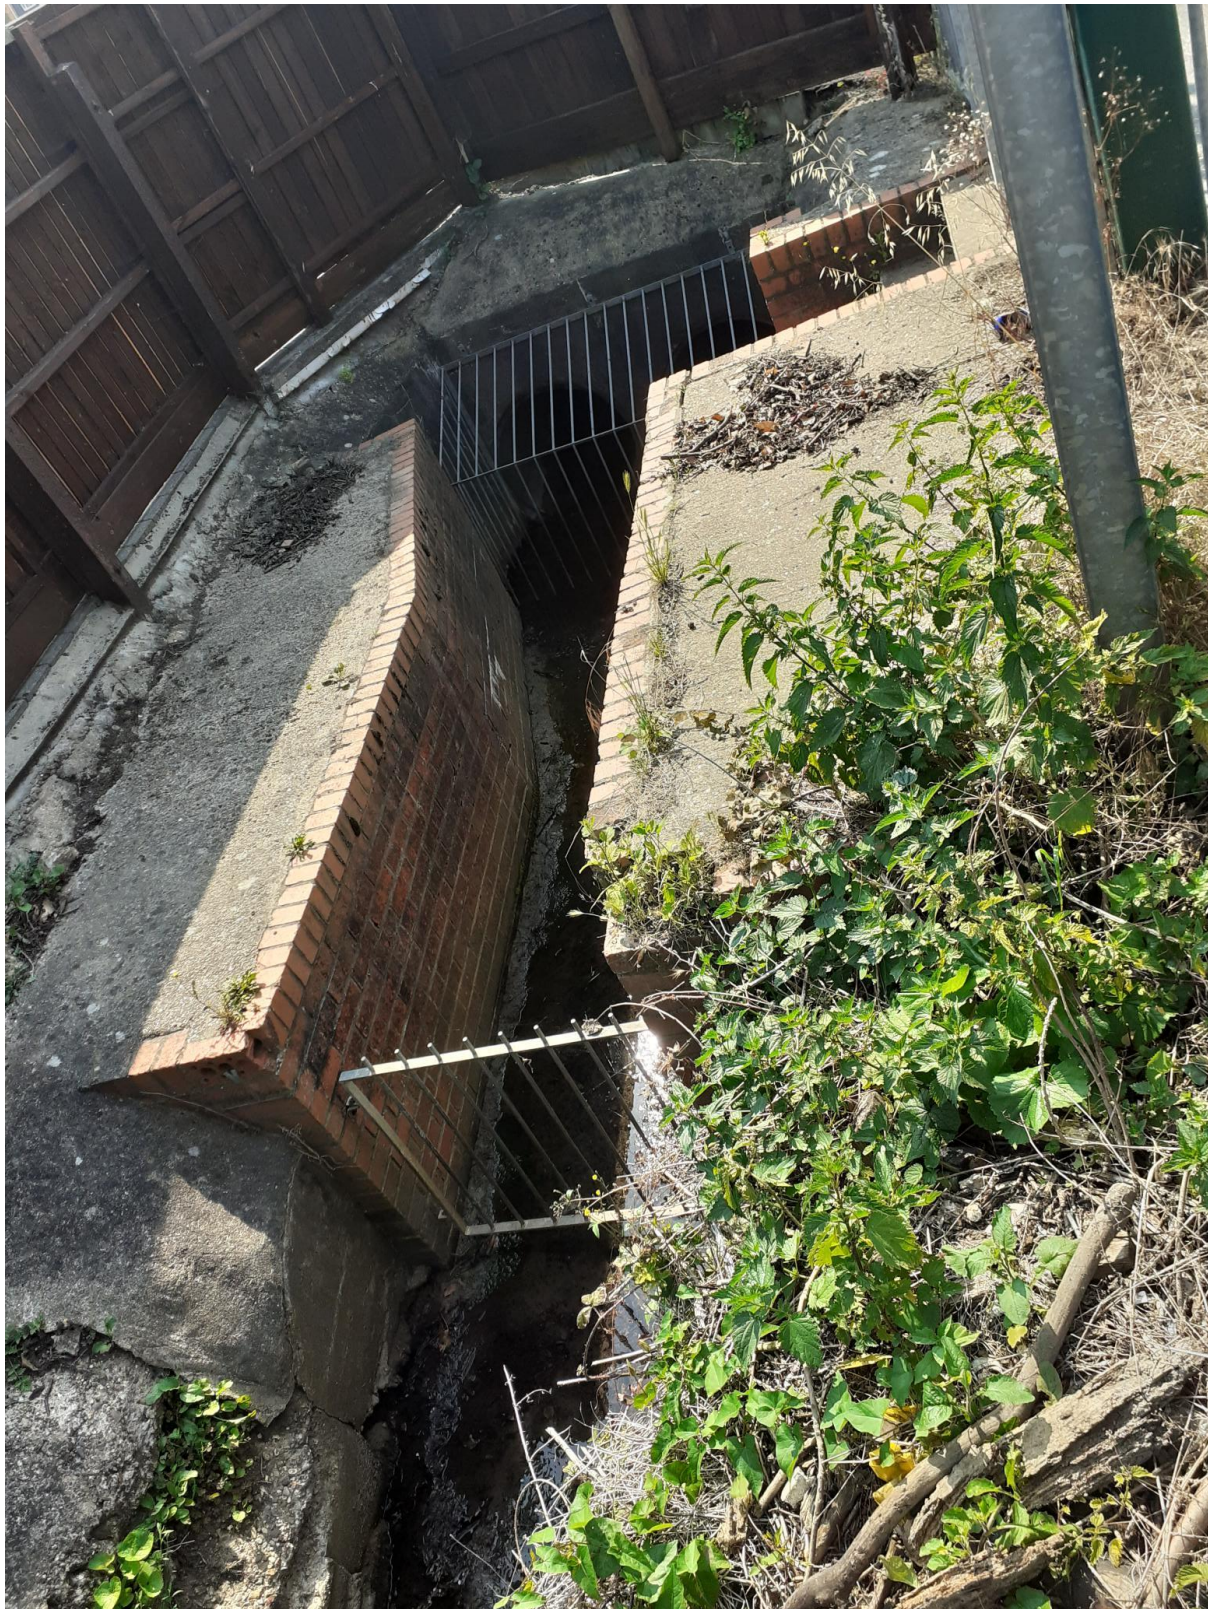
4 WOODSIDE CHASE/ELMWOOD AVENUE

As the brook runs out of the camp site there is a channel running alongside a path which goes underground near the junction of Woodside Chase and Elmwood Avenue. There was a report of rubbish being dumped, but it was clear when I visited. (I have records indicating that this stretch is a Rochford District Council responsibility – to be checked by land search)

The Brook emerges at Main Road and runs between gardens, under the road at Thorpe Close, then across the Country Park to Clements Hall Way. The brook was observed to be clear with no visible obstructions.

To check on RDC responsibility for the culvert at Woodside Chase.

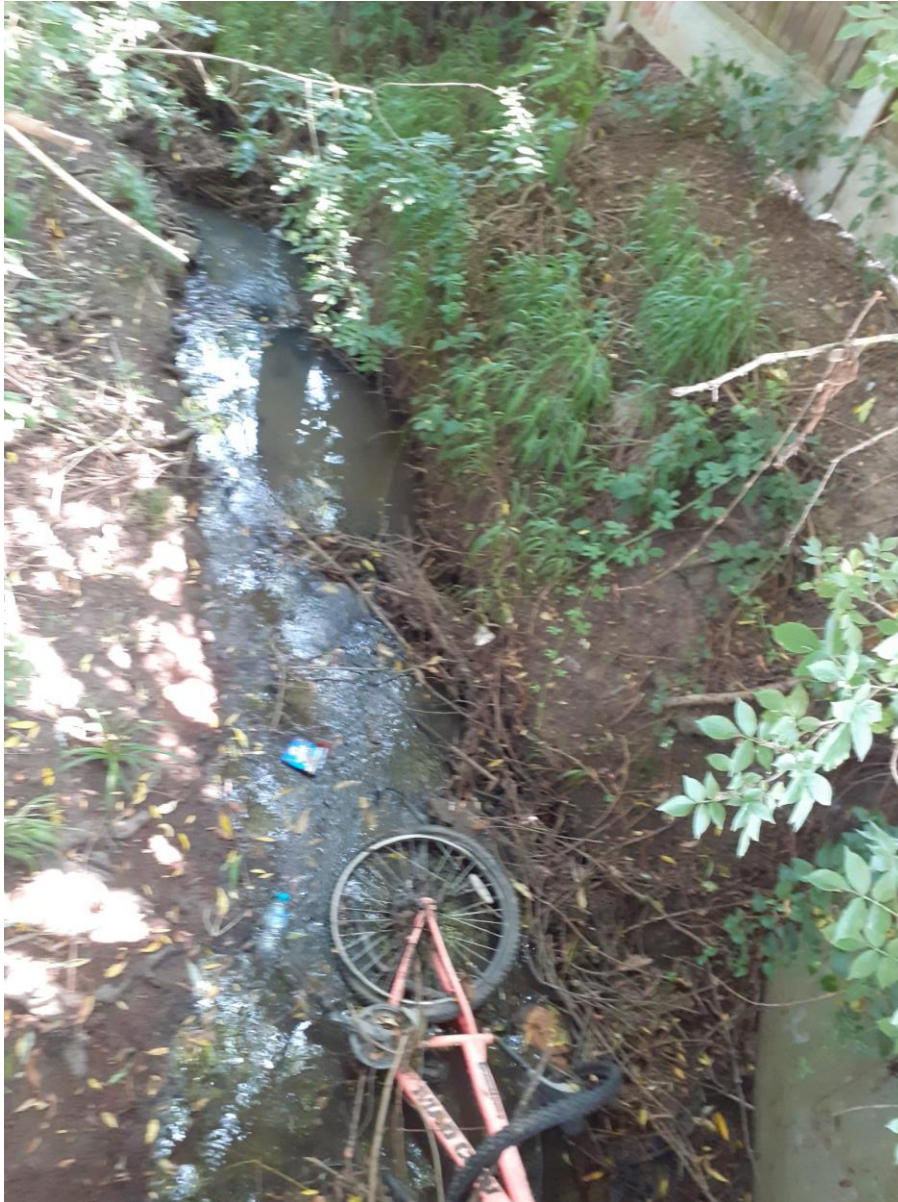
5 CLEMENTS HALL WAY

The brook runs along the edge of the Clements Hall Leisure Centre and then into farm land. It was observed to be clear of obstruction, the only dumping being a bicycle. Reports of flooding implicate run off from the Christmas Tree Estate, but there were no obvious signs that this is the case.
