Local Development Framework
Evidence Base

Battlesbridge Conservation Area
Appraisal and Management Plan

LDF Evidence
Base

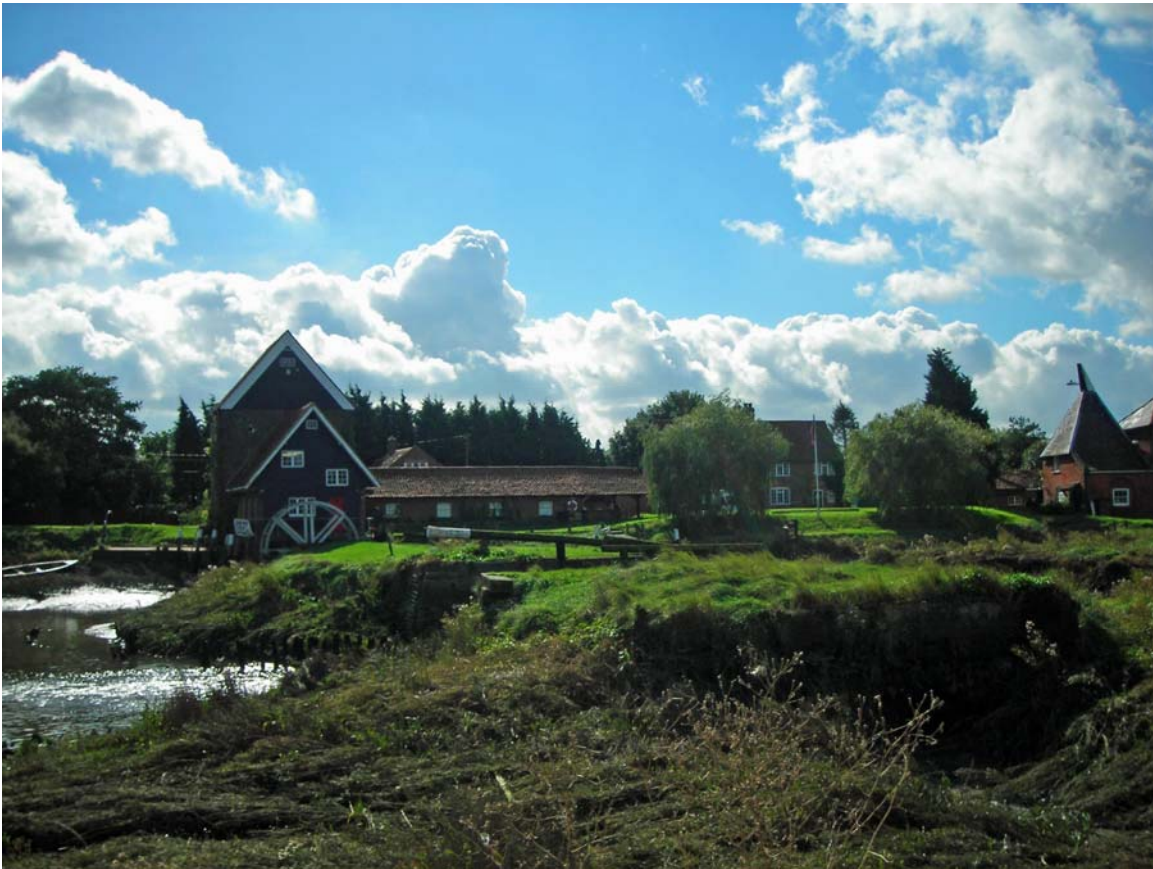
Fig. 1 Old tide mill, mill cottages and drying kiln.

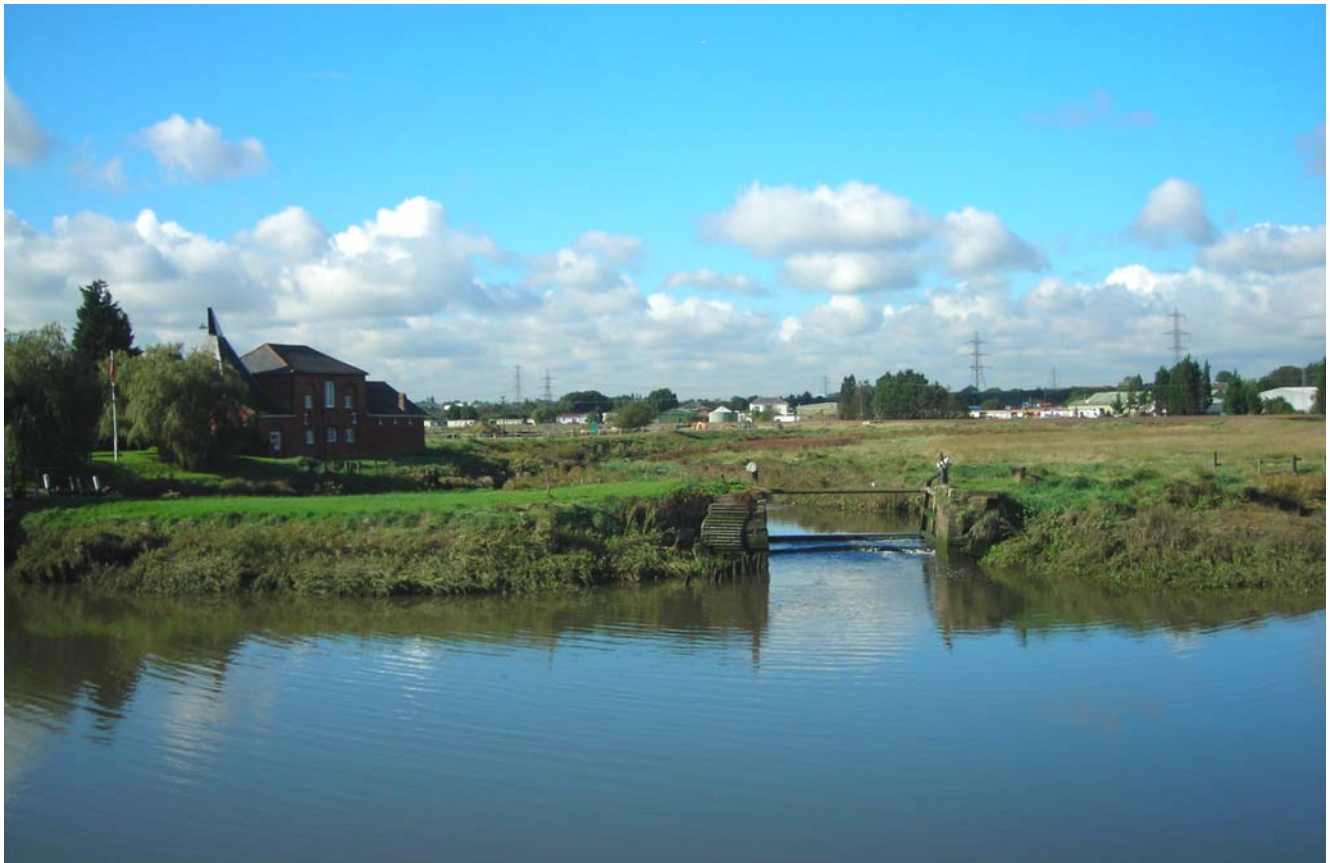
Fig. 11 View south from bridge with drying kiln and tide gates.

- 7.4 The sea walls, tidal mud flats and salt marsh plants introduce an estuarine atmosphere in this small enclave in an otherwise rural area. Drainage ditches and ponds add to the low lying riverside landscape, and the ditch to the rear of the Barge Inn was formerly a navigable waterway. The openness of the area allows views out into the countryside, particularly to the east and west along the river, which are largely unspoilt. Views to the south across the river channel and salt marsh, towards the tidal mill and granary, are particularly good (*Fig. 11*). However the overhead power lines, A130 and Hawk Lane industrial area are intrusive in the distance to the west and south west. The Battlesbridge Harbour area also appears untidy and detracts from the views directly south across the river. The sea wall has been raised in height on the north side as part of a major scheme of flood defence works. Although the new coping is robustly detailed and appropriate for its maritime context, the height of the wall and the difficult access to the riverside divorces the antiques centre car park and Hawk Hill from its riverside setting. The salt marshes in Battlesbridge have diminished over time with alterations made to the river and future works to help re-instate them may be beneficial.

9. The lock gates are currently in a very poor condition and are on the County Council's buildings at risk register. These gates are both historically important and a vital element in the attractive views across the river channel to the old mill. The landowner should be encouraged to repair these structures by Rochford District Council.

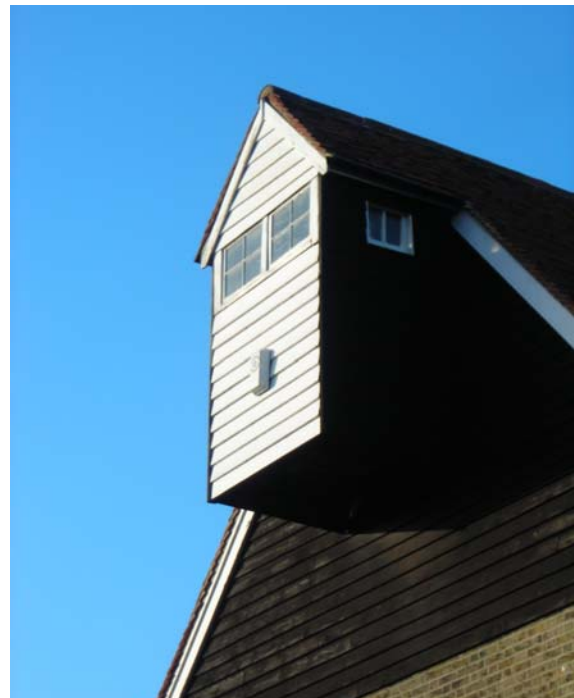
Fig. 14 Weatherboarded lucam on the old tide mill.

- 7.8 A varied palette of local traditional building materials contributes to the distinctiveness of the conservation area. The oldest buildings in the conservation area are typically timber framed, and may be weatherboarded, smooth rendered and painted, or with plaster infill panels. Some later brick built buildings are also smooth rendered and painted, usually in white or cream. Weatherboard is prevalent, and is generally painted white for buildings of domestic appearance (sometimes black to the side and rear elevations), and black for agricultural and ancillary buildings. White painted weatherboard is also traditionally used on some mill buildings (*Fig. 14*). Red brick, usually laid in Flemish bond, is also a commonly used walling material, as is yellow stock brick used from around the 1830s (*Fig. 15*). However the practice of

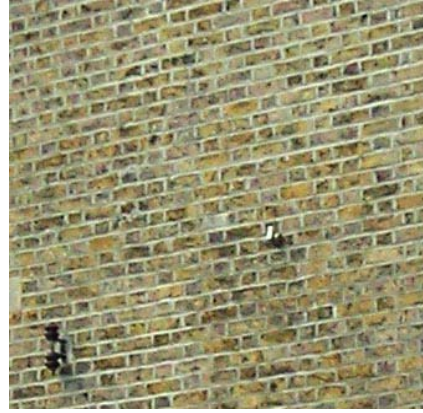
Fig. 16 Natural colour variation in handmade clay roof tiles on The Barge Inn.

- 7.9 Roofs are generally clad in handmade plain clay tiles for steeply pitched roofs (over 45°) that give a natural colour variation (Fig. 16). Natural blue/grey slates or orange clay pantiles are used for lower pitched roofs (generally 30°-40°). Pantiles are more commonly used on ancillary and non-domestic buildings.

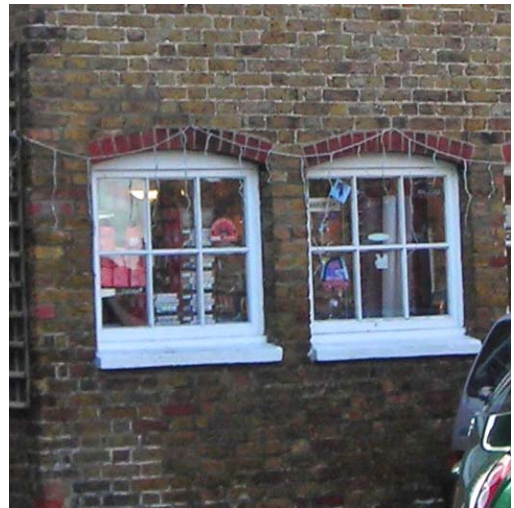
Fig. 17 Horizontally proportioned windows with cambered brick arches and painted timber joinery adjacent to the old tide mill.

- 7.10 Traditional window and door treatments tend to be simple and understated. Timber joinery with a painted finish (often white) is typical, and traditional windows are generally symmetrical sashes or casements sometimes subdivided into small panes. Windows may be vertically or horizontally proportioned (Fig. 17). In brick buildings recessed windows typically have cambered brick window arches. Some unsympathetic replacement plastic windows intrude on the character of the conservation area. Painted timber boarded doors are traditional particularly on non-domestic buildings, and painted timber panelled doors are also seen in the conservation area.

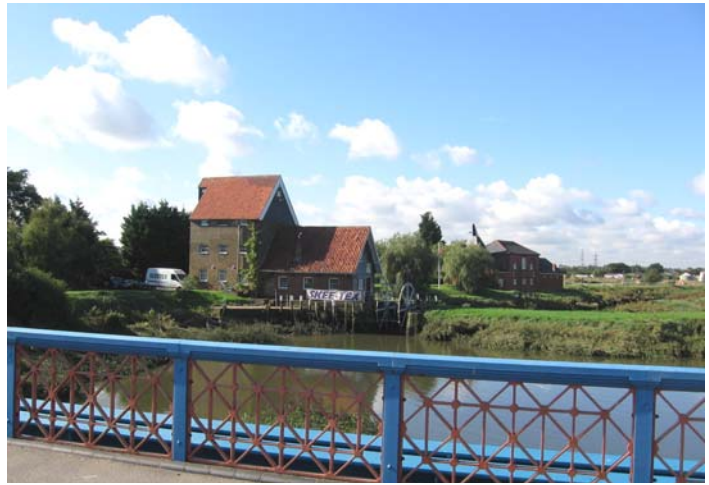
Fig. 21 View south from the bridge to the old tide mill, granary and drying kiln

7.13 The Grade II listed bridge is a focal point and a fine piece of Victorian engineering in its own right, although the strengthening works detract from its appearance. From the bridge there are good views along the river and across to the mill house, tidal mill and granary with drying kiln to the south-west, which form an impressive group (*Figs 21 and 22*). The road bridge is a Grade II listed structure and was built in 1872 by William Webster of London at a cost of £3,500. It has a cast iron central arch with stock brick side arches and brick parapets and end pillars. Although the construction of the A130 removed some of the traffic from the bridge, it continues to carry significant volumes of traffic which can be intrusive at times. The road bridge narrows to single file, which can cause waiting traffic to build up on either side at busy times. Crossing can also be difficult and dangerous for pedestrians.

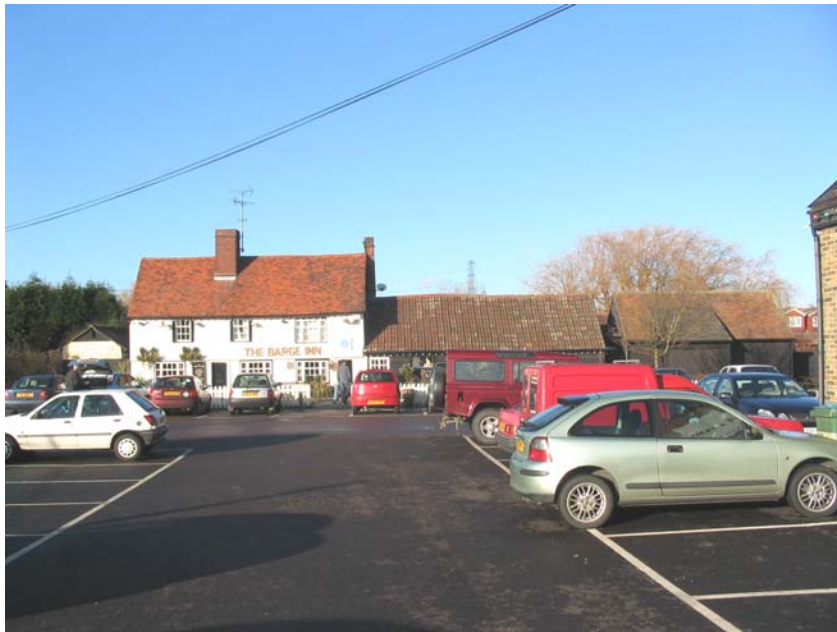
Fig. 23 The Barge Inn viewed across the car park of the Antiques Centre.

The antique centre granary is the dominant built feature and serves as a reminder of the settlement's strong association with riverside and agricultural activity. It stands high as an important local landmark and gives a sense of approach from the north and west, although from the south it appears suddenly on the approach along the curve in Chelmsford Road. It is illuminated at night and is clearly visible by passers-by on the new A130. The car park has been resurfaced in tarmac, with standard white lines used to mark the parking bays. This surface looks very harsh, undermines the rural character of the area and provides a poor setting for the buildings (*Fig. 23*).

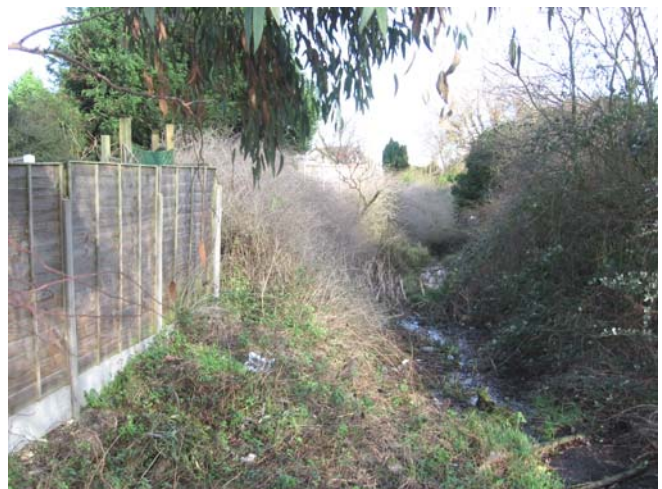
Fig. 24 Drainage channel to rear of Barge Inn.

The drainage channel to the rear of the Barge Inn was historically a navigable inlet, but at present appears untidy and is bounded by visually intrusive panelled fences (*Fig. 24*). The barges moored at the riverside add significantly to the maritime character (*Fig. 25*) of the area and reinforce the historic use of the navigation.

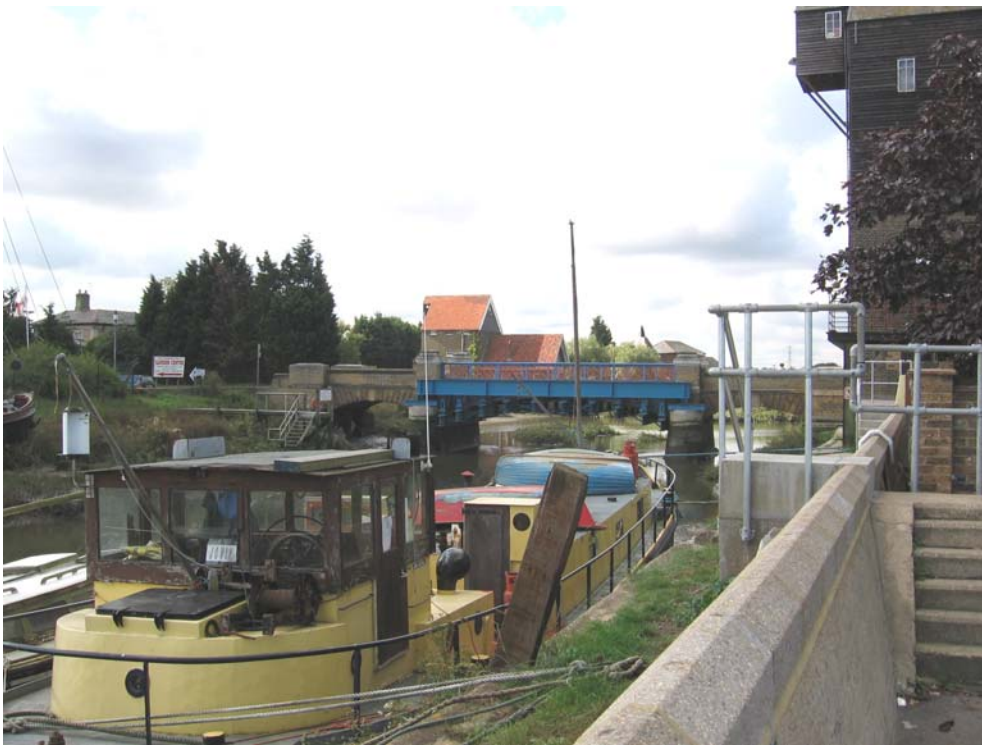
Fig. 25 Barges on riverside.

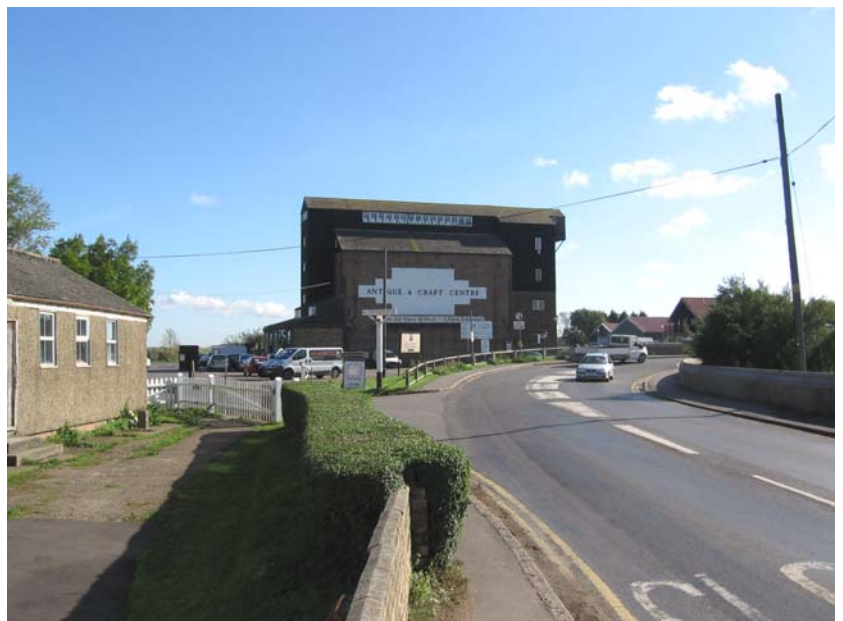
Fig. 26 Granary Antique Centre. The church hall is on the left.

The main approach from the west gives good views to the antique centre granary (*Fig. 26*) and along the river, into the open countryside. The pond to the side of The Green provides an open setting to the buildings grouped to the north and east.

The chapel at the corner of Hawk Hill and Maltings Road is a strong feature on the approach to the bridge. Its simple form and slate roof are typical of mid nineteenth century chapels. Its windows have been replaced with inappropriate, lifeless, manufactured plastic windows. The hall to the east is a valuable local facility. Its orientation contributes to the informality of the building group's layout, but it is a run down temporary building made of poor materials. (*Figs 26 and 29*).

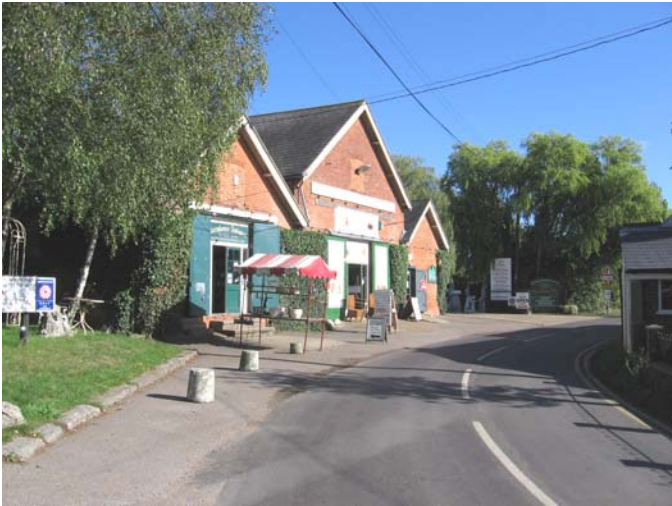
Fig.32 Muggeridge Farm barn.

The buildings at Muggeridge Farm comprise many elements. Those of the most historic interest are located on the southern part of the site. The three gables to the nineteenth century brick barn enclose the corner of Maltings Road (*Fig. 32*), with the other buildings to the rear forming two courtyards. The rare Grade II listed eighteenth century octagonal dovecot is glimpsed from Maltings Road (*Fig. 33*).

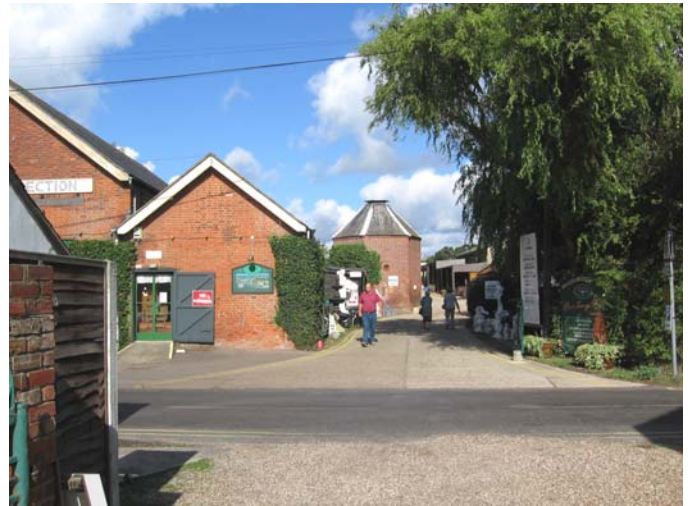
Fig. 33 Muggeridge Farm dovecote.

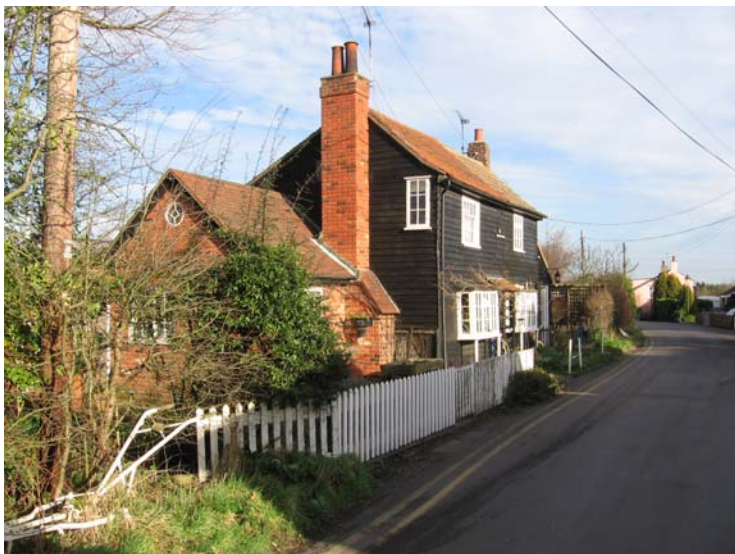
Fig. 35 Nos 7-9 Maltings Road

Beyond the farm buildings, Numbers 7 and 9 (*Fig. 35*) are modest early nineteenth century cottages with a steep plain tile roof, black weather boarded walls and small paned painted timber windows. The pond, open garden, trees and white painted picket fence add to the building's rural setting. To the east the road edge is defined by hedges enclosing agricultural land beyond. The lack of kerbs and minimal road lines add to the rural character of the road.

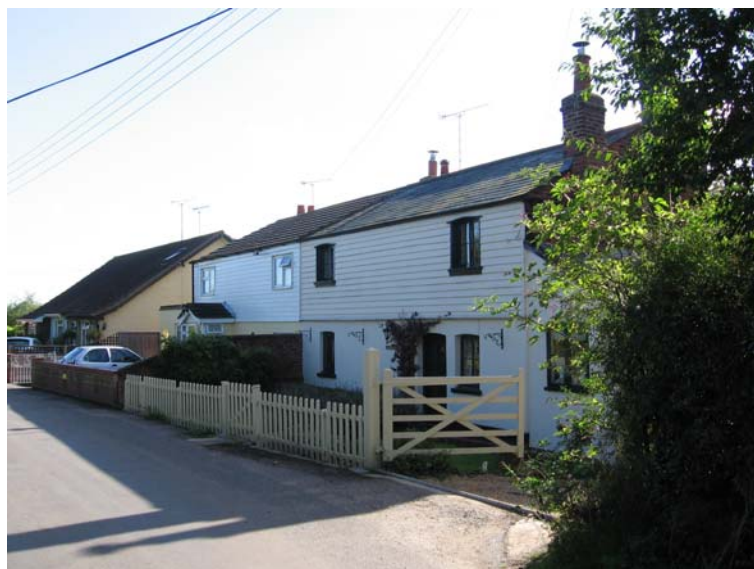
Fig. 36 Nos 18-22 Maltings Road.

Number 16 is a modest detached Edwardian cottage with rendered walls and a plain tile roof. The large open garden of number 18 provides a break in the built form and adds to the informal rural character of the area. This mid nineteenth century building was formerly a terrace of four, subsequently converted into two. Number 18 remains picturesque, but the other half of the pair, number 22, has been significantly altered (*Fig. 36*).

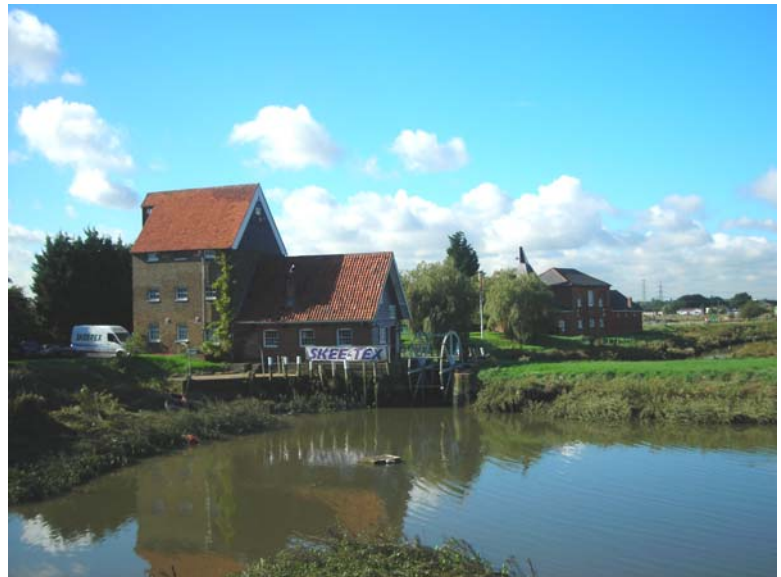
Fig. 37 The old tide mill with the granary and drying kiln beyond.

- 7.17 The old tide mill is what remains of the 1830s tide mill, and an important and rare survival in Essex (*Fig. 37*). It is Grade II listed, and the main building is of three storeys with a loft and a weatherboarded lucam, built of yellow stock brick with a clay tile roof. A single storey red brick and weatherboard range with a pantiled roof extends to the river bank and dam wall. The mill has been converted for business use, and suffers from over-prominent advertising on the riverside that detracts both from the building itself and from the wider setting and views across the river channel.

An attractive stock and red brick outbuilding with pantile roof is included in the listing for its group value. A lean-to red brick and pantile extension has been added in recent years, along with a large covered seating area along the river edge, representing a significant modern intervention to the west of the building. The adjoining dam wall and tide gates are listed along with the mill. These features are historically important and make a valuable aesthetic contribution to the conservation area. They are currently in a very poor state of repair, and are included on the County Council's Historic Buildings at Risk Register.

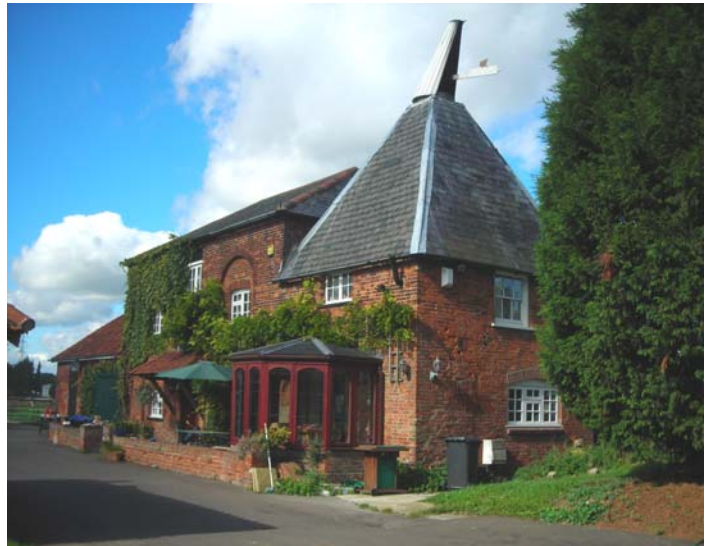
Fig. 38 Toad Hall viewed from the south.

To the west of the tide mill the former granary and drying kiln are also Grade II listed. They were constructed in the early 19th century and were associated with the tide mill (*Fig. 37*). Now converted to a house (and known as Toad Hall), these buildings are constructed of soft red brick with a central main block that has a hipped slate roof and a single storey range extending west with a clay tiled roof. Like the mill, this building with its pyramidal slate-tiled kiln is a rare and important survival. To the south, the building is spoilt by an unsympathetic conservatory with brown framing, but viewed across the river along with the mill it contributes to an attractive and bucolic scene.

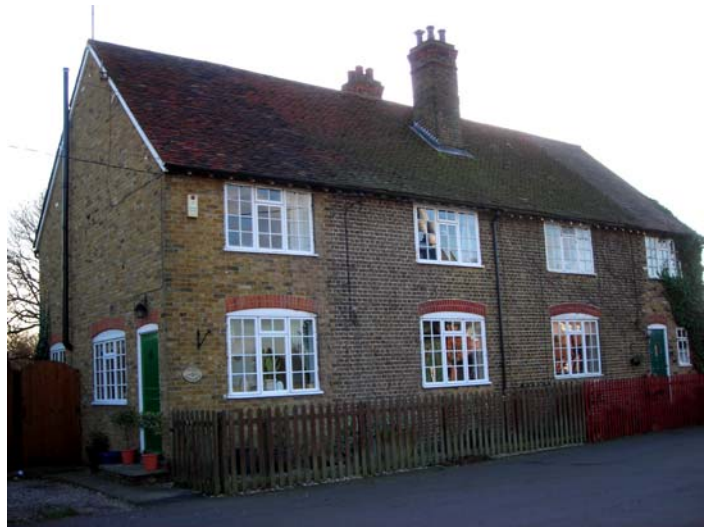
Fig. 39 Mill Cottages.

Mill Cottages are a pair of simple stock brick cottages built between 1897 and 1922 (*Fig. 38*). They complement the industrial mill buildings, and are well presented as a pair. The picket fence front boundary treatment is appropriate to the rural character of the area.

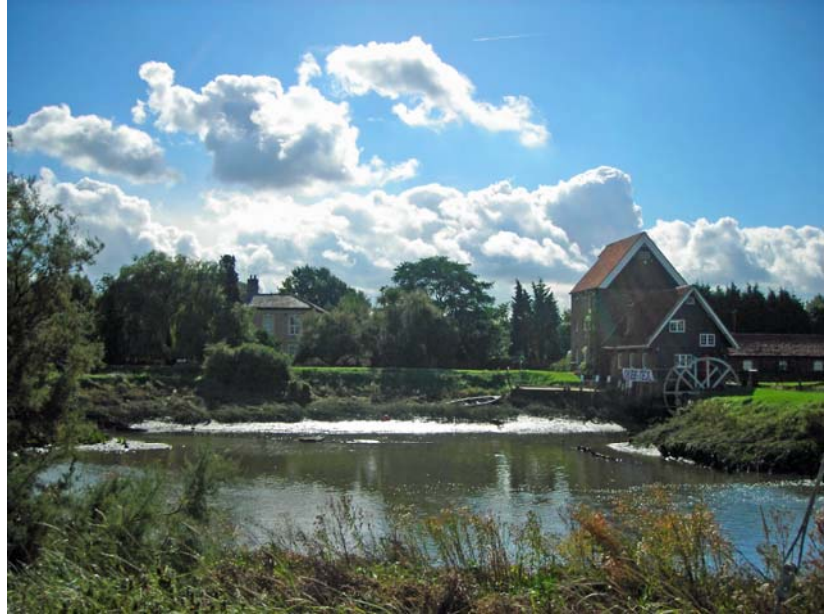
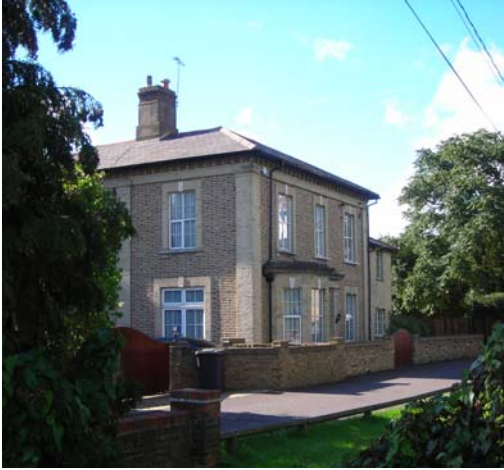
Figs. 40 and 41 Mill House (above) and viewed from Hawk Hill with the tide mill (right).

Mill House is an important element in the group of mill buildings south of the river (*Figs. 40, 41*). Along with the other elements in the group it is accessed along a private road off Chelmsford Road. It was built in 1857 by William Meeson, and is a handsome building in extensive grounds now converted into one dwelling. Constructed of yellow stock brick with gault brick detailing including quoins, window surrounds and eaves course, its elegant appearance is spoilt by replacement UPVC windows. Mill House is visible from across the river and from the bridge, and with its wooded setting it contributes to the picturesque scene from these vantage points. Across the access road from Mill House an open green bank with trees and a brick well contribute to attractive views from across the river and enhance the green and rural character of the area.

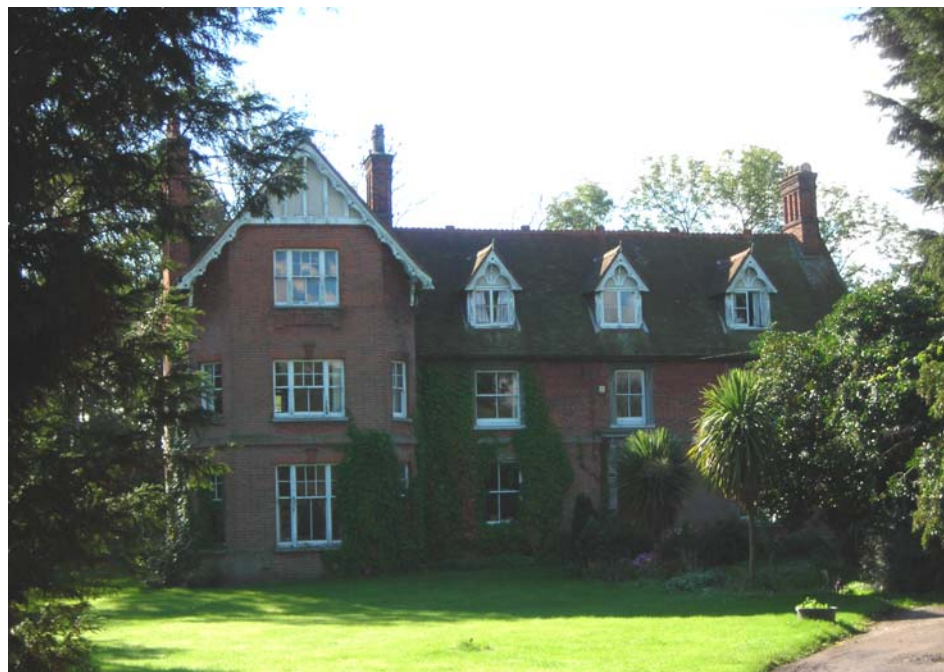
Fig. 42 Telfords

7.18 Telfords is an imposing Victorian villa, a former mill owner's house, constructed of red brick with decorative bargeboards and gabled dormers (*Fig. 42*). Although the present house is of 1890s appearance, there has been a house and farm in this location for centuries previously. It is set in wooded grounds with a meadow to the rear, and a footpath passes along the hedged field boundary at the eastern edge. Telfords Farm is accessed along a private track continuing past the main house. The modern farm buildings of Telfords Farm and others associated with the mill to the rear of Toad Hall are sufficiently set back to be only occasionally visible from across the river, and they are not intrusive. However any further developments towards the river may harm important views as well the setting of the listed buildings.

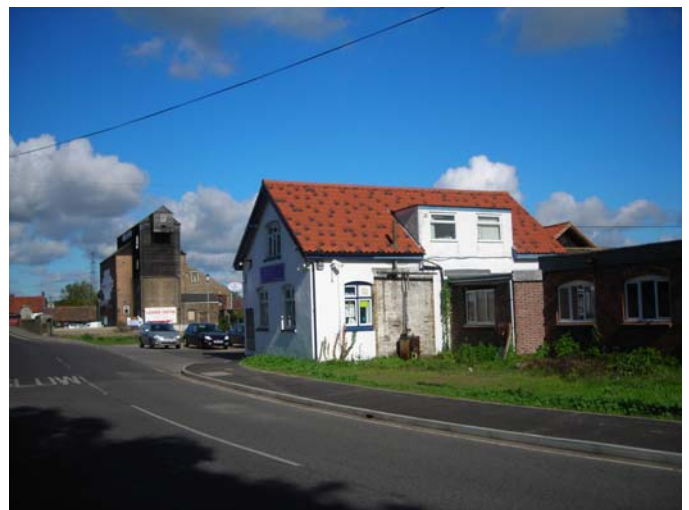
Fig. 45 Quay House from Chelmsford Road with redundant south range to the right. The granary antique centre is beyond to the north.

Battlesbridge Harbour is an industrial complex on the site of the 1930s mill that was demolished within the last 30 years, and which itself replaced an earlier mill destroyed by fire (Fig. 43). Some former mill and quayside buildings remain here. Quay House (now Perfect Vision) at the entrance to the site is an 1890s building that stood at the entrance to Meeson's mill site (Fig. 8). It is much altered with dominant flat roofed dormers and now displaying an assortment of advertising that intrudes on the character of the area (Fig. 44). To the south there is a redundant single storey red brick range which is in poor condition, and appears neglected and untidy from the Chelmsford Road (Fig. 45). The site also includes a distinctive long single storey weatherboarded and slate roofed building (Tack Shop) built around 1900 (Fig. 43, Fig. 44). These two buildings have the potential to make a more positive contribution to the character of the area, particularly in views from the opposite shore, with improvements to their appearance and enhanced landscaping of their setting. An old pump building also survives, but has been significantly altered with a dominant deep-eaved roof which is over prominent in views from the north shore and on the approach along Hawk Hill (Fig. 46).

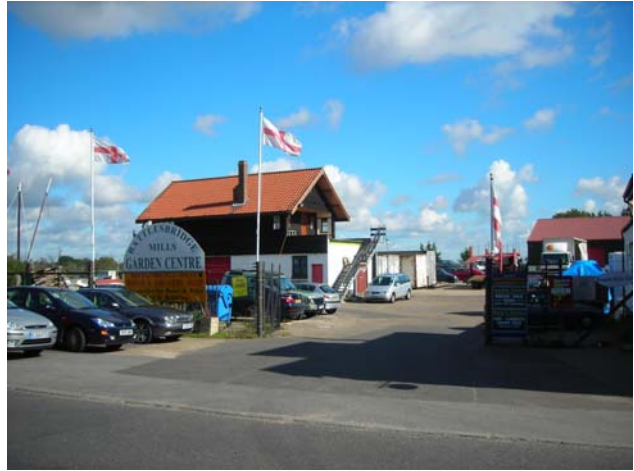
Fig. 46 Entrance to Battlesbridge Harbour from Chelmsford Road, with former mill pump building on left.

As well as these historic industrial buildings, the Harbour area includes modern industrial sheds, shipping containers and large open areas of car parking. Whilst an industrial character is appropriate for this former mill and wharf site, the appearance is generally poor, and creates poor views from the bridge and from Chelmsford Road. The high wire boundary fence along the road edge with open views into the site detracts from the attractive appearance of the conservation area, and cars parked outside the entrance also undermine the character of the area. Adjacent to Battlesbridge Harbour is Battlesbridge Mills Garden Centre, which again has a poor boundary fence along Chelmsford Road (concrete posts and chainlink wire) which displays an excessive amount of advertising (Fig. 47).

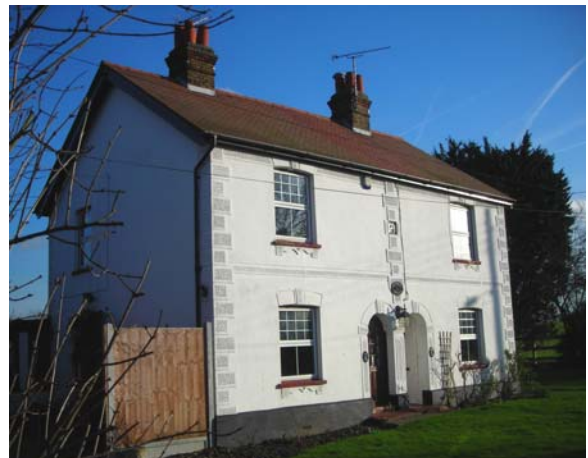
Fig. 48 Telford Cottages.

Where Chelmsford Road turns sharply south a neat pair of white rendered cottages, Telfords Cottages, mark the edge of the conservation area (Fig. 48). These late Victorian or early 20th century cottages have good decorative stucco detailing and round headed recessed doorways that create shadow lines, but they have replacement UPVC windows that detract from their appearance. The close-boarded fence with concrete posts to the left would be better replaced with a boundary treatment more in keeping with the character of the area, such as a hedging.

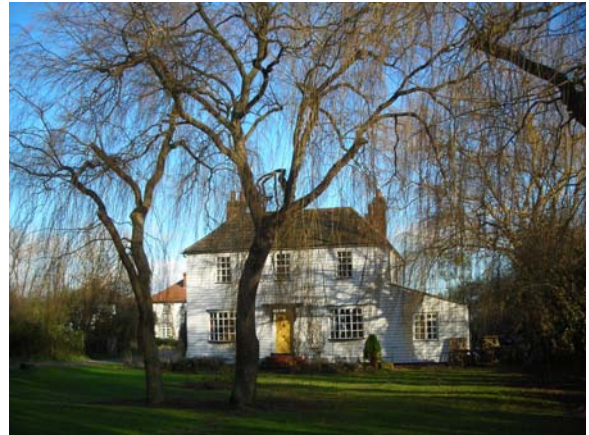
Fig. 49 No. 7 Timber Wharf Cottages

7.19 Behind Little Beeches an unmade tree-lined private track leads to Timber Wharf Cottages (Figs. 49, 50). These cottages form an attractive grouping, and although they have suffered some loss of original features and other alterations (including modest extensions and replacement of windows) the extent of these alterations has not as yet undermined the overall coherence of the group or their traditional character. The group consists of an elegant detached house set back on a green with willow trees, and three pairs of more modest semi-detached cottages. They are all weatherboarded

They are all weatherboarded painted in a traditional scheme of white to the front and black to the side. The detached property has been reroofed with machine made interlocking tiles, whilst two of the pairs have slate hipped roofs and one pair has a clay tile hipped roof. Their informal front boundaries and garden planting contributes to the rural quality of the area. These cottages were mainly constructed between 1830 and 1838, with one pair of cottages added subsequently to the same design. They were associated with the Marsh Timber Yard and quay, located on the riverside to the west of the cottages within a drainage enclosure. Although not visible from the public highway on the south side of the river, they can be seen from the north from Maltings Road across the river channel. Opposite the cottages is an undeveloped green plot with trees and hedges which to some extent helps to screen the industrial site. The informal and unmade access track is an important contributory element in the informality and special character of this grouping.

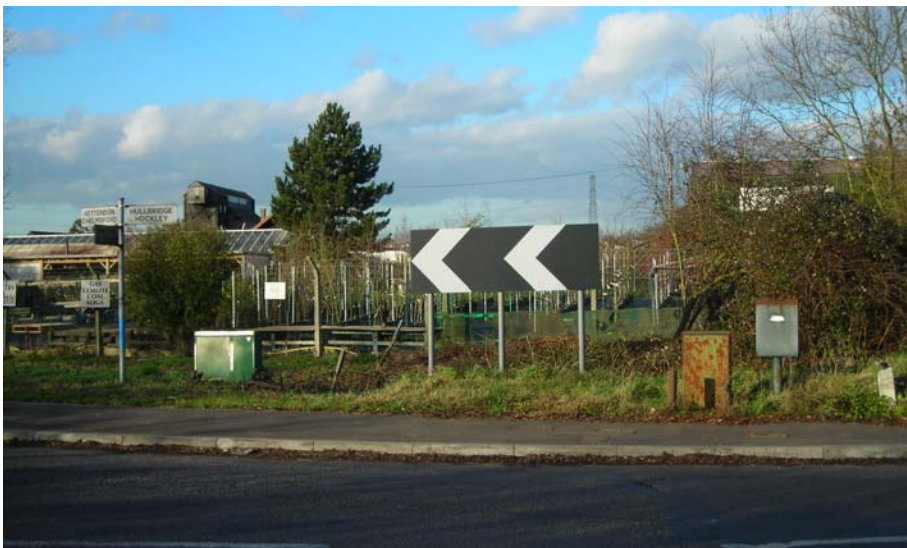
Fig. 51 Street signs and furniture, Chelmsford Road.

11. Approaching the conservation area from the south along Chelmsford Road the road edge on the prominent bend west is cluttered with signage and old street furniture. Rationalisation and replacement with more sensitively designed signs would enhance the appearance of the conservation area, and this will require the cooperation of Rochford District Council and Essex County Council Highways team (*Fig. 51*). In addition if Highways works are carried out replacement of concrete kerbstones with natural stone would enhance the appearance of the public realm.
