Local Development Framework  
Evidence Base

Canewdon Church Conservation  
Area Appraisal and Management  
Plan

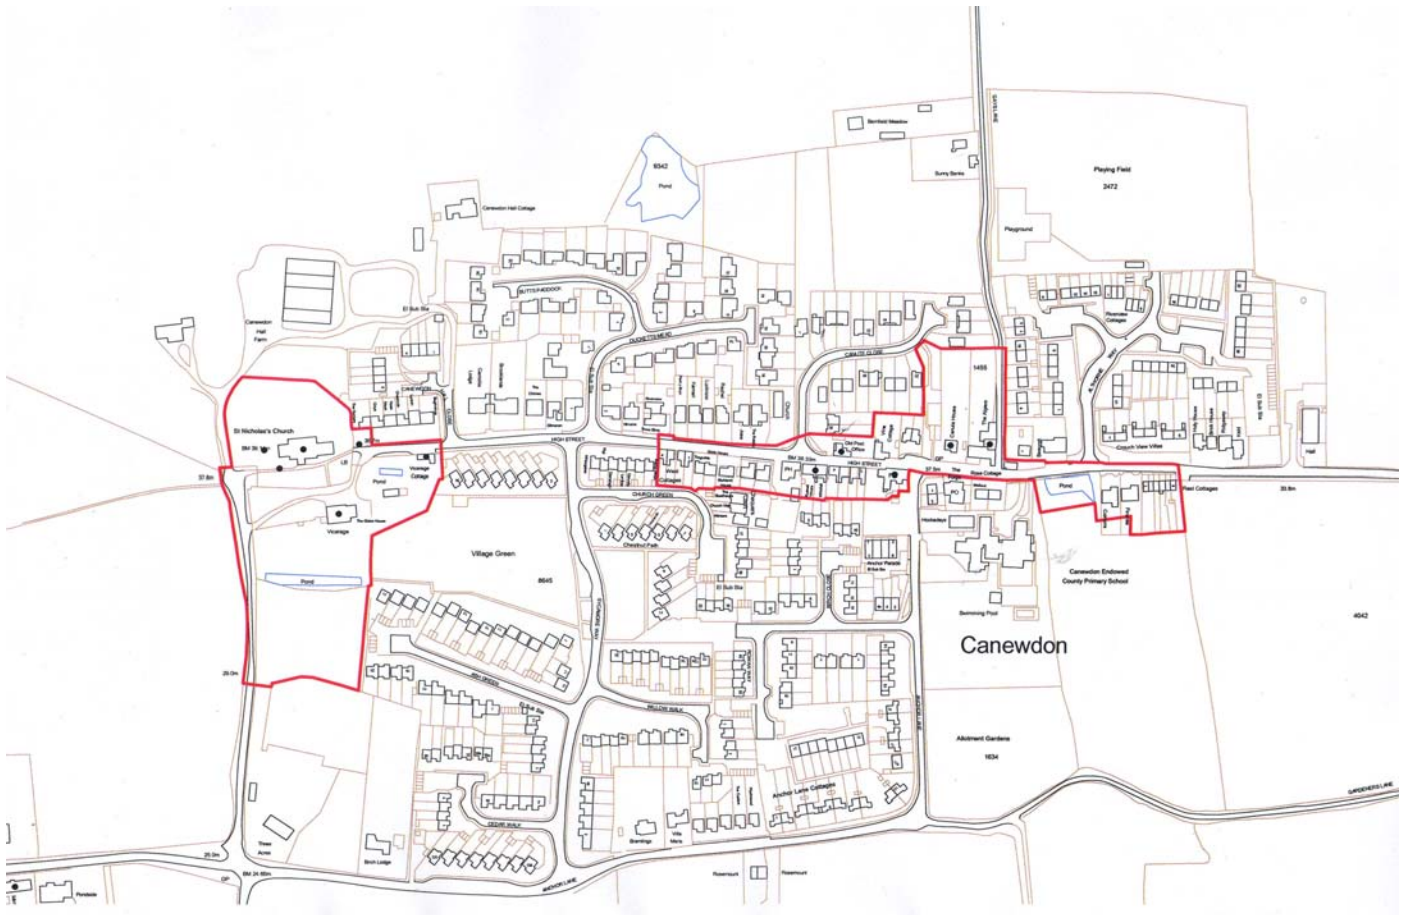
Fig. 1 Canewdon showing the two designated conservation areas and listed buildings (dotted)

- 1.2 There are two conservation areas in Canewdon village, one taking in most of the High Street, the other centred on the church. Canewdon Church conservation area (*Fig. 1*) comprises St Nicholas church and churchyard and The Vicarage and grounds, and covers the western end of the High Street where it meets the churchyard, taking in the village lock-up and stocks and Vicarage Cottage.

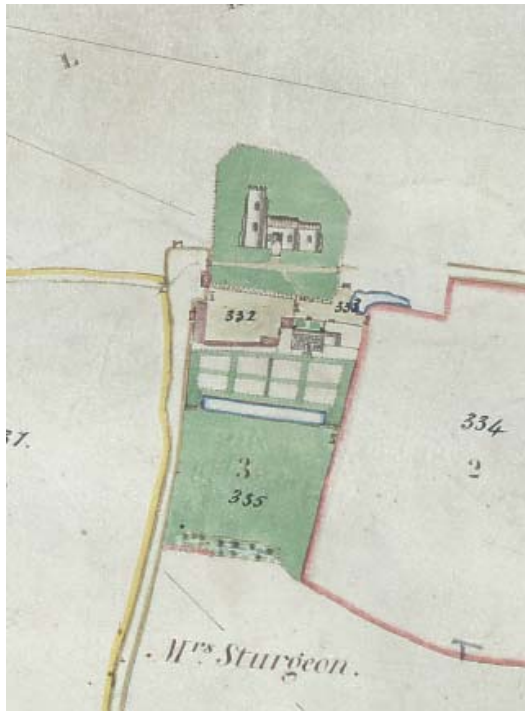
Fig. 3. Map of Vicarage Lands, 1788 (ERO D/DU 743).

- 6.12 The churchyard and vicarage grounds follow the historic layout as they appear in the 1788 map of Vicarage Lands at Canewdon (*Fig. 3*). The churchyard is dominated by the grey Ragstone church which is unusually large for a rural parish church and separates the more enclosed and varied south side of the churchyard from the extensive and open north side. The south side of the churchyard is overlooked by the red brick façade of The Vicarage, and views of the vicarage grounds fall away over the churchyard wall.

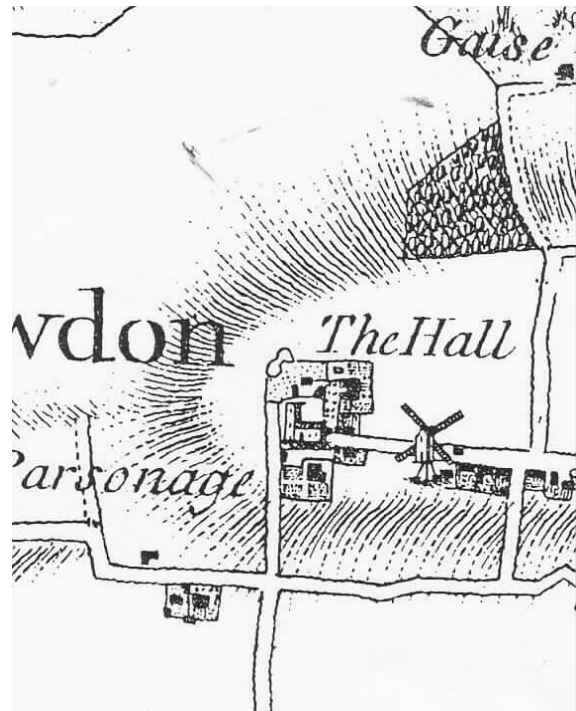
Fig. 4 Chapman and André map, 1777.

- 5.14. A degree of nucleation took place in the later medieval and post-medieval period with the development of the village along the High Street to the east of the church and hall, as well as more dispersed settlement around the four smaller manorial halls and scattered isolated farms and cottages. The extent and location of the later medieval village settlement can be assessed from the 1777 Essex map of Chapman and André, which shows the church/hall complex and a line of dwellings along the southern edge of the High Street (Fig. 4).

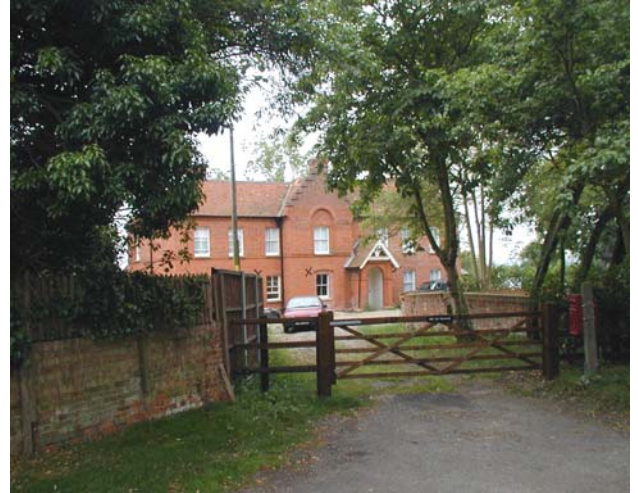
*Fig. 13 View from the High Street to The Vicarage.*

6.6 Just before reaching the gate into the churchyard, a driveway branches round to the left, and here the view opens out across a field gate to the red brick vicarage, a two storey building with a crow-stepped gable and off-centre porch (Fig. 13).

- 6.14 The vicarage stands close to the churchyard boundary on the south east and is a fine brick building with an elegant façade that is clearly visible over the low boundary wall, providing architectural contrast with the church (*Fig. 20*). A memorial in the church records that the vicarage was built by George Walker M.A. in 1758. There have been extensive 19<sup>th</sup> century alterations since this date. It is constructed of warm red brick laid in Flemish bond with some burnt black headers, with a plain clay tile roof to the front range and vertical sliding sash windows. The off-centre 19<sup>th</sup> century crow stepped gable and gabled porch add interest to the elevation. Other elevational details include a brick string course running at first floor level across the east end and the gable and an eaves cornice. The Vicarage and its grounds are currently undergoing extensive sympathetic repairs and restoration. The grounds had become overgrown but are being tidied and a red brick garden wall which is a significant feature visible from the churchyard is being repaired. A new laurel hedge has been planted along the boundary with the churchyard, where perhaps a more mixed hedge of native species would have been more appropriate to the rural character of the area.

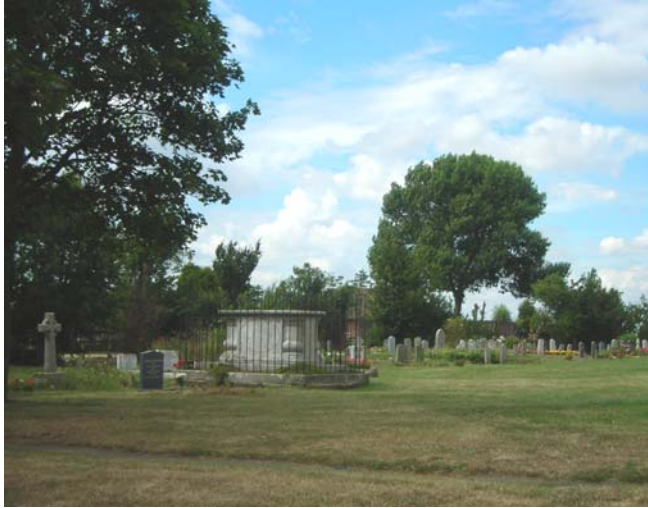
*Fig. 16 North side of the churchyard looking north-west.*

6.8 The space is generally more open and sparse on the north side, except in the north-west corner where the majority of the graves are clustered (Fig. 16).

- 6.16 The north side of the churchyard is more open, with the majority of the graves clustered in the north-west corner, including the most recent. The churchyard is clearly in active use with well tended graves and colourful plantings of flowers. The graves are of varying design, and mostly arranged in neat rows. There are few grand monuments in the churchyard, but there is a fine Grade II listed table tomb west of the church tower dated 1795, with a moulded top slab, bulbous corner pilasters with moulded capitals and bases (*Fig. 24*). This tomb has undergone repairs in recent years following vandalism, and the iron railings around it have been reinstated. There are a high number of post-war wooden crosses, probably reflecting a past decline in economic prosperity. Some are now 40 years old or more, and they have become a characteristic feature of the churchyard (*Fig. 25*). Several memorial trees have been planted in the open area to the north of the church, adding visual interest particularly in the otherwise sparse open area. The buildings of Canewdon Hall Farm are visible through gaps in the hedge, and these do not unduly detract from the character and setting of the churchyard. To the north and north east the churchyard is generally of less visual interest, with fewer views out to the surrounding countryside and modern housing in close proximity. There is a heap of cleared scrub and flowers tidied from graves, together with a water trough and some containers evidently for use by families tending graves. This heap includes discarded plastic bottles, polystyrene and other rubbish, and is unsightly in the otherwise well maintained churchyard.

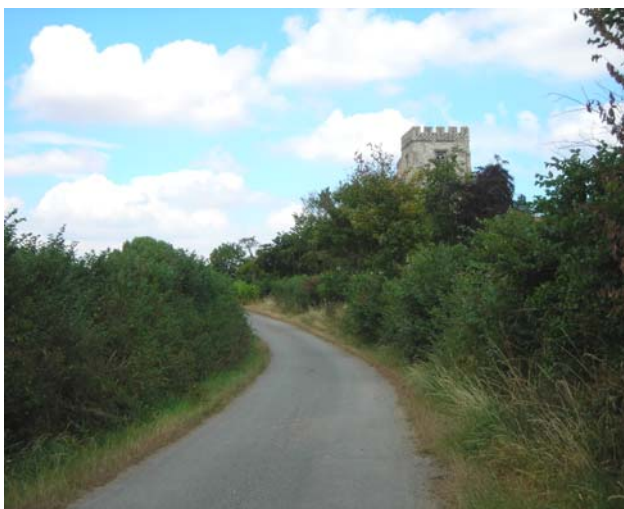
*Fig. 17 Lane leading up to the church.*

- 6.10 The lane running off Lark Hill Road is a historic route leading to Canewdon Hall. It climbs the hill to the church tower in a gentle curve that draws the eye upwards, providing visual drama as the massive tower reveals itself above the surrounding trees and hedgerow (*Fig. 17*). The lane is edged with hedgerow contributing to the rural character, and the modern housing developments of Canewdon village are visible across paddocks to the east. Field gates provide access to the vicarage grounds from the lane. At the top of the hill the lane opens up to provide a parking area by the west gate to the churchyard, and a field gate leads through to Canewdon Hall Farm. Gaps in the hedge at the top of the lane allow expansive views north towards the Crouch estuary and west across arable fields towards Ashingdon.

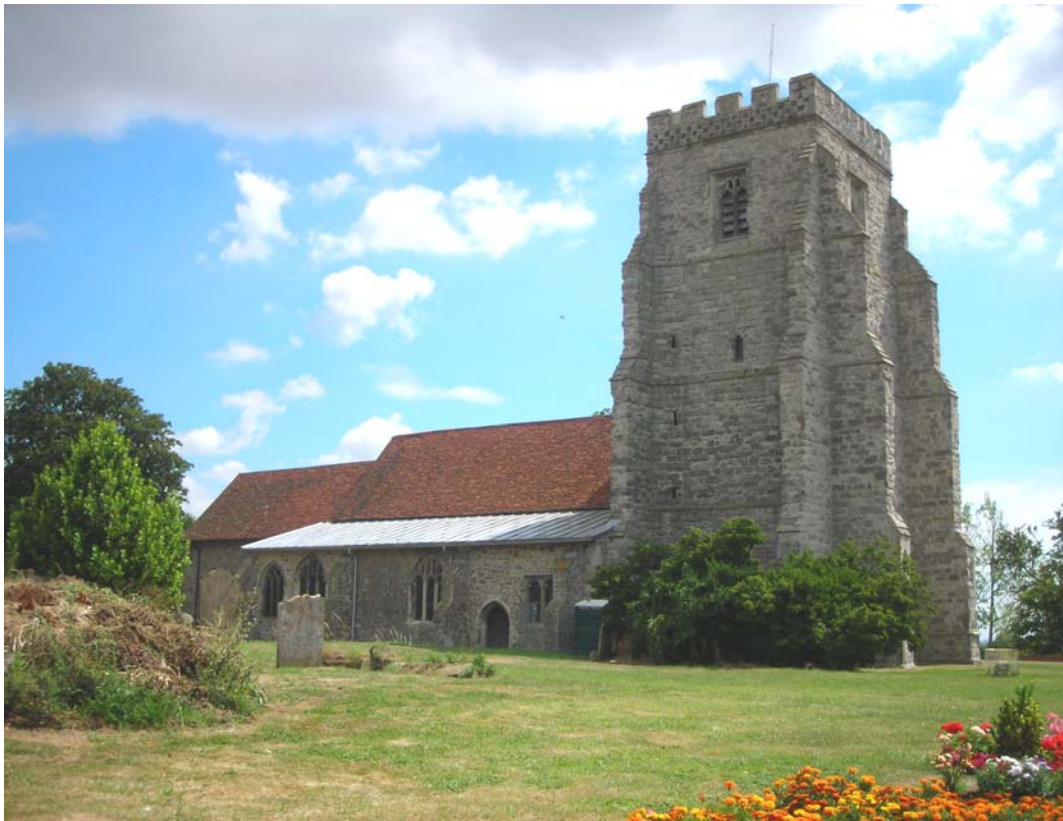
- 6.13 The large parish church provides the focus for the conservation area (*Fig. 19*). It is mainly constructed of Kentish Ragstone with some septaria and flint and limestone dressings. The building is about 38.5 metres in length, and 14 metres wide (excluding the south porch). The roof is mainly red plain tile, with lead over the north aisle. The dominant feature of the church is the early 15<sup>th</sup> century tower, which is an important local landmark clearly visible on the skyline, and provides an exceptional viewing point to the surrounding landscape. It is about 23 metres in height, and is constructed of ashlar Ragstone, and is heavily buttressed with crenellations with flint chequerwork. The tower was restored in 1998. Great difficulty was experienced in obtaining new Kentish Ragstone to match the original. New stone from the Nicholls quarries at Folkestone was used which although geologically similar to the original proved to be an unsatisfactory match. It is not now considered suitable for repairing historical Ragstone buildings. In view of the prominence of the tower, it is important that any future repairs use matching Ragstone. This can be obtained provided there is sufficient early planning and allowance is made for long delivery times. Although the building is generally in good condition, at the time of visiting the door to the west tower had been removed for repair following damage during an attempted break-in, and some windows were broken as a result of vandalism. Some windows are protected by grilles and more are to be installed in the future. Building work is underway to introduce new facilities into the church including toilets, with the intention that the building will be used for a wider range of community activities. The church is Grade II\* listed.

*Fig. 19 The north side of the church.*

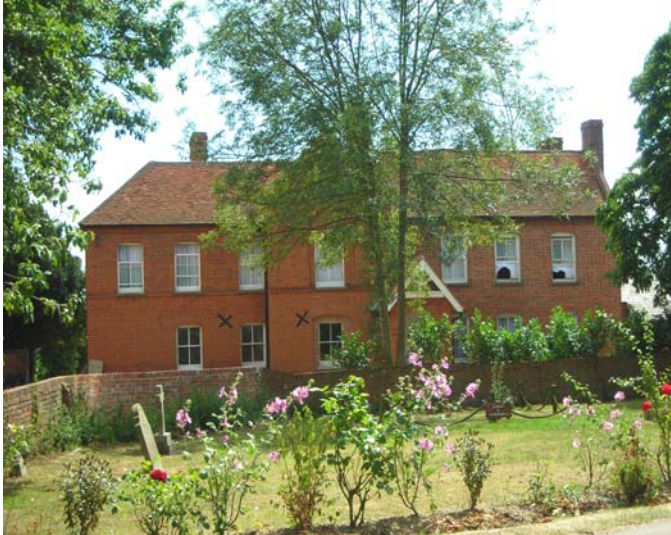
*Fig. 20 The Vicarage viewed over the churchyard boundary wall.*

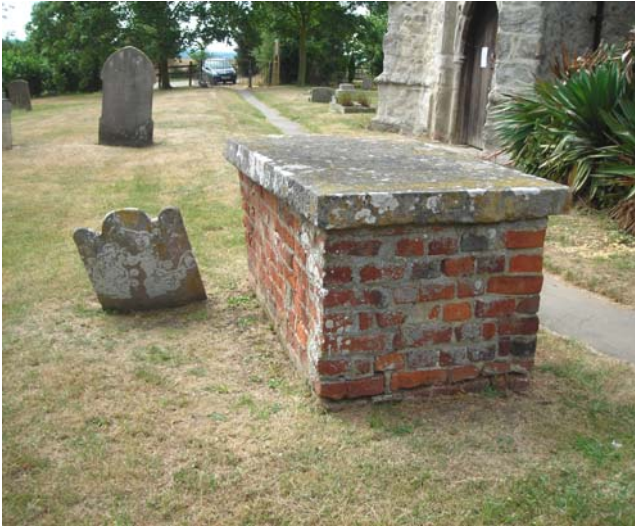
*Fig. 22 Listed headstone adjacent to a table tomb.*

Headstone. Date 1691. Top with 3 arches, the centre taller, carved skull and crossbones. Inscription reads "Here lieth the body of John Allen who died 2 October 1691.

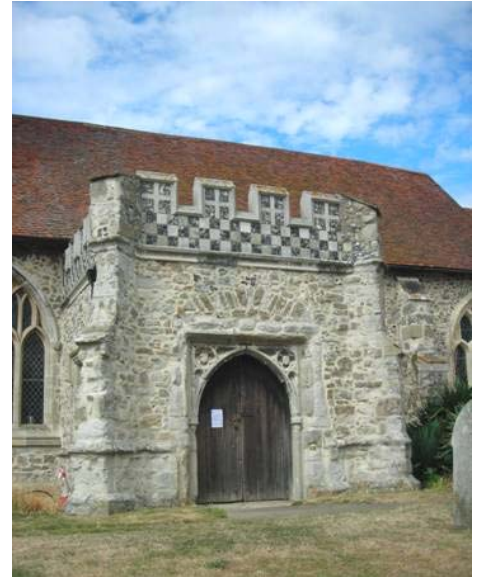
*Fig. 23 The south porch.*

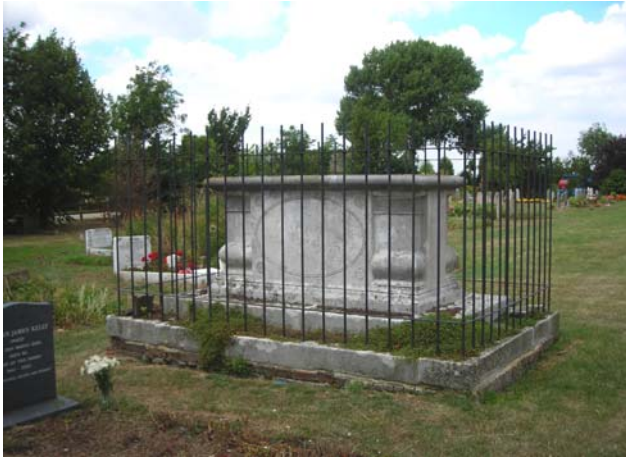
*Fig. 24 Listed table tomb.*

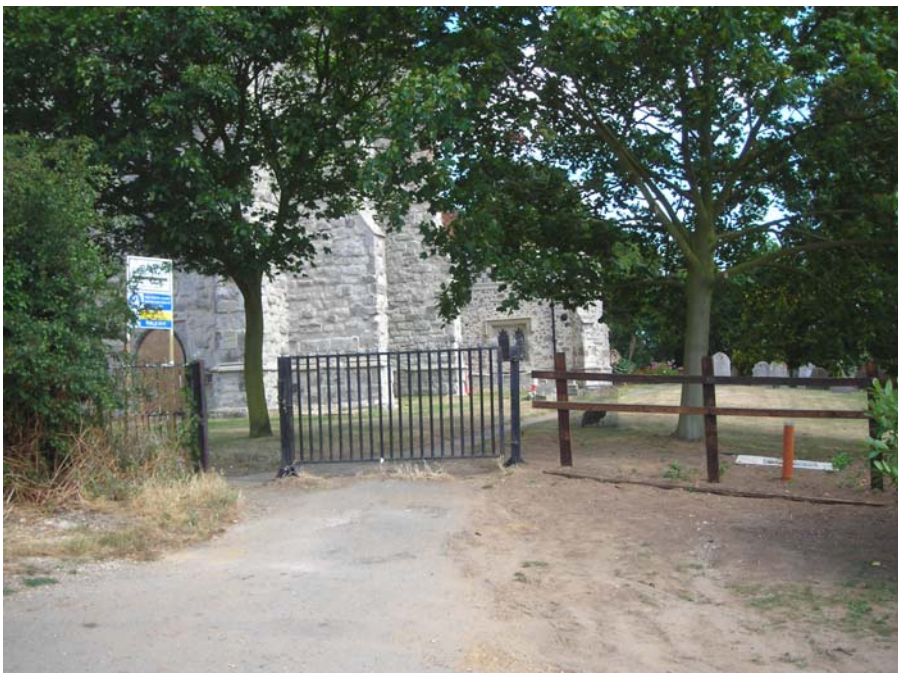
- 6.17 The west entrance of the churchyard has a metal gate with a wooden post and rail fence, and leads to a small parking area (*Fig. 26*). There is an iron side gate with a heart detail matching that at the east end which has been incorporated into the fence. At the time of visiting this presented a rather unattractive entrance to the churchyard, but as building work was underway at the time this is likely to improve. A new cess pit has recently been dug in the south west corner adjacent to the gate to provide toilet facilities in the church. The northern end of the lane leading to the church with rough grass edging and hedgerow on each side contributes to the attractive rural character and low level management of this lane is important to retaining this quality.

*Fig. 26 The west gate.*

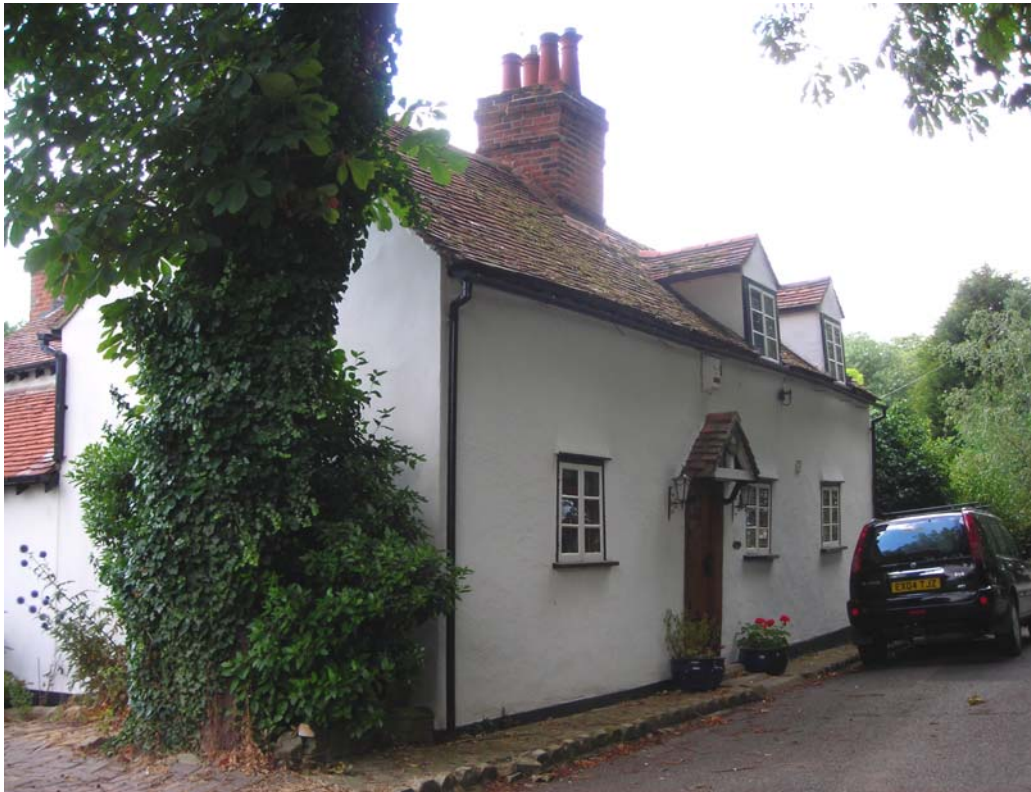
- 6.19 Vicarage Cottage stands on the street edge on the south side, and was built in 1799 on charitable property known as Poors Land to serve as the village school and schoolmaster's house<sup>3</sup> (*Fig. 27*). It is a white rendered timber framed cottage with black and white painted joinery and a plain clay tile roof. It is one storey with two gabled dormers and 19<sup>th</sup> century small paned casement windows. The off-centre door has a small clay tiled gabled hood. An early 20<sup>th</sup> century photograph of the cottage shows that it was once fully weatherboarded, a material that was historically more prevalent in the vernacular architecture of the village than it is now. The cottage is Grade II listed.

*Fig. 27 Vicarage Cottage*

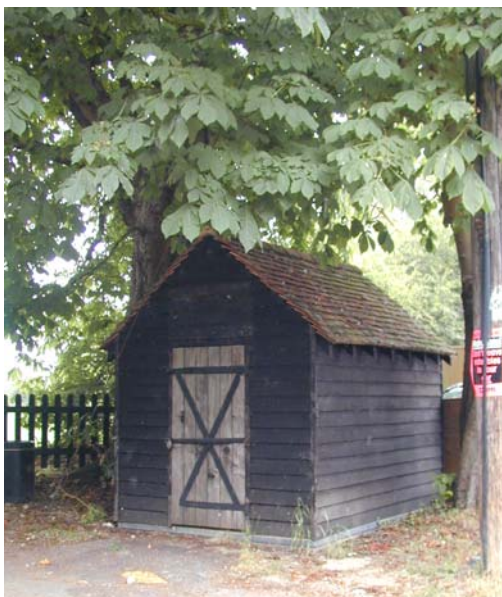
- 6.20 The village lock-up sits just outside the east gate of the churchyard, and is a curious shed-like building, timber framed with black weatherboard and a clay tiled roof, positioned gable-end to the road (*Fig.28*). It has a vertically boarded door with two strap hinges and crossed metal straps. The door is sometimes left open to reveal the village stocks on the floor inside. The structure is in good condition, having undergone significant restoration in 1983. However until recently a board hung over the door identifying the building, along with a round plaque presented to the village for the 900<sup>th</sup> anniversary of the Domesday Book. Both these were recently stolen. This little structure is a good survival of a building type that has been lost from many villages, and is a fascinating nugget of social history<sup>4</sup>. The stocks and cage are Grade II listed.

*Fig. 28 The village lock-up.*

- 5.15. The village lock-up or cage, used by the parish constable for the temporary imprisonment of felons, is believed to have been constructed in 1775. It was originally located along with the stocks now housed within it close to the village pond. About 1913 the cage and stocks were moved to Anchor Lane, with a charge of one penny made to view the interior, and the building underwent large-scale restoration at the time. It was moved to its present position outside the east gate of the churchyard in 1938.
