Local Development Framework
Evidence Base

Rochford Conservation Area
Appraisal and Management Plan

This document was produced by Essex County Council for Rochford District Council.

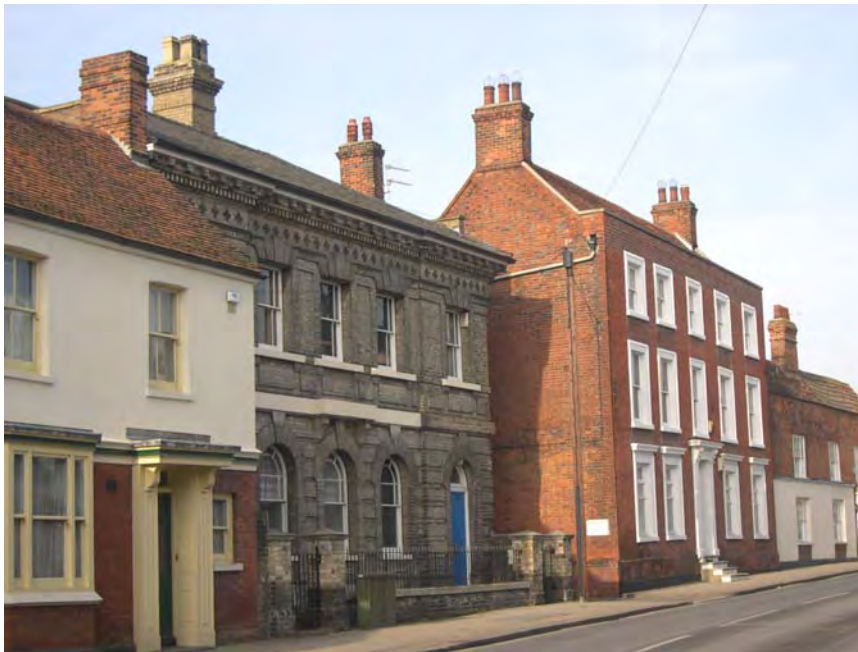
- 9.46 **No. 22**, tall three-storey house, somewhat out of scale with its surroundings. 19th-century, or perhaps earlier (*Fig. 28*). Listed grade II. White painted stucco surrounds to door and windows, ground-floor windows with cornices, door case with consoles to flat hood. Parapet to roof. End stacks. Red brick, flared headers in side walls. Tuck pointing with black mortar fillets and traces of ruddling, but none of this well preserved. Long been used as offices.

Fig. 28 South Street, no. 22 and the Masonic Hall, formerly the County Court.

- 9.47 **No. 24**, built as a Court House in 1859, formerly Rochford Rural District Council offices, now Masonic Hall (*Fig.28*). Listed grade II. White or gault brick façade, stock brick to sides and rear, where there is a huge rectangular flat-roofed block which must house the original court room. This is fortunately invisible from the street, but prominent from the car park to the rear. There is also a modern rear extension, recently the subject of an application to improve access arrangements. The detailing of the façade is slightly heavy-handed and very sharp-edged: the ground floor has imitation rustication, with round-arched windows with raised surrounds; the first-floor has gauged brick arches with imitation voussoirs. The sash windows have marginal glazing. The façade is very well preserved, the only significant change being the loss of the original railings to the low brick boundary wall. They have been replaced with unfortunate spindly railings with silvered arrow tips. The appearance of the building would probably benefit from cleaning; white brick usually withstands the process successfully and comes up well.

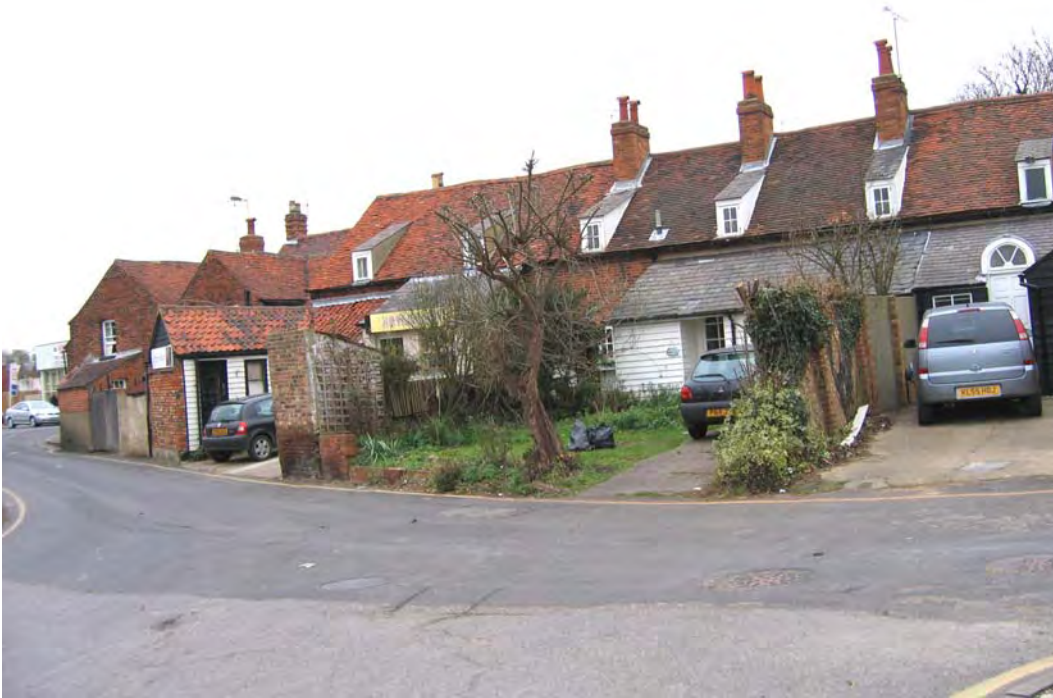
Fig. 32 Back Lane, rear of cottages at the rear of the west end of West Street.

9.60 The Lane is narrow, its surface patched, and there are no sidewalks. It feels like a pedestrian space, but in fact traffic can drive two ways along it, though access is only possible from South Street. It is generally free from parked cars, but where there is space behind the West Street buildings, there is parking on hard standings or in yards. The gardens of the cottages at the west end have been turned into parking lots (*Fig. 32*).

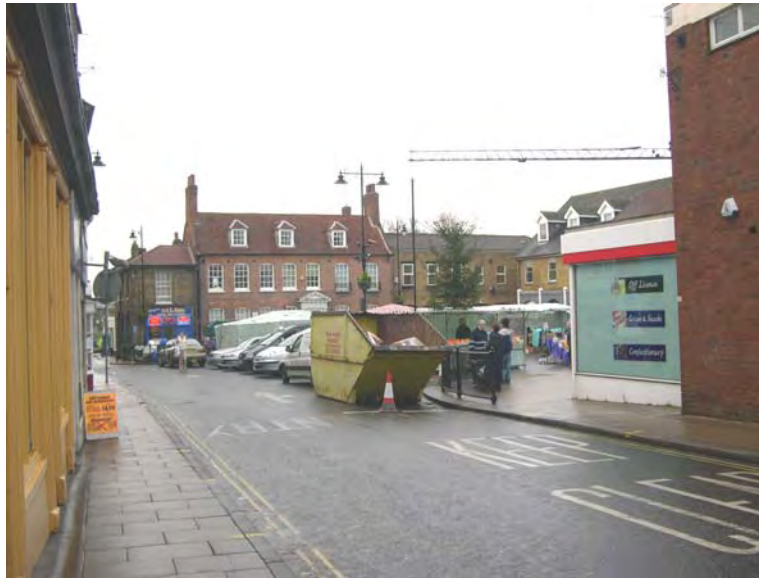
- 9.65 The market seems to have lapsed at the end of the Middle Ages. It was revived in the 18th century. In the 19th century, there was a weekly corn market on Thursday, with a market for livestock every other Thursday (Benton II, 887). It then lapsed again, lasted until 1959, and was resurrected again in 1979. Today there is an active Tuesday market which is significant feature of life in the town. Litter removal is a problem associated with the market, a large yellow skip being parked conspicuously in the Square on market days (*Fig. 33*).

Fig. 33 Market Square on a market day.

- 9.66 Short stay car parking is allowed in Market Square. A consequence is that there are often queues of cars backing up into South Street waiting for a parking place, only adding to the dangerousness of the traffic at Horners Corner. Traffic and parking in the Square should be reviewed. Since the Back Lane car park is

only a short walk away, parking could be confined to taxis and the disabled, and the Square effectively pedestrianised.

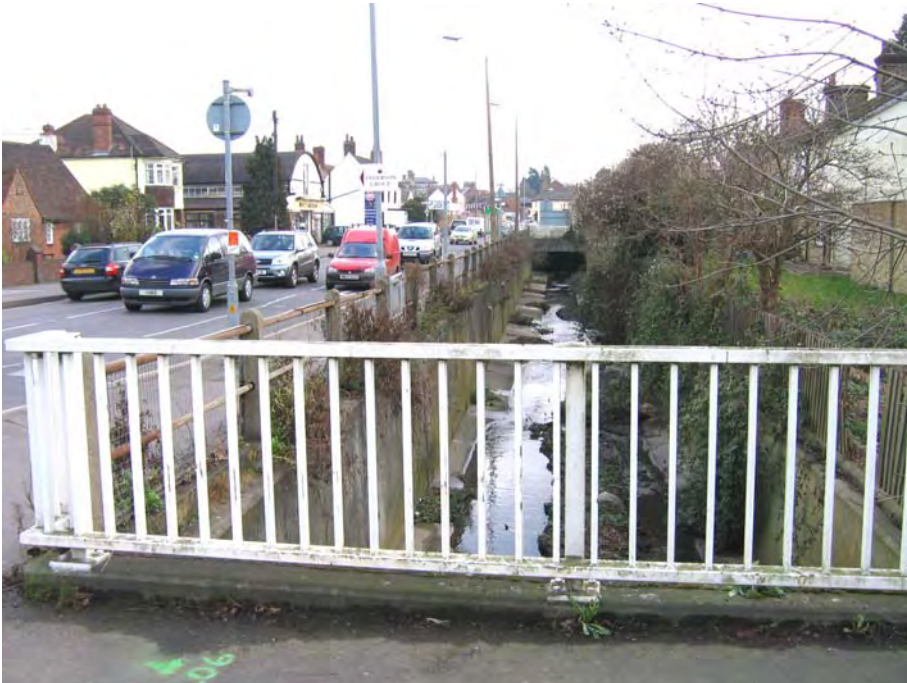
- 9.73 On the south side of the road, the stream which runs next to the pavement ought to be a feature of interest in the landscape. However, it is channelled in a concrete sided conduit which is overgrown and traps litter (*Fig. 36*). Worse, the conduit is bordered by tubular railings set in concrete posts, to which have been attached, presumably for safety reasons, wire mesh screens. Whilst the conduit may be a fact of life, this boundary treatment is ugly and should be improved.

Fig. 36 West end of West Street, the concrete lined conduit for the Iron Well Stream.

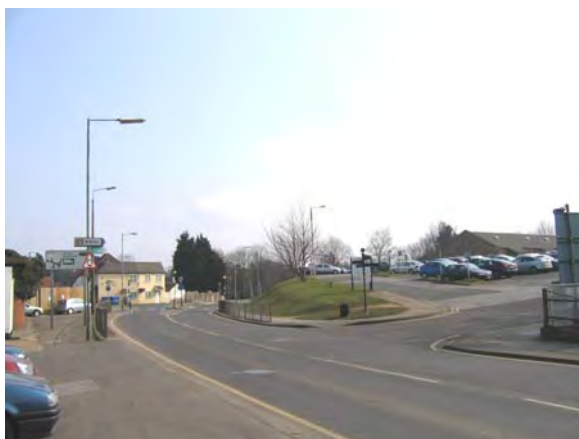
- 9.75 Further east, the land rises from the road side back to **Rochford station**. Unfortunately, this low hill is a car park and the station buildings are mostly single storey and insignificant as a landscape feature. By the road edge there are utilitarian galvanised railings. A bare grassed bank separates the pavement from the car park, where there is a forest of signs, lights and cameras (*Fig. 37*). On the north-western boundary there is a tatty hedge of ivy-grown trees. The potentially attractive station buildings are not well maintained. The southern two-storey part, the former station master's house, is boarded up and to let (*Fig. 38*). The platforms retain their old canopies supported on cast-iron columns. The brickwork of the buildings facing the platforms has been painted terracotta. The appearance of the iron footbridge has been adversely affected by a high level safety screen. There is no sense of any coherent overall design to the works that have taken place at various times to the station and its environs. This area is badly in need of improvement.

Fig. 37 West Street, view of Rochford Station car park.

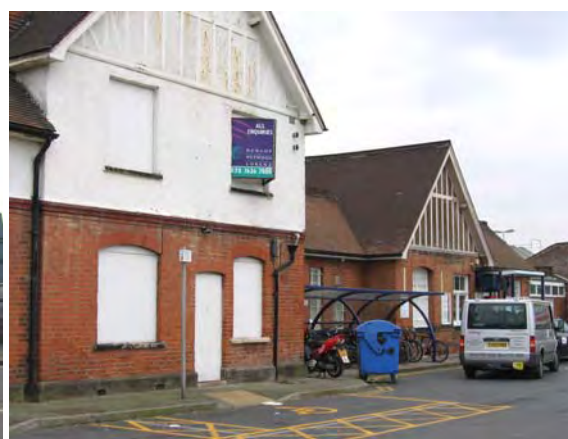
Fig. 38 Rochford Station, boarded up former station master's house.

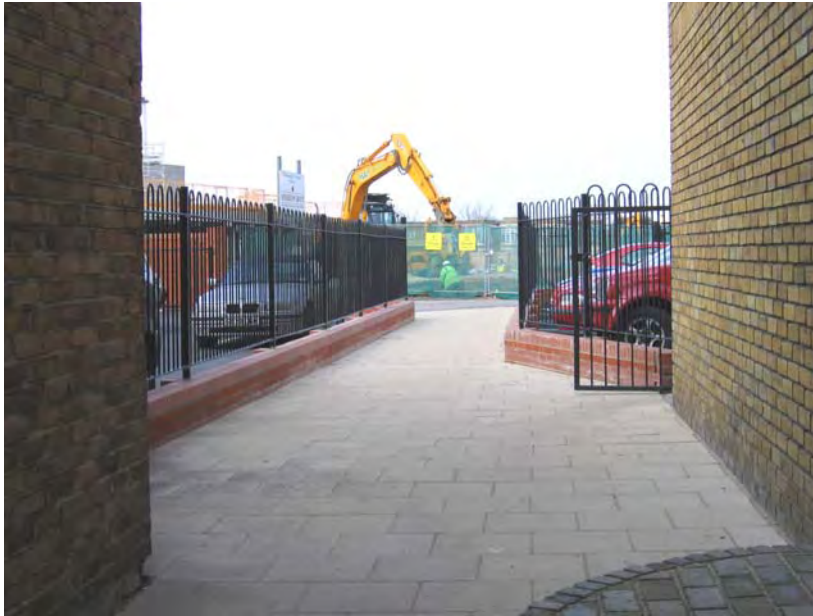
alleyway flanked by new hoop-topped railings, and flanked by newly surfaced shiny black car parks, leads to the supermarket and library development site and North Street. The view down this alley to the area of the superstore development is potentially important: the existing treatment of the alley is rather mean and uninspired, and not very promising for its future appearance (*Fig. 42*).

Fig. 42 View down alley at north-west corner of Market Square to the new development on the hospital site.

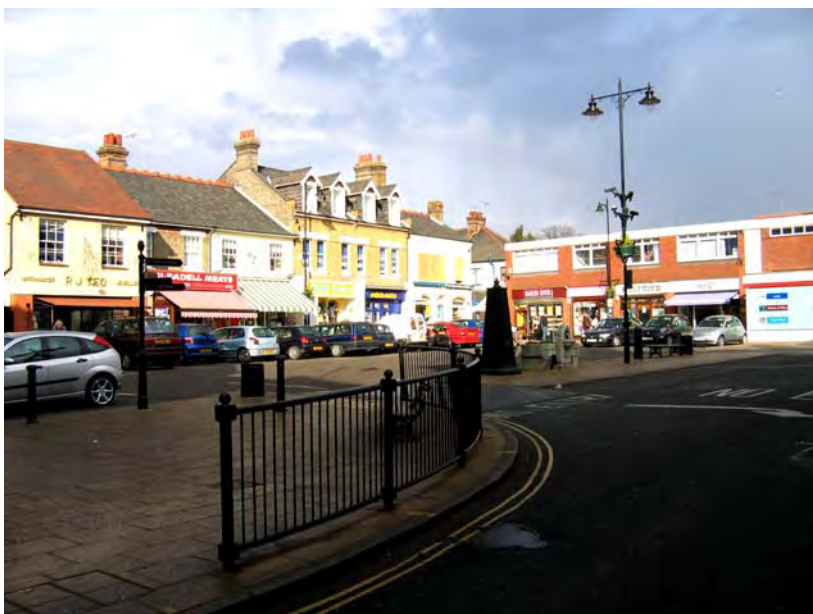
Fig. 43 Market Square, north and east sides.

- 9.92 **Nos 20-22**, Cleadell Butchers and Miss Daisy, a low two-storey late 19th-century stock brick building. The butchers shop front projects out at ground floor to bring it in line with Yeo Jewellers, and has been modernised, with a large plate glass window with unattractive tiles below. Miss Daisy has a nice traditional shop front, but the brickwork above has been painted cream (*Fig. 43*).

- 9.93 **Nos 16-18**, Home Plus 2 and Abbots estate agents occupy a tall two-and-a-half storey late 19th-century building stock brick building with prominent dormers. Decorative stone lintels and cills to windows, fancy bargeboards to dormers. Shopfronts quite good, but let down by poor signs (*Fig. 43*).

- 9.95 The east side of the Square is occupied by a late 1960s building consisting of four shops, of which the most prominent is the Spar supermarket, as it sticks out into the Square reflecting the footprint of the buildings which formerly stood here (*Fig. 43*). The building is low, two storey, with a flat roof, of a reasonable quality brick, with tile hanging at first floor to the Square. The shop fronts are plain; there are metal framed windows. The main problem with the building, what makes it actively ugly, is the projecting part of the supermarket, a glazed box, the windows of which are largely blanked out. The elevations to West and North Streets are also unsatisfactory, that to West Street being a plain brick wall, and that to North Street being functional, with service doors and areas and no sense of presenting a façade to the street.

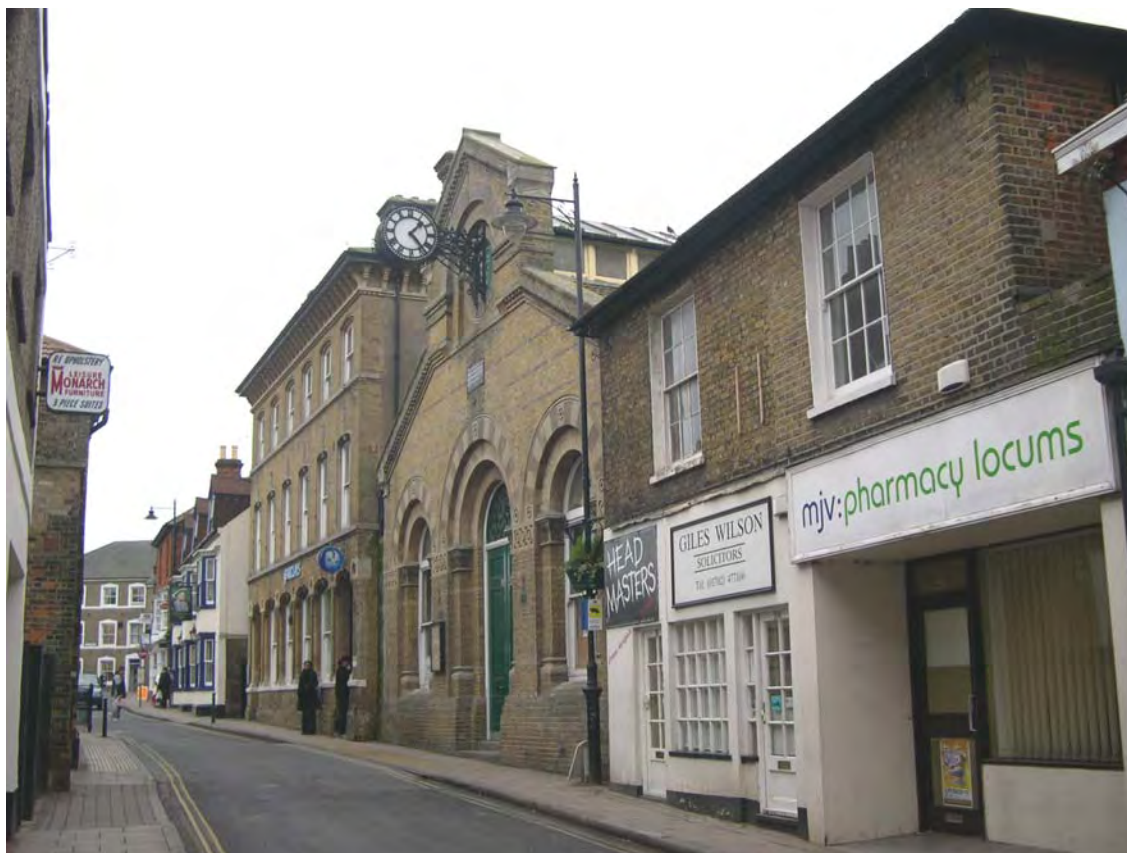
- 9.100 **Barclays Bank**, listed grade II stock brick with stone detailing and ornament, very imposing, three storey and out of scale with its surroundings, though the effect of this is to some extent absorbed by the slope in west Street (*Fig. 44*). Built in 1866 (Benton II, 898).

Fig. 44 West Street, nos 21-23, former Corn Exchange, and Barclays bank.

- 9.101 Former **Corn Exchange**, built 1866 to a design by Frederic Chancellor, the well-known Chelmsford architect, now the Women's Institute. Listed grade II. Stock brick with white brick and stone detailing and ornament. A good example of a building of this kind. A conspicuous feature is the clock projecting on an iron bracket erected for Queen Victoria's jubilee in 1897 (*Fig. 44*).

- 9.102 **Nos 21-23**, two storey, stock brick with sash windows at the first floor (*Fig. 12*), well preserved, but the ground floor a sad contrast, being rendered and white painted (*Fig. 44*), a series of shop fronts, the right hand one (mjb pharmacy locums) having been remodelled and set back behind the line of the façade with a large plate glass window.

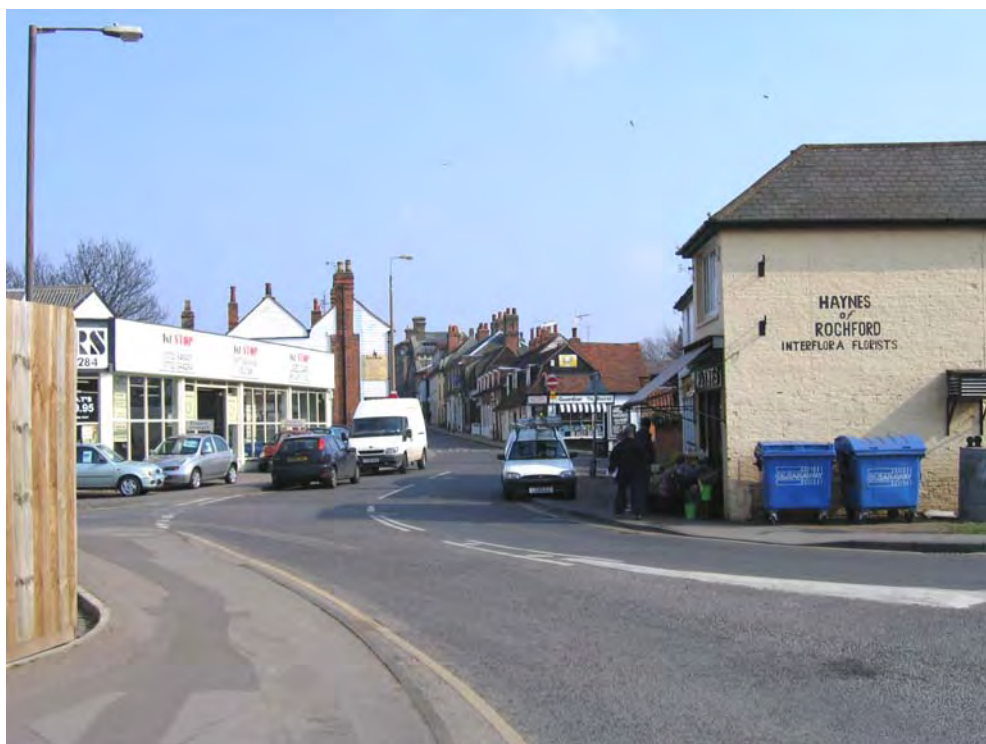
- 9.112 An isolated building, occupied by the Royal Tandoori Restaurant and Haynes Florists, stands in a prominent position on the south side of West Street at the entrance to the town centre. Two storey, brick, now white painted, concrete roof tiles. The restaurant has a garish plastic sign. Haynes is painted yellow. It is not enhanced by two skips outside it, and two ventilation units in its west wall (*Fig. 46*).

Fig. 46 West end of West Street, at the junction with Bradley Way.

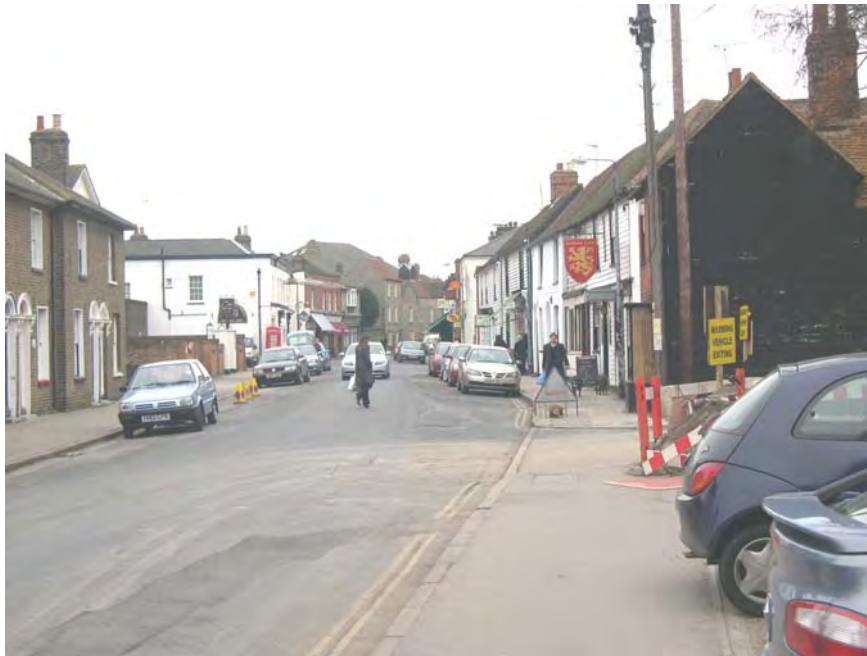
9.113 This is a long straight flat road, uncluttered by excessive signs or wires; the views up it are pleasant but undemonstrative, the road flanked by low buildings (*Fig. 47*). At the north edge of the conservation area, there is a slight bend and drop in level where the White Horse stands, a view that hints that it might lead to open country, which of course it has not done for a long time. At the south end, the road narrows, doubtless the result of encroachment in the course of market infill, and there is a change in scale with taller buildings. There is a contrast, too, between the commercial use at the southern end of it, a secondary shopping area, and the more residential character of the rest of the street. Typical of it are rows of 18th- or 19th-century weatherboarded cottages, as well as two notable terraces of 19th-century stock brick terraces. It seems to have become built up from the 18th century onwards. The presence of two Non-Conformist churches may also be significant as shortage of space in town centres often caused these to be built in peripheral locations. There is no evidence today that the road was settled in the Middle Ages.

Fig. 47 North Street, looking south to the stock brick buildings of the Horners Corner complex, the Golden Lion on the right.

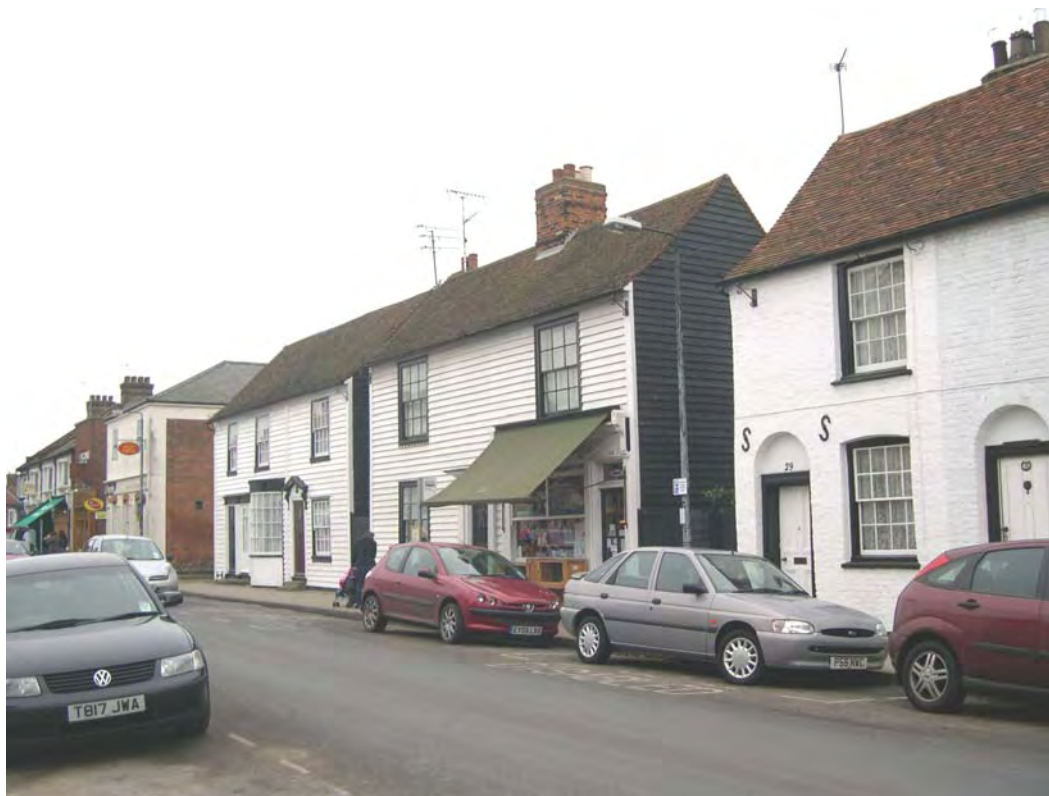
- 9.117 **No. 17**, post office and Premier store; the good if not very special quality of the original post office has been eroded by successive alterations (*Fig. 48*). Red brick, white painted pebbledash to the front, where there is an excess of unsuitable signs, the white box metal ones creating a visual ambiguity with the white wall. North elevation functional, south has sash windows and ramped block paved access to the entrance door. On this side there is a yard shared with no. 15, currently an ugly space filled with bins and a skip. To the north, a gap with views through to the hospital development site and car parking on the north side of the Square. This will be one of the ways into the new supermarket development. Unless some landscaping is carried out, it will not be very enticing. The flank wall of the post office is ugly, whilst there are modern extensions to the rear of the Market square shops. Adjacent to the post office, a nice ERII letterbox with two posting slots, and a grade II listed cannon used as a bollard.

Fig. 48 Nos 21-31 North Street.

- 9.118 **Nos 21-23**, two, formerly three, nice weatherboarded cottages, white fronts and black sides, grade II listed, probably late 18th century (*Fig. 48*). Rear gambrel roofed extension; bow-fronted small paned ground floor window. Right hand cottage has a Norwich fire insurance sign.
- 9.119 **Nos 25-27**, grade II listed, probably late 18th century, nice weatherboarded double-fronted house, now with a shop (Animal Fayre) to the right (*Fig. 48*). The shop front is old, a full width sash window. Good door case with frieze with paterae. Gambrel roofed rear extension.

- 9.120 **Nos 29-35**, terrace of grade II listed 18th-century or later cottages, with the **Golden Lion** public House at the north end. First a pair of white painted brick fronted cottages (*Fig. 48*), the brick doubtless replacing an earlier material, weatherboarded side, round arched doors, sashes with panes of various types. No. 35 is weatherboarded, with a wide glazed shop front, currently empty, and in need of decoration. The Golden Lion is also weatherboarded, white painted with black joinery, an attractive double-fronted elevation with restrained signage, modern gambrel roofed extension to the rear. View through to asphalted yard used for parking and the hospital building site.

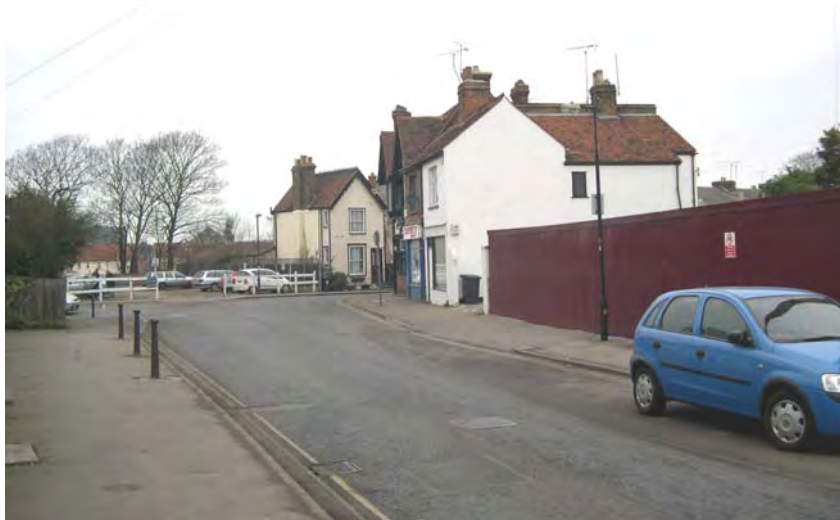
- 9.123 There follow two empty plots, the first apparently the site of a demolished building, currently overgrown with buddleia and littered with refuse, and the second the car park for the Rose and Crown on the other side of the road. The car park is large, potholed, with crumbling larchlap fencing covered with no parking signs. Unfortunately it occupies a prominent position at a junction, being particularly visible from Weir Pond Road (*Fig. 49*).

Fig. 49 Weir Pond Road, looking west to the Rose and Crown car park in North Street.

- 9.124 **No. 55**, Ash Cottage, a tall conspicuous partly weatherboarded detached house, the fancy ridge tiles and bargeboards, and large stock brick flank stack, indicative of a 19th-century date. Cream painted, black and white joinery, basement area (*Fig. 49*).
- 9.125 **Nos 57-59**, brick and weatherboard houses with sash windows, separated by a wide carriage arch. A new development, possibly of the 1980s, they fit in nicely.

- 9.144 Old photographs show Weir Pond Road to have been a pleasant rural lane, and reveal that some impressive old buildings on its north side at the west end have been lost. Today, it is rather bleak, its north side built up with houses in the 1960s or 1970s, set back from the road, most with their front gardens paved for parking, very few with traditional hedges. On the south side at the west end, there are attractive rows of cottages. There is also a degree of mixed use giving visual variety, represented mainly by Does premises. Parked cars on both sides in the eastern half of the road, where there are no restrictions, do not enhance it. At the west end of the road, there is a depressing view into the Rose and Crown car park on the west side of North Street (*Fig. 49*).

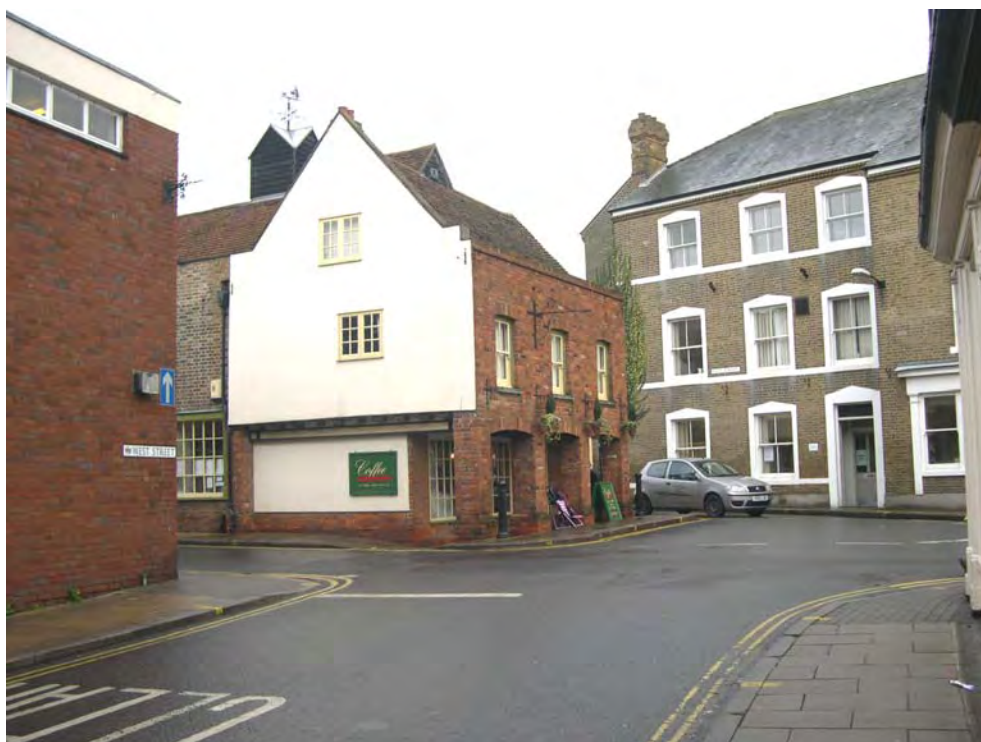
- 9.129 **Nos 2-4**, the **Horners Corner** complex, listed grade II (*Fig. 50*). The building facing on to the South Street junction was revealed as 16th-century and timber-framed when restored in the 1980s (see East Street). A sign still marks the English Heritage grant to its restoration. To the rear is a 17th-century building cased in stock brick and then a 19th-century three-storey stock brick building.

Fig. 50 Horners Corner, Acacia House in the background.

- 9.157 **No. 1, Horners Corner**, is a complex of buildings which was a former butcher's shop (*Fig. 50*). It was empty and boarded up for about ten years in the 1970s and 1980s, but then was restored in phases from 1986 by Lawrence and Adrian Chapman, with the help of a town scheme grant and English Heritage. Observations on the building and its archaeology were made by Essex County Council but remain unpublished. In brief, opening up of the structure facing on to South Street revealed a timber-framed building of the 16th century, whilst foundation trenches exposed layers representing a sequence of small buildings dating back probably to the 13th or 14th century and representing the gradual building up of an open market place. The building occupies what is arguably the most prominent position in the town, at the intersection of the four principal streets, and closing the view at the end of South Street. The restoration has seen the removal of the render from the façade exposing the red brickwork encasing the timber frame, and the replacement of the shop window with two brick arches, a new shop front being set behind these. The porticoed appearance is somewhat alien in an Essex town, but has the advantage of creating more pedestrian space in an area where the pavement is narrow. The cupola above the roof is not architectural whimsy; it covers a matchboarded shaft which rises the height of the building and may have been for smoking meat.

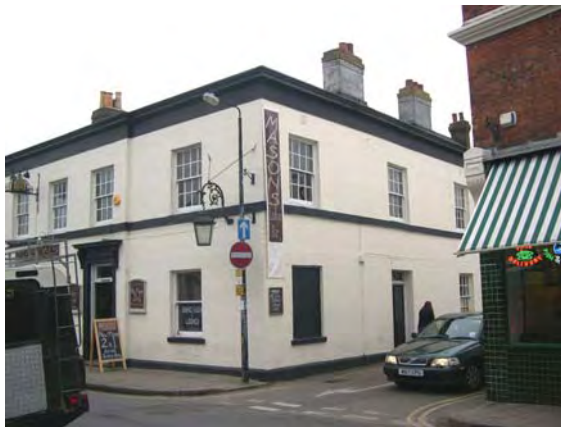
- 9.133 The **Old Ship** public house, listed grade II, 19th-century in appearance, large, imposing and historic but exterior painted leading to a loss of character, abetted by the signage associated with its new identity as Masons Lounge Bar (*Fig. 51*). Of six window bays, the central four projecting forward. Moulded parapet to low hipped roof. Stucco string course. Consoles to the hoods of the two doors. Nice cast iron lamp and bracket at right corner. Well preserved 19th-century rear extension on this side in stock brick. Carriage arch on left hand side. A K6 telephone box stands next to the pub on the north side, where is an old stock brick wall, the back of a lean-to stable, set well back from the frontage; the space in front of it has unfortunately become a hard standing for parked cars. Depressing view into the pub garden through an open carriageway (*Fig. 52*); the front part of it is gravelled and used for parking; the rear, partially screened by evergreens, is a beer garden with a derelict children's play area and three garages. Litter is a prominent feature of this space.

Fig. 51 North Street, The Old Ship.

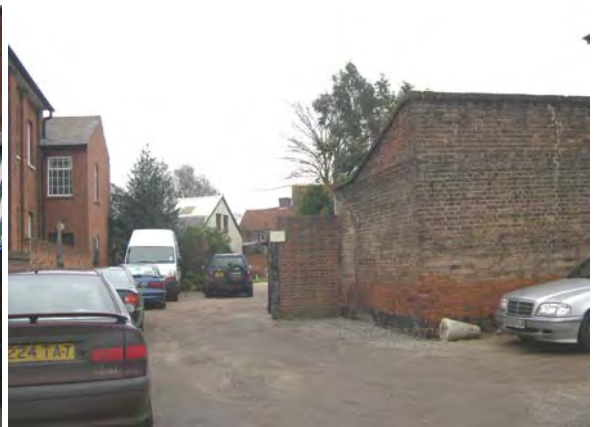
Fig. 52 Hard standing adjacent to the Old Ship, with view through into its garden.

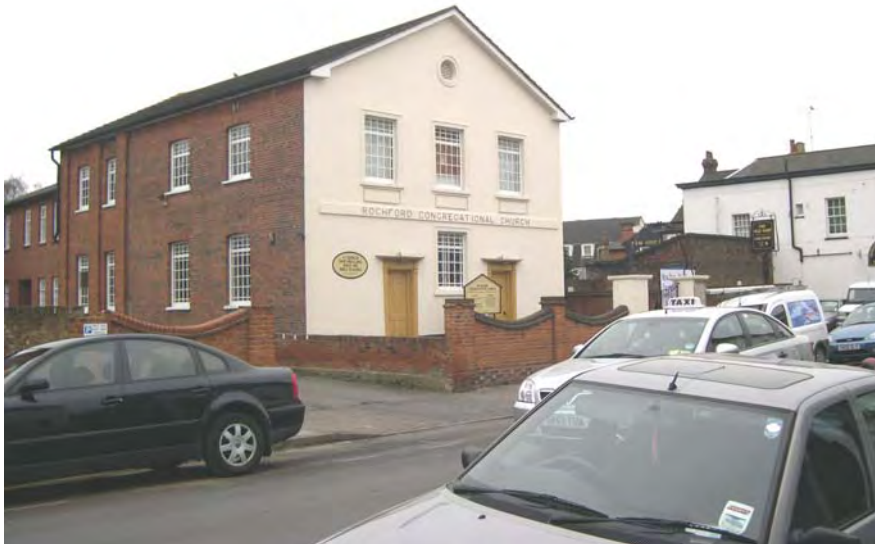
- 9.134 **Rochford Congregational church**, a plain gaunt building, the more so because of the sea of asphalt in which it stands (*Fig. 53*). The car park extends right to the back of the plot on the north side. The asphalt covers a burial ground which has been completely cleared. The chapel is a red brick building, but the front is stuccoed and lined out, with two entrance doors. The original building was square in plan, and dated from 1741 (Benton 1888, II, 888; Kaye 199, 62). It was extended by two bays in 1838, at which time the existing galleries must

have been put in. A large extension has since been made to the rear in the late 20th century. The site is enclosed by modern brick walls, but the old stuccoed brick gate posts, with their iron gates and lantern on an iron arch above them, are notable. The setting of this building desperately needs to be softened by some planting. In view of its age, the chapel could be considered for listing. To the rear of the site, there is a nice detached stock brick building of four window bays; UPVC windows to the first floor.

Fig. 53 North Street, the Congregational chapel.

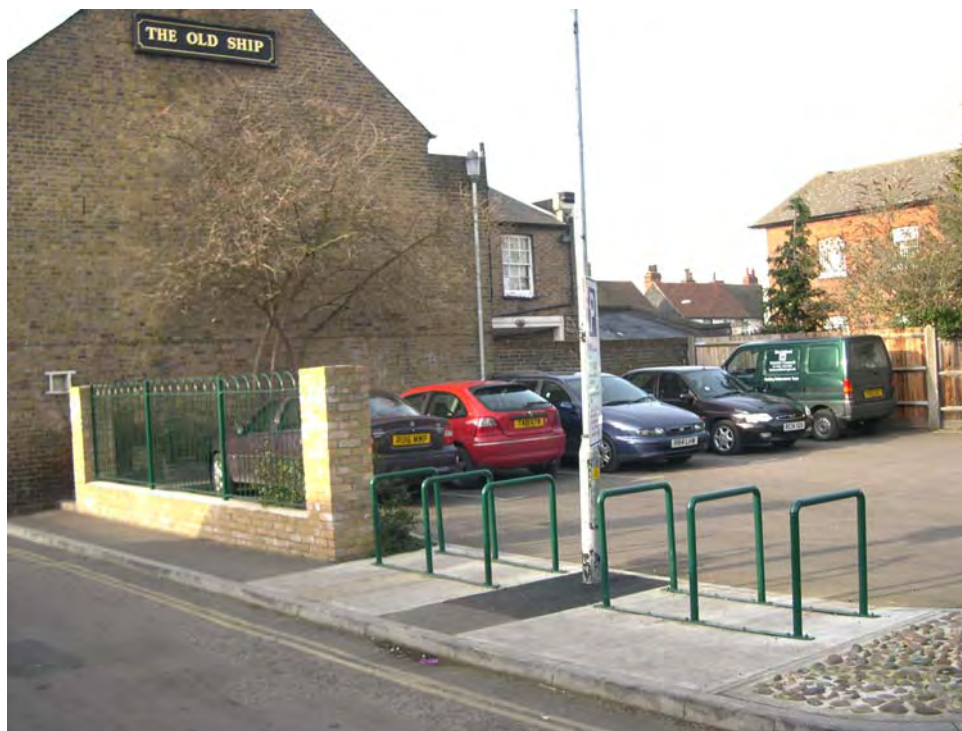
- 9.142 From North Street, the lane begins well, being enclosed by the buildings to the rear of nos 8-10 and the Old Ship and by stock brick walls with wooden gates. On the north side, however, the sense of enclosure is broken by a newly laid out and very unsatisfactory car park (*Fig. 54*). The boundary to the lane is a low brick wall marred by salt efflorescence, with crude cement flaunching on top of it, above which are spindly hooped railings which have been already vandalised. The effect of this car park is made worse by a degree of visual continuity with the bare asphalt car park to the south belonging to the New Ship. Despite the presence of these car parks, parking is allowed on the south side of the Lane.

Fig. 54 Old Ship Lane car park.

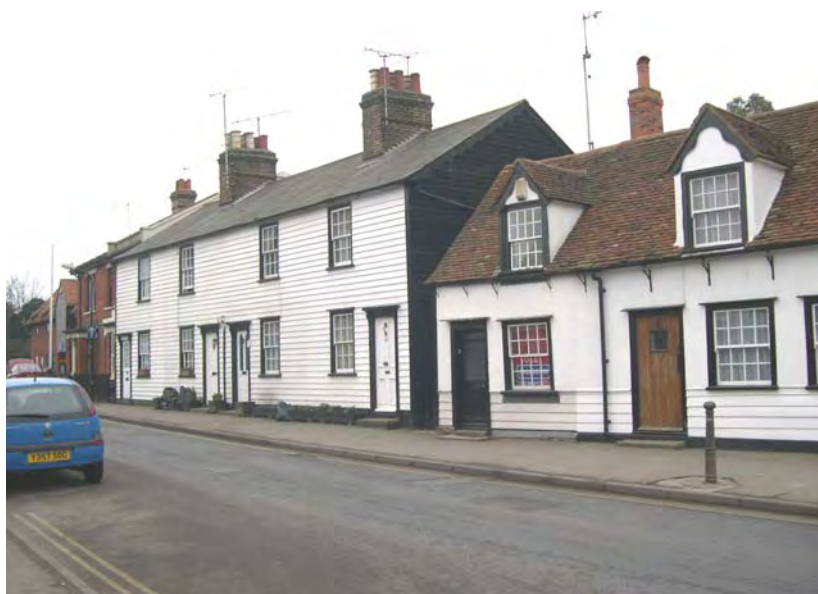
- 9.146 Four cast iron bollards on the south side of the road are a reminder that this is part of the conservation area. **Nos 2-8** are a row of rendered one-and-a-half storey cottages with dormers with fancy bargeboards. Grade II listed; probably 18th-century. They are a picturesque group presenting a unified appearance, but may not all have been built at one time. They are rendered, white painted with black joinery in the style typical of Rochford. At the bottom of the front walls, there is a weatherboarded skirt or plinth. **Nos 10-16** are another row of low attractive grade II listed cottages, the weatherboarding painted white at the front and black at the sides, the joinery black. Slate roofs and stock brick chimneys, which together with the slack roof pitch indicate a 19th-century date (*Fig. 55*). **Nos 18-20** are a pair of early 20th-century semi-detached houses, with red brick fronts and fletton sides, slate roofs and ground-floor bay windows. No. 18 has UPVC windows and doors.

Fig. 55 Weir Pond Road, cottages at the west end (nos 6-16).

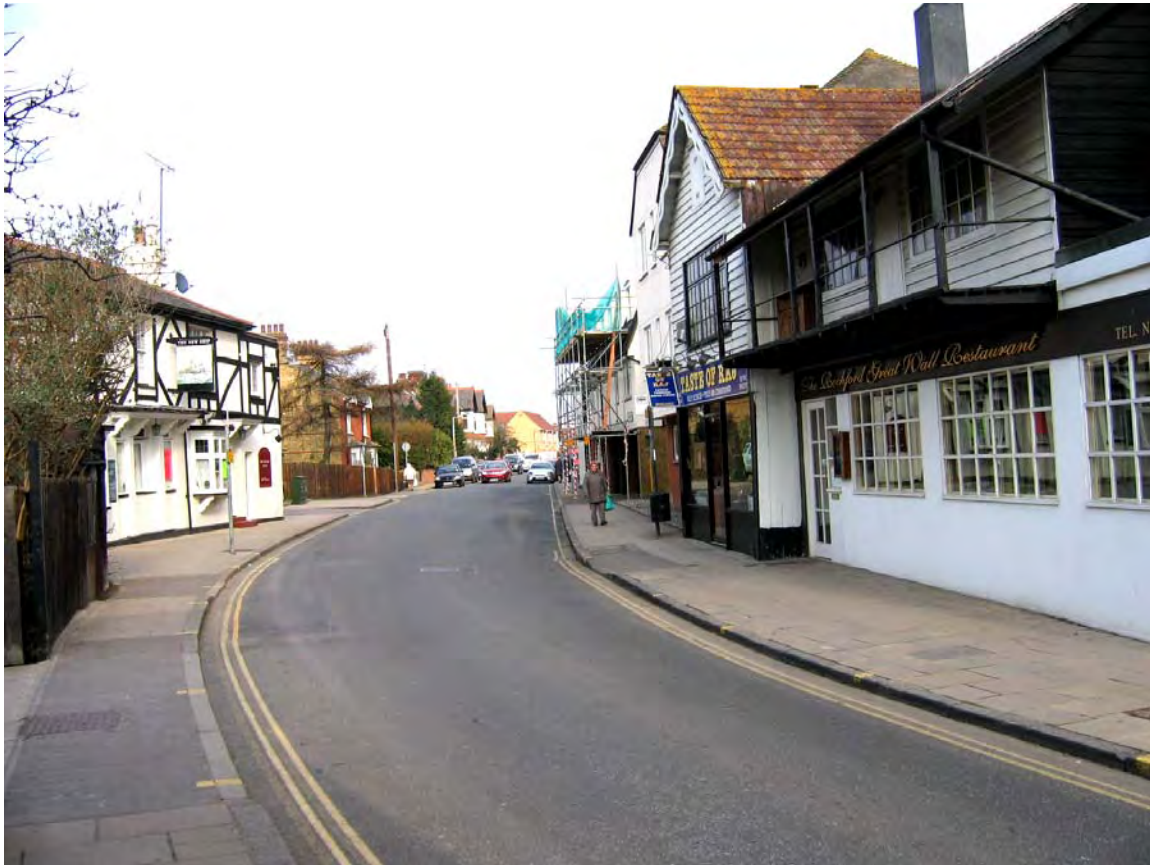
- 9.152 **Woodys Wines**, interesting late 20th-century block, its corner chamfered to present an aspect across the open space in front of it. It is however rather tall, its brickwork has been painted cream, and the timber windows are of indifferent design.
- 9.153 The **Great Wall Restaurant**, and **Taste of Raj** takeaway, form an attractive group of adjacent timber-framed buildings, of 19th-century or earlier date (*Fig. 56*). Both are weatherboarded at the first floor. The Great Wall restaurant is rendered at the ground floor, and has a slate roof which forms a pentice to a nice wooden balcony, an unusual feature. The Taste of Raj is of cross-wing form; the ground floor is taken up with large plate glass windows and has a rather garish shop sign; the roof has concrete tiles.

Fig. 56 East Street, looking east, Great Wall restaurant and Taste of Raj takeaway, the New Ship on the left.

- 9.159 The **New Ship** is a 19th-century building given a 20th-century make-over, rendered at ground floor, false half timbering above (*Fig. 56*). Although retaining most of its original windows and joinery, it looks rather unconvincing, probably because its decoration has been oversimplified in recent times. The main central door has been blocked up, which has not improved its appearance. 19th-century buildings to the rear. The New Ship car park is a desolate unenclosed strip of asphalt on the frontage, across which there are views of outbuildings at the rear of the pub (*Fig. 57*).

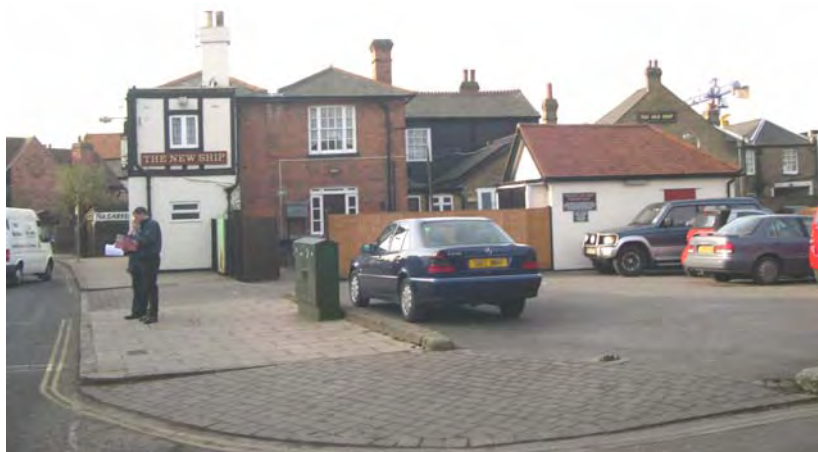
Fig. 57 East Street, the New Ship car park.

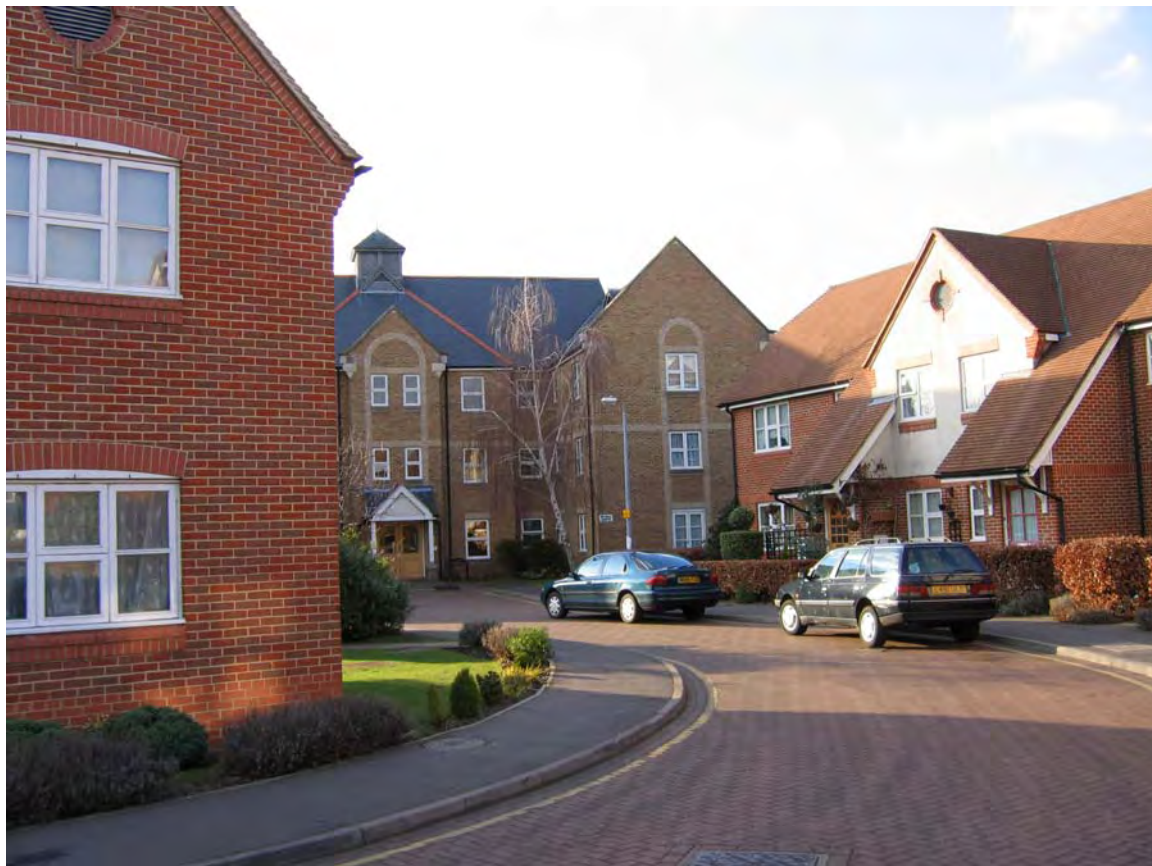
Fig. 58 Lever Lane and Winnowers Court.

9.164 Within the conservation area are **nos 20-28**, a distinctive row of tall three storey houses in red and stock-type brick, with steeply pitched roofs and integral garages. Lever Lane leads past pleasant terraces of two storey housing to **Winnowers Court**, a three storey block of flats in stock brick with a slate roof (*Fig. 58*). Its height makes it a prominent landmark, both from this side and South Street. Although a satisfactory design, its size and the materials make it slightly forbidding, reminiscent of a workhouse. Lever Lane also gives access to **Millview Court**, a very large block of two storey flats dated 1986 and 1988, and built round a courtyard. It is carefully designed. The first floor has a pargeted finish, the render with the slightly dead look that results from the use of cement. To the south of it, there is a large well kept garden. On the north side, there is an area of car parking which links up with the car park of the Rochford District Council offices. This extensive area of hard standing and brick walls should be softened with some planting and trees.
