Local Development Framework
Evidence Base

Rochford Conservation Area
Appraisal and Management Plan

This document was produced by Essex County Council for Rochford District Council.

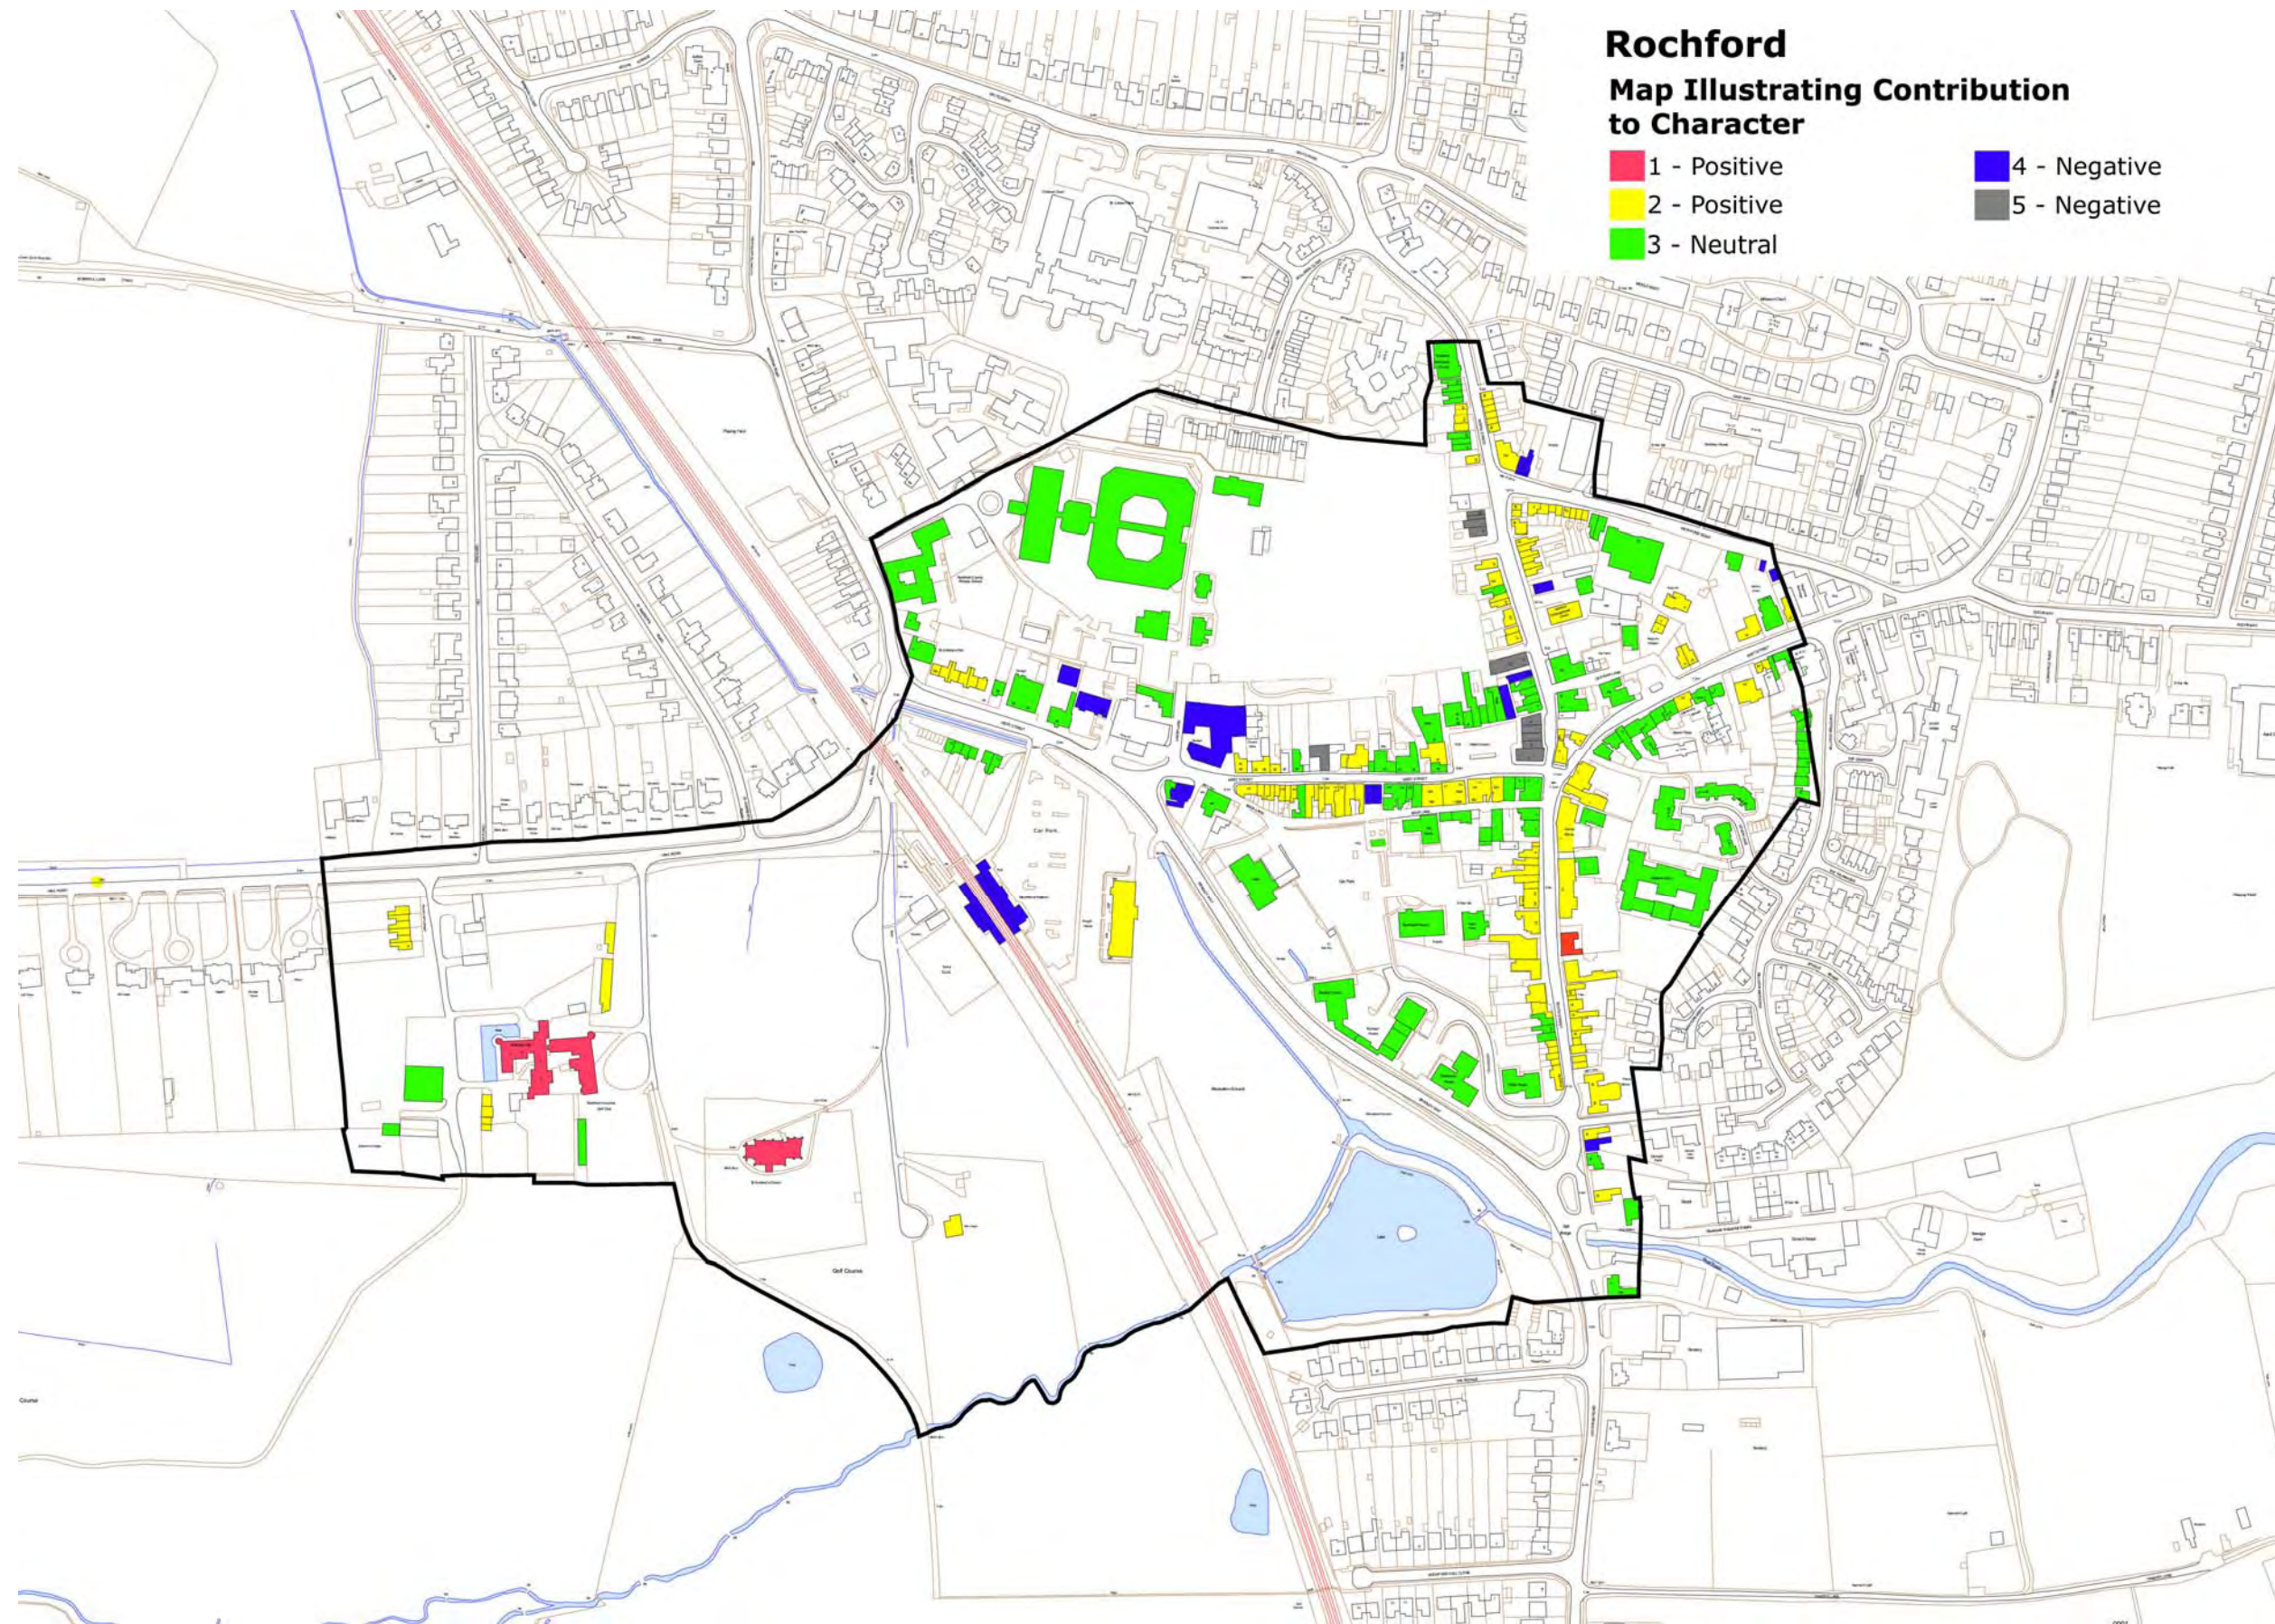
Fig. 59 Map to illustrate the contribution of individual buildings to the conservation area.

- 10.1 A map (*Fig. 59*) has been prepared assessing the contribution made by individual buildings to the appearance and character of the conservation area. Although a subjective process, the map can be a helpful guide in the planning process. Buildings have been graded on a scale of five according to the following criteria:

- Positive, listed buildings or landmark buildings.
- 10.2 Unsympathetic alterations or ‘improvements’ can have the effect of moving a building down a grade. Similarly, reversal of such alterations could restore its original character and move it up a grade.

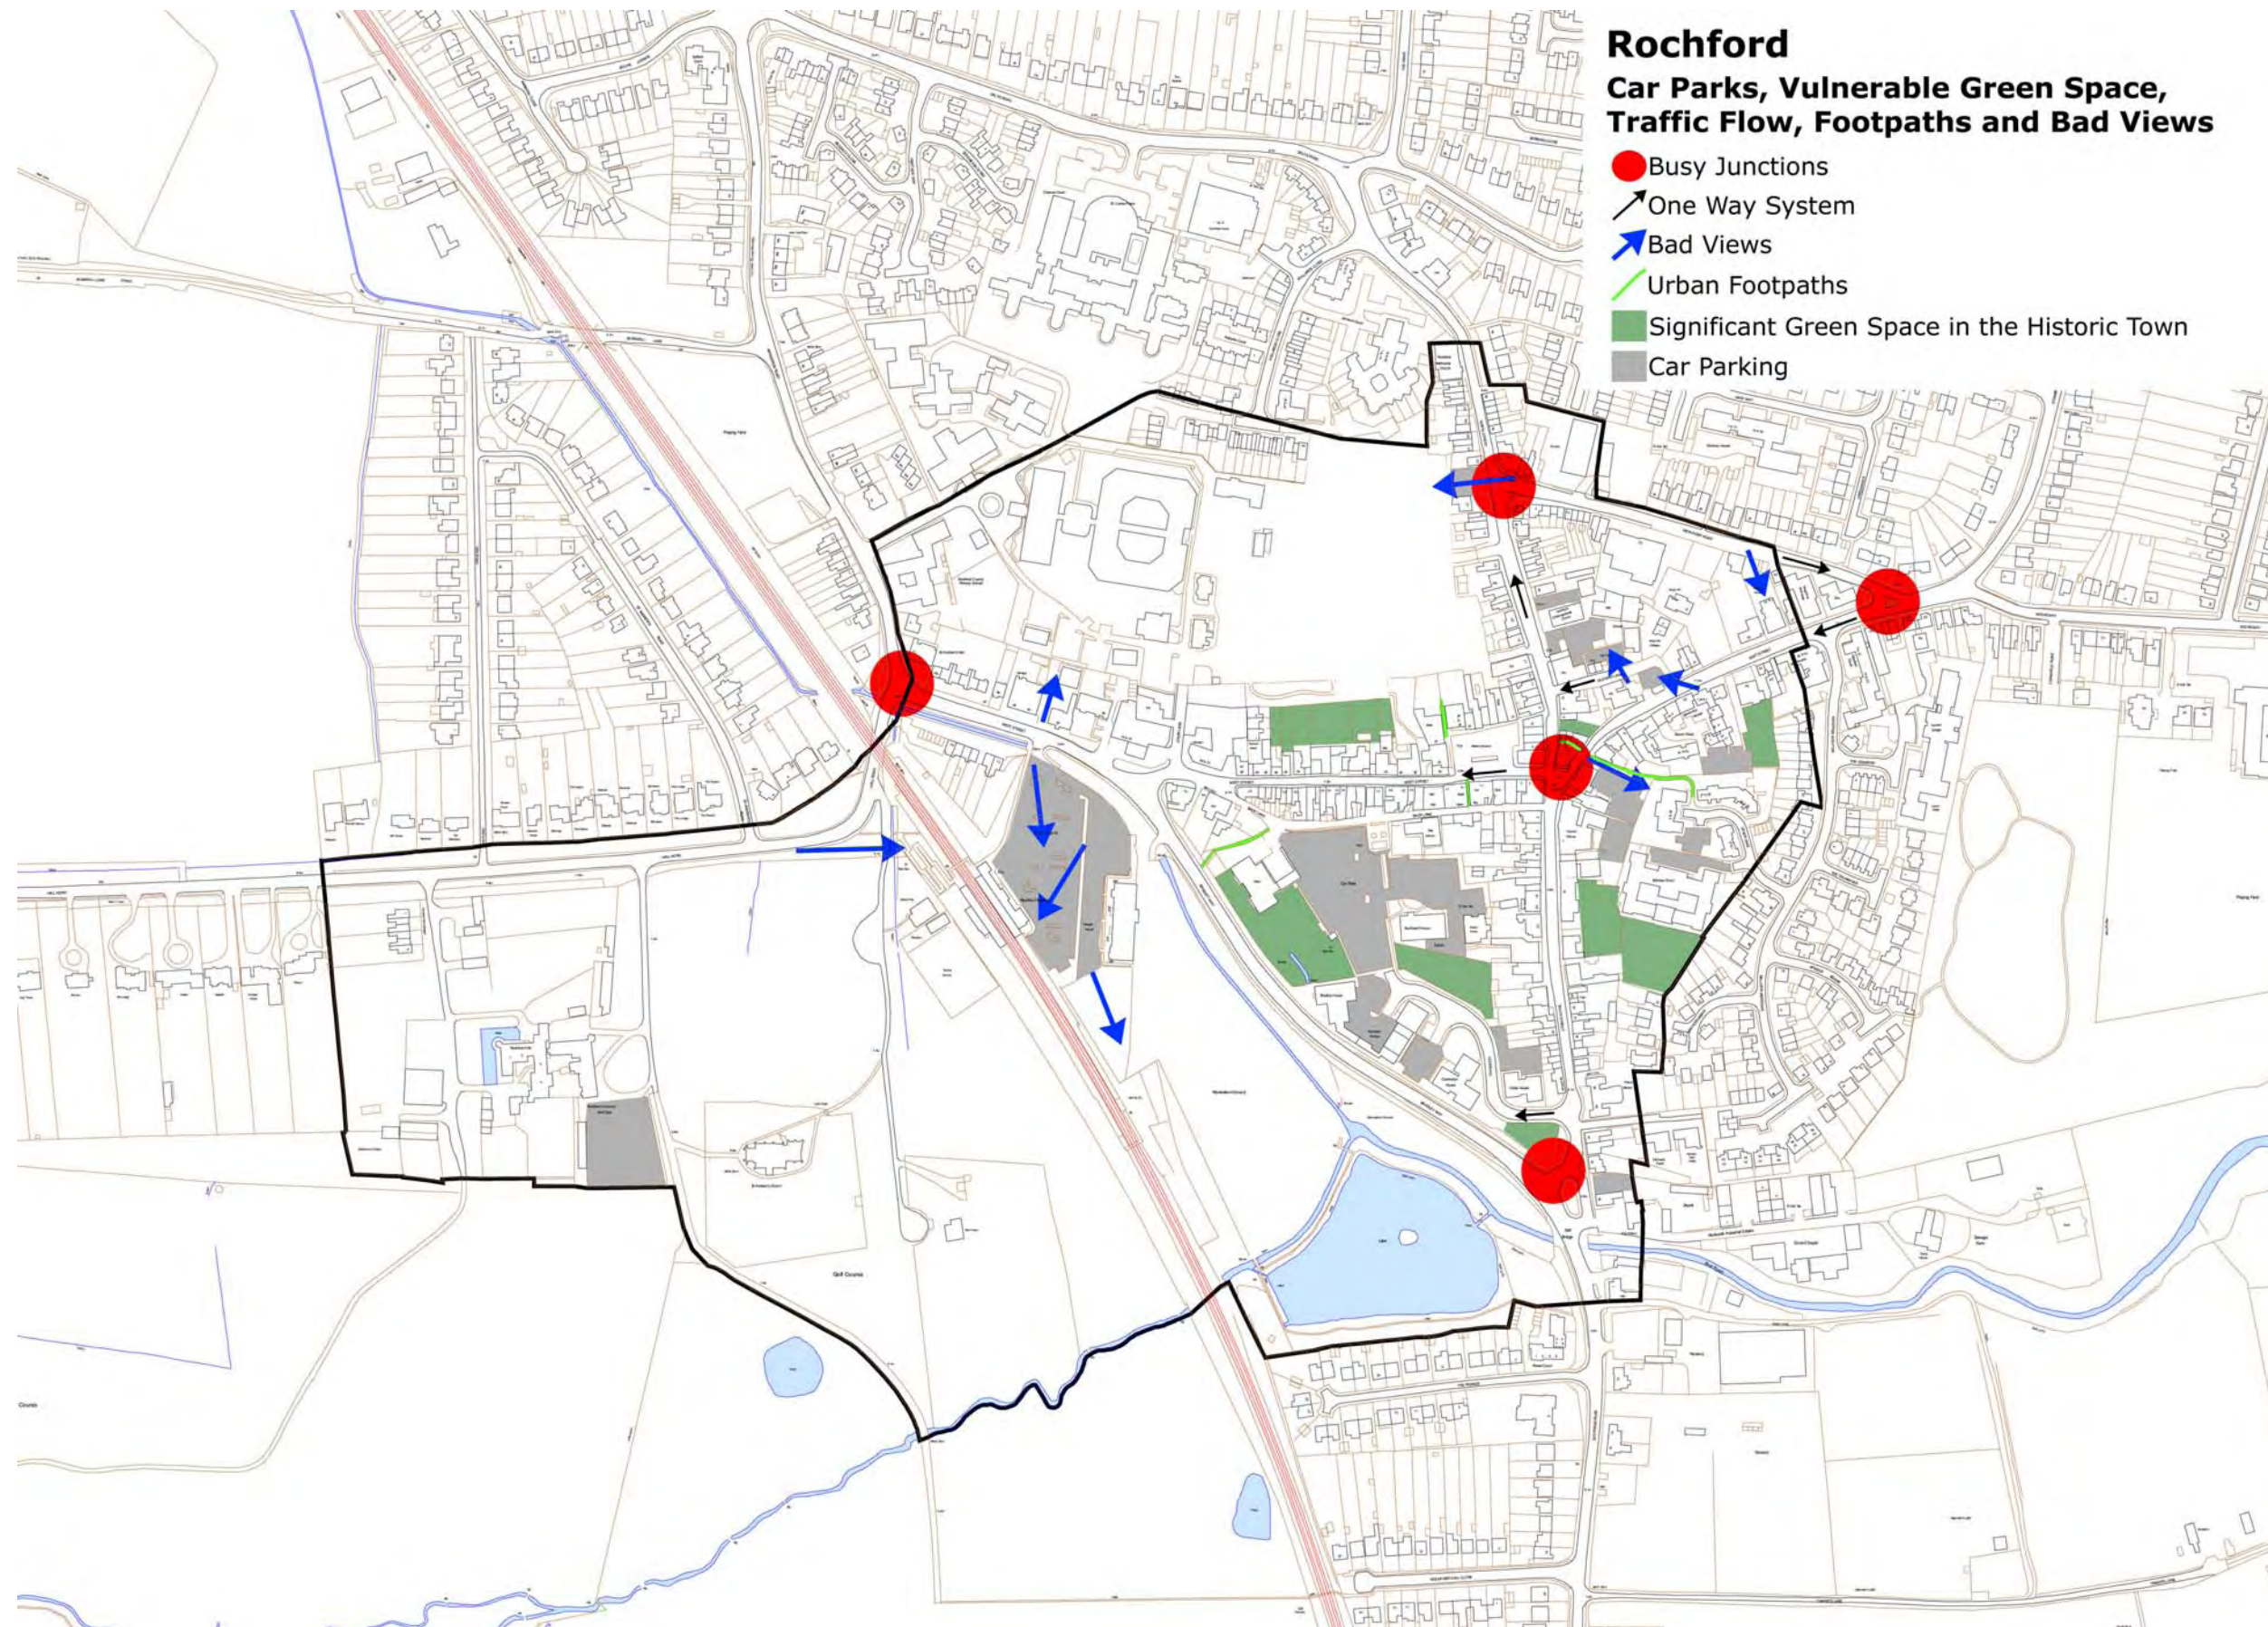
Fig. 60 Map indicating car parks, vulnerable green spaces, traffic flows, footpaths, and bad views in the conservation area.

- 10.3 *Fig. 60* attempts to assess the public realm and open space within the conservation area. It shows bad views; the extent of car parks and parked cars which form negative townscape; green spaces which contribute to the character of the town centre and warrant protection; traffic flows and problems, and footpaths.

- 12.12 The backlands in the Rochford historic town centre are now almost entirely developed for housing, offices or car parking. They have mostly lost their historic relationship to the street frontages and are largely impermeable to them, inasmuch as there are few footpaths leading into them. Important surviving open areas are identified on *Fig. 60*, and should be carefully protected.

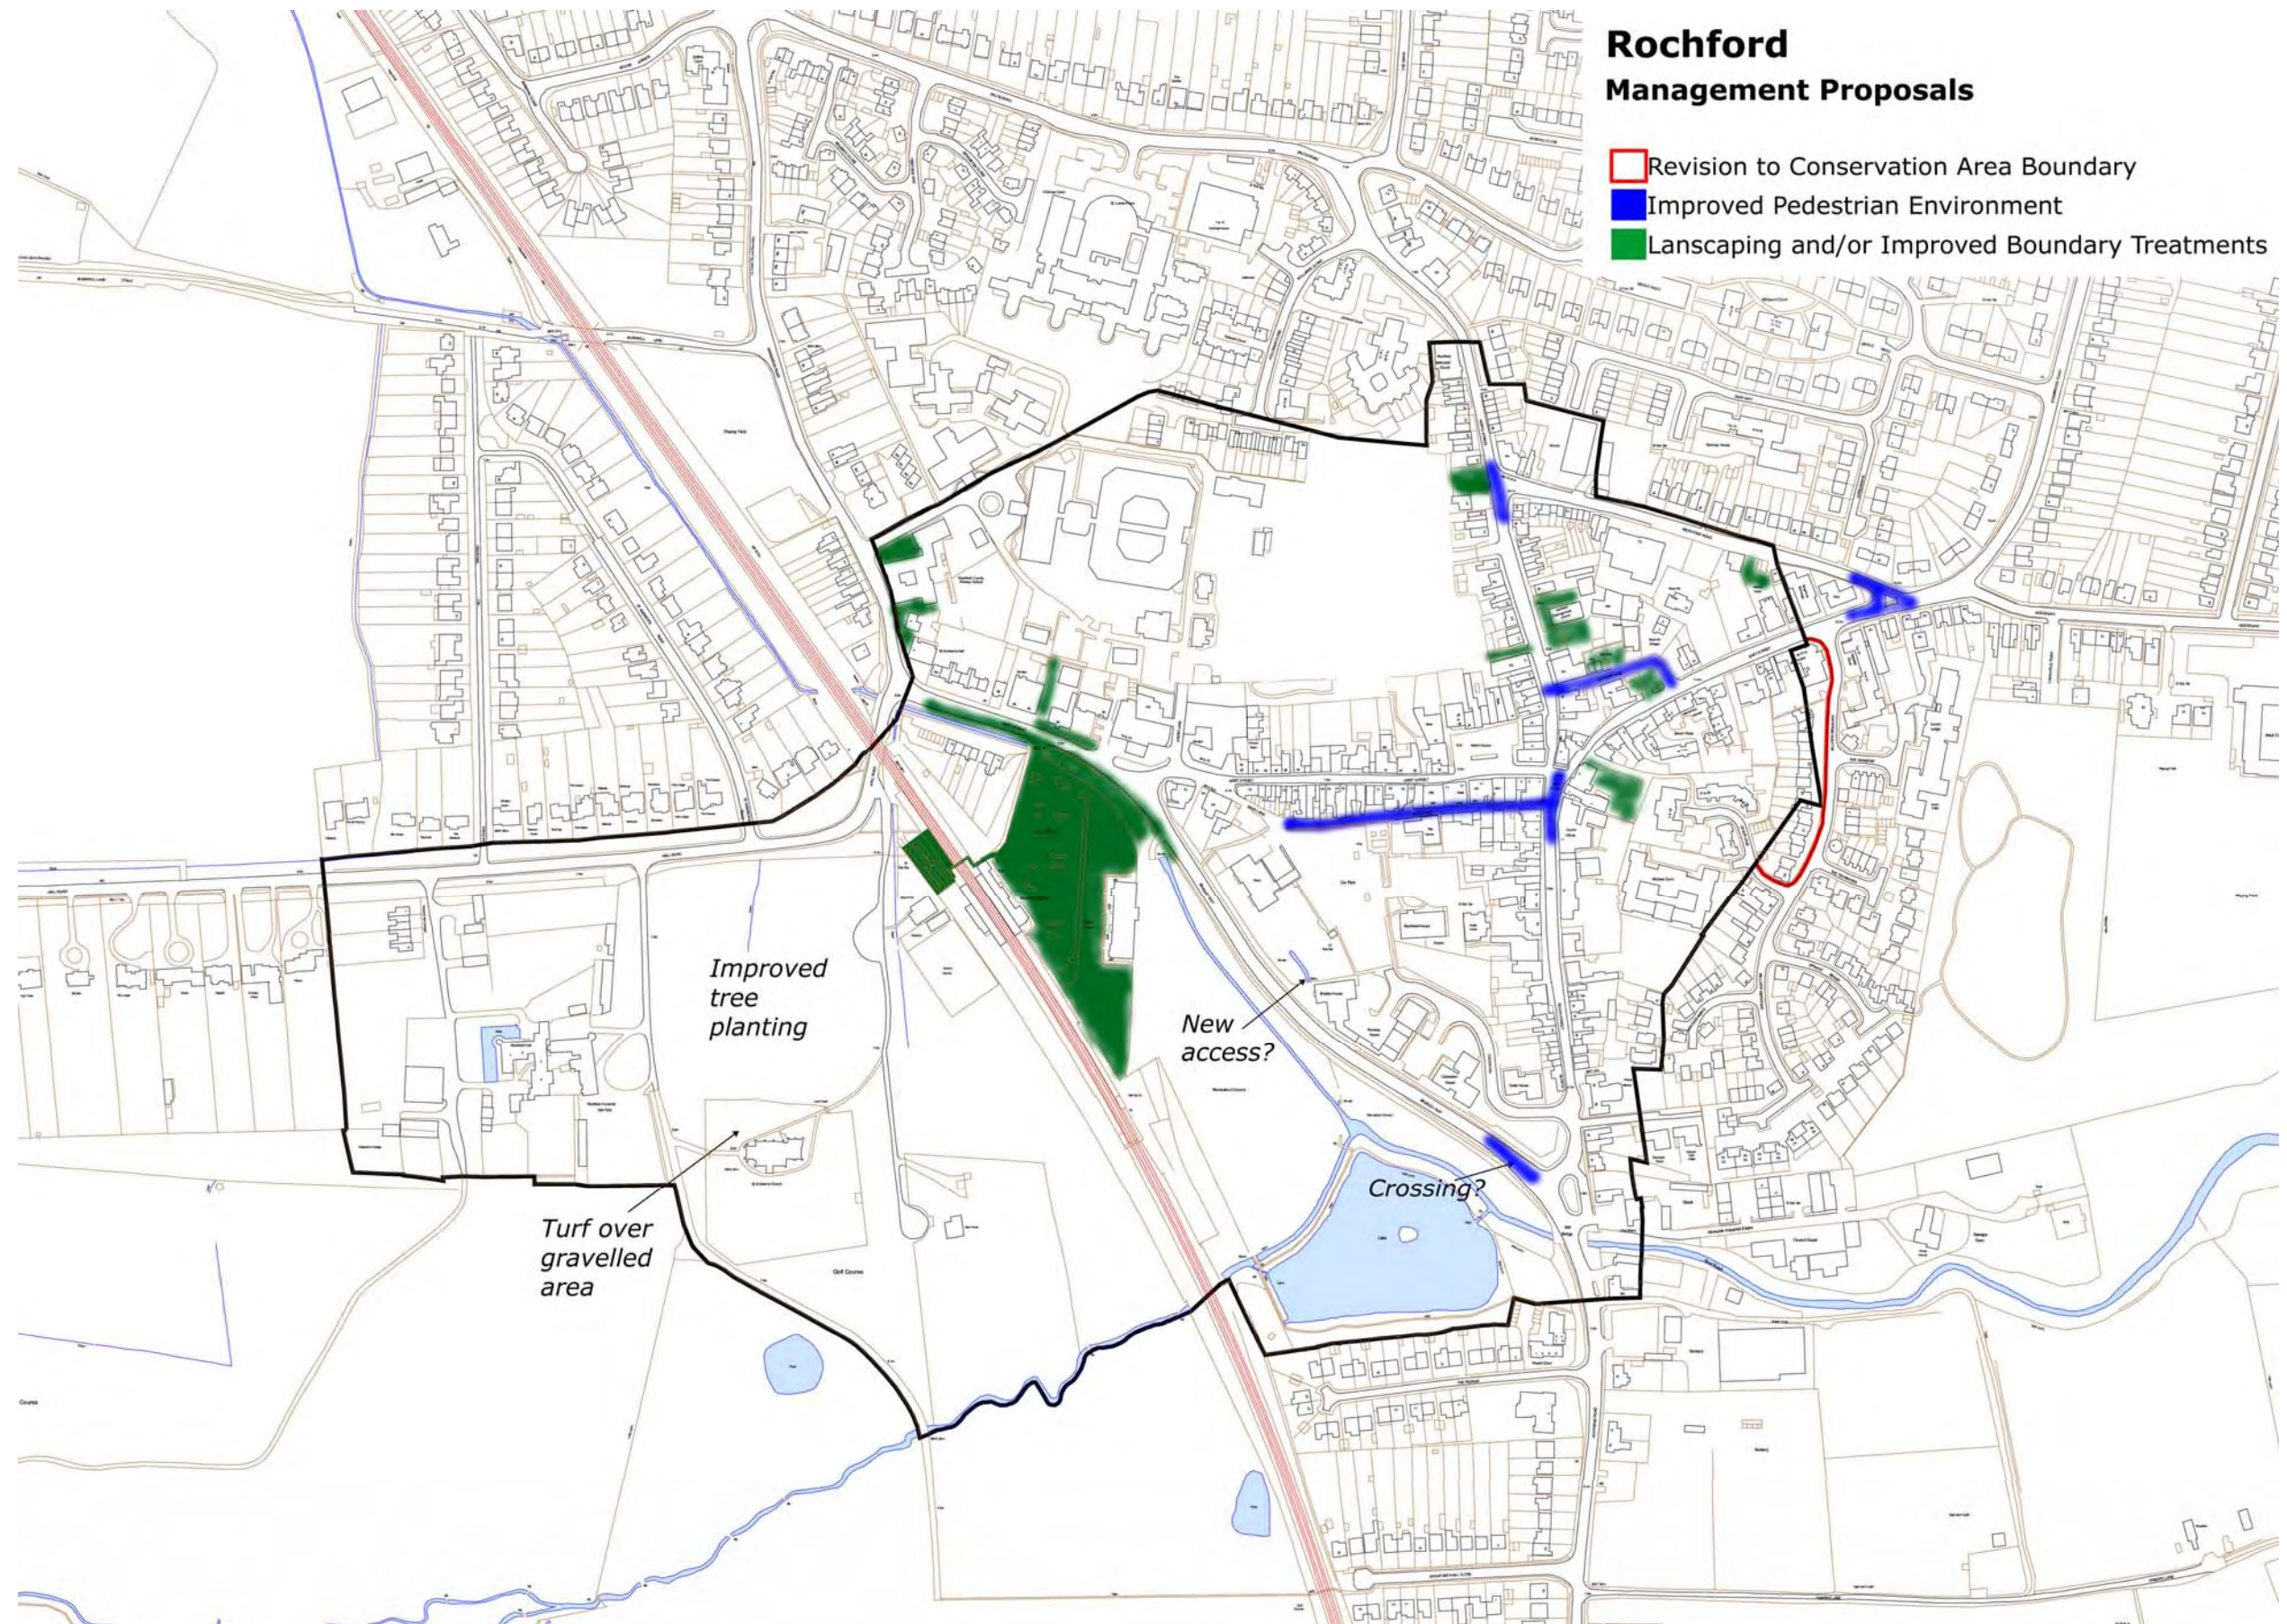
Fig. 61 Map to illustrate management proposals for the conservation area.

- 12.1 The Rochford conservation area is attractive and presents few problems. There are few dilapidated buildings, except in West Street. Maintenance is generally good. The District council has promoted effective street improvements and other initiatives, though the Old Ship Lane car park is an aberration. The one conspicuous blot on the landscape is the station and its environs. A series of recommendations about the conservation area and its management are outlined below, for the most part picking up on observations made in the Area Analysis.

- 12.2 Access arrangements to the west side of the station need improvement to make them less of an eyesore. The fence should be replaced, and the hand rails painted more subdued colours. The plastic revetment could be obscured by planting.
- 12.3 The station buildings need refurbishment and a use found for the former stationmaster's house. The car park area needs landscaping. Its appearance should be softened by tree planting. A hedge should be planted to screen it from Bradley way. The signs and notices at the entrance to the car park should be rationalised. The hedge and trees on the west boundary need attention and possibly some replanting. New boundary treatment is required between the car park and the Freight House. The derelict land at the south-east corner of the station area should be landscaped if it has no imminent beneficial use.

- 12.4 The busy junctions on the one-way system and at the extremities of the conservation area have already been commented upon. They are hazardous to pedestrians, who are also ill-served by the narrow pavements and shortage of footpaths in the town. When the town centre street enhancement scheme was carried out, one objective was doubtless to avoid the signs, road markings and street furniture that accompany zebra crossings and traffic calming. This has been successful, but measures should nevertheless be considered to try and slow traffic further and to provide a more relaxed environment for pedestrians. This is particularly necessary at the Horners Corner junction. It should be possible to achieve these ends by narrowing the street width at raised crossing places made with carefully selected natural materials.

- 12.5 On Bradley Way, where crossings would be less visually intrusive, one should be provided to give access to the public open space, which is cut off from the town by a steady stream of traffic. To try and relieve the South Street/Bradley Way junction, the possibility of using land in the hotel garden to provide a more direct access to the Back Lane car park could be considered.

- 12.6 Both Back Lane and Old Ship Lane feel like pedestrian spaces but in fact are not so. Whilst it may not be possible to close these roads to traffic, schemes could be designed to make the pedestrian the dominant user. They could be paved in tegula or similar with rumble strips made from granite setts, and a pavement could be provided along one side of them.

- 12.7 Cars queuing for short stay parking in the Market Square back up into South Street and are a hazard to other motorists and pedestrians. The old objective of the 1973 Town Centre Plan of pedestrianising West Street and the Market Square may have proved unattainable, but this situation could be improved by denying Market Square to its junction with Back Lane to all but disabled drivers.

- 12.8 In the churchyard, the paths would look better with a bound gravel surface, and in the western part of the graveyard the loose gravel should be replaced with turf. The Tudor wall in Hall Road should be released from ivy and overgrowth, so that it becomes more of a landscape feature. In the area round the reservoir, a dog waste bin should be replaced, and the trees need to be kept free of ivy and brambles.

- 12.19 There are a number of places in the town where improvements could be effected by street enhancement, better signage and boundary treatments, and tree and other planting (*Fig. 61*).

- 12.24 The existing conservation area boundary makes reasonable sense and does not seem in need of alteration, except at its eastern edge where it should be modified to include the office buildings at the junction of East Street and Millview Meadows and then to run down the frontage of the latter (*Fig. 61*). A case could be made for omitting all or part of the hospital site, in particular the healthcare part of it. Since the hospital site is intimately connected with the town centre, occupying its former backlands and influencing views in the area of West and North Street, and since the development is not very far advanced, this is a question that is probably best left for consideration at a later date.
