Local Development Framework  
Evidence Base

Rochford Conservation Area  
Appraisal and Management Plan

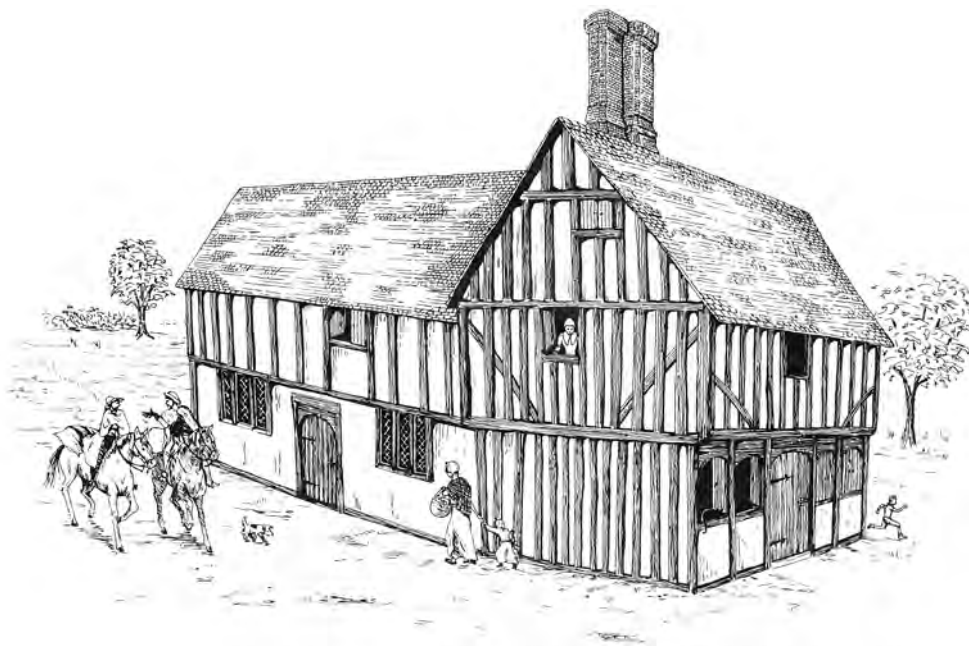
A reconstructed view of the timber-framed buildings which exist behind the brick cladding at Horner's Corner

*Fig. 4 Reconstruction of the timber-framed buildings at Horner's Corner as they might have appeared in the 17th century.*

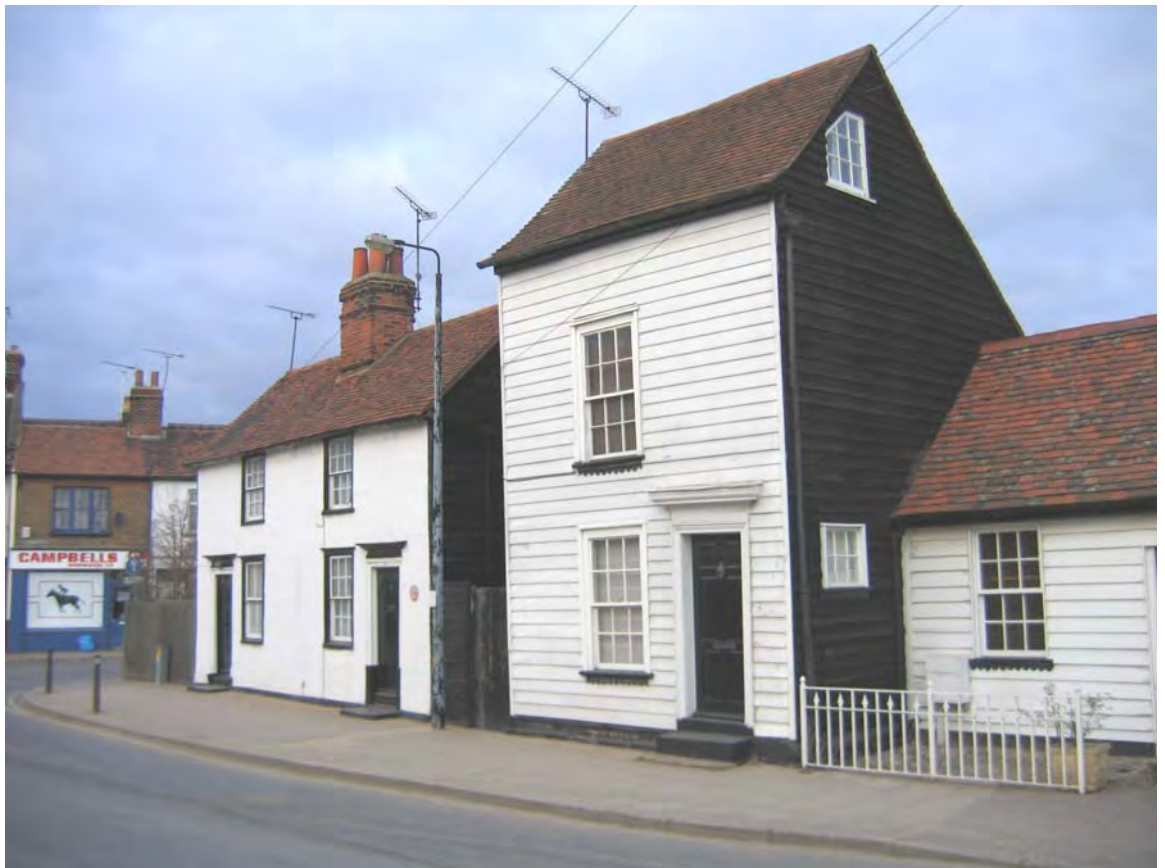
*Fig. 10 North Street, no. 36, typical weatherboarding and black and white painted joinery. Nos 38-40 have a rendered or Roman cement painted façade, lined out in imitation of masonry.*

- 9.137 **No. 36**, 18th- or 19th-century, listed grade II, tall narrow weatherboarded house with single storey weatherboarded garage and outbuilding on south side, rear gambrel roofed extension. Weatherboard, white to front, black to sides. Simply moulded door case (*Fig. 10*).

- 9.138 **Nos 38-40**, grade II listed, 18th- or 19th-century, pair of semi-detached houses, front rendered and lined out, white painted, black weatherboarded flank, central chimney stack, rear outshot (*Fig. 10*).

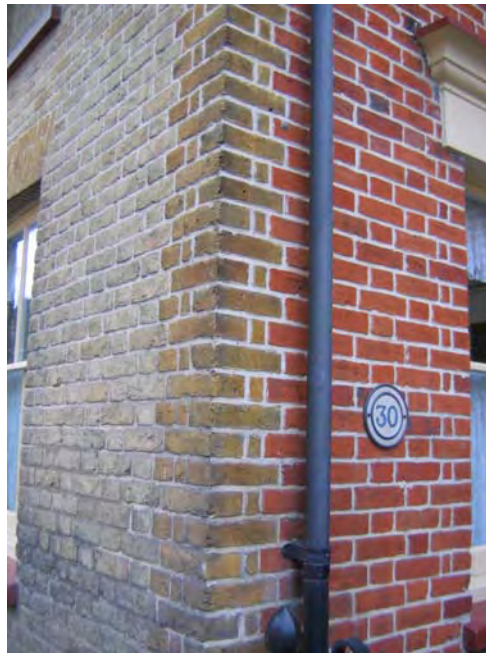
6.4 Tudor brick can be seen today in the tower of All Saints church, parts of Rochford Hall, the chimney stack of 17 South Street, and the less restored parts of the Rich almshouses. 18th- and 19th-century brick is the predominant building material of the conservation area. From the end of the 18th century, there seems to have been a trend to case old houses in brick, or to build anew in red brick. This may reflect increased prosperity, or the relatively low cost of a readily available locally made material. In the 19th century, two new types of brick became available: white or gault brick, and brown London stocks (*Fig. 11*). White brick was a prestige material and probably was not made locally. Stocks seem to have been made locally from quite early in the 19th century.

*Fig. 11 Angle of nos 30-32 South Street. White bricks were used for the façade, with stocks for quoins and window lintels, and red bricks in the side.*

- 9.50 **Nos 32-36**, row of three 19th-century houses, the right hand one probably incorporating an earlier building that belonged to the Sydenham House school. Gault brick facades, stock brick quoining, red brick sides. Sawtooth cornice at eaves. Sash windows with segmental heads. Since 1986, all the windows, except for those at no. 32, have been replaced in plastic, adversely affecting the appearance of what would otherwise be an attractive terrace. Shutters to windows of no. 36 not entirely appropriate.

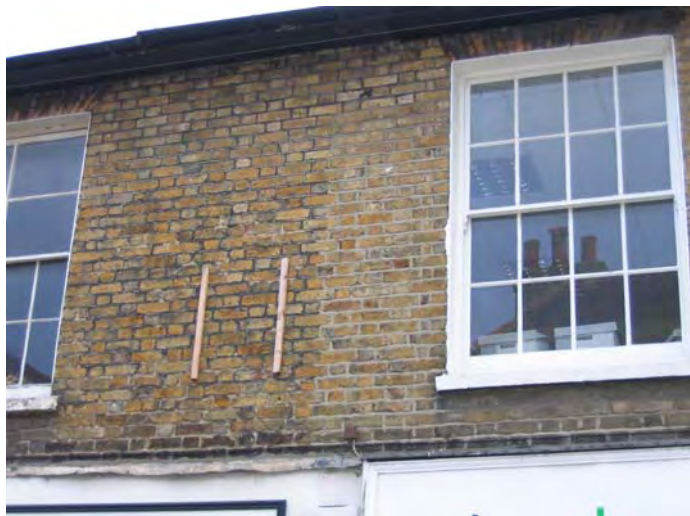
6.5 These different types of bricks present a palette of materials which were used in a variety of different ways which are not always evident today. The older red brickwork was sometimes ruddled or treated with a red wash, and in the grander houses must in some cases have been jointed with tuck pointing. Traces of this seem only to survive at no. 22 South Street. Tuck pointing was also used in some stock brick buildings (e.g. no. 21 West Street, *Fig. 12*). Penny-struck pointing must once have been common, but can only be seen in a few instances today. Most of the brick buildings have been re-pointed in the second half of the 20th century, in many cases probably unnecessarily. This has led to an erosion of the character of the original brickwork (*Fig. 12*).

*Fig 12 Nos 21-23 west Street. To the left, stock brickwork with tuck pointing. To the right, unnecessary repointing has had an adverse effect on the character of the brickwork.*

- 9.102 **Nos 21-23**, two storey, stock brick with sash windows at the first floor (*Fig. 12*), well preserved, but the ground floor a sad contrast, being rendered and white painted (*Fig. 44*), a series of shop fronts, the right hand one (mjb pharmacy locums) having been remodelled and set back behind the line of the façade with a large plate glass window.

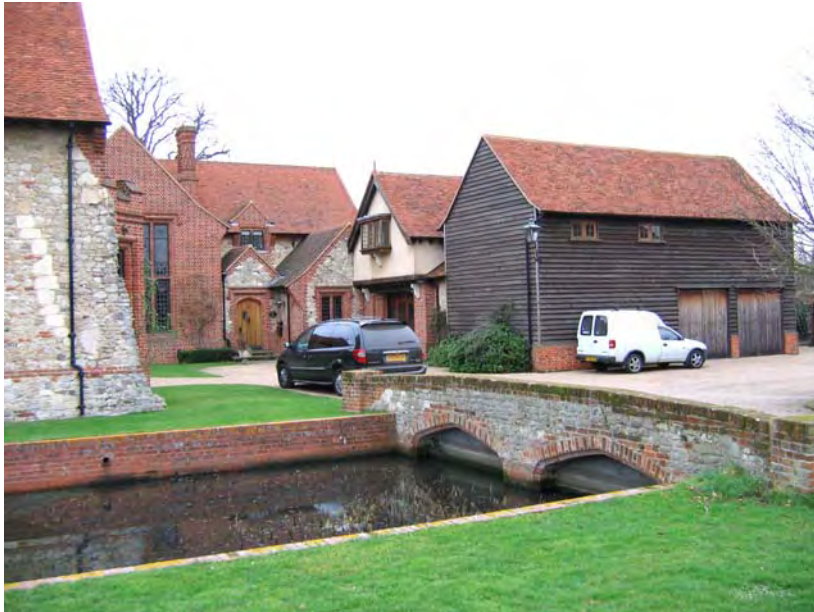
- 9.5 The conversion of the barns was done in an accurate mock Tudor style. It included small extensions, and also conversion of some farm buildings. Despite the density of the development, and the element of pastiche, 20 years on it looks good and has worn well (*Fig. 17*). The landscaping around it has also enhanced its setting.

*Fig. 17 Rochford Hall, a view of the residential conversion of the former barns area.*

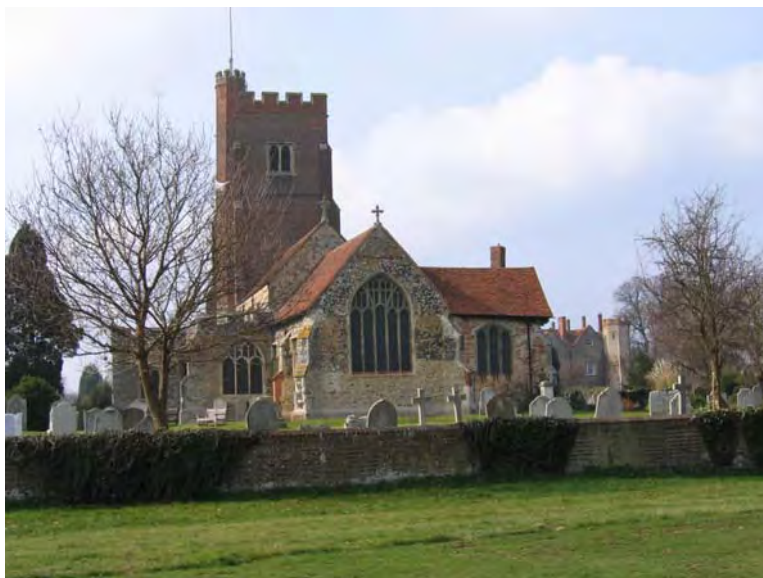
*Fig. 19 St. Andrews church, the Hall in the background.*

- 9.9 **St. Andrews church** is large with aisles, built mainly of Kentish ragstone, and predominantly 15th-century in appearance (RCHM 1923; *Fig 19*). Its most prominent feature is the magnificent late 15th-century brick tower with diaper work. Of interest is the vestry on the north side of the chancel which was probably built for a chantry priest in the 15th century. In 2005, two-thirds of the north aisle was partitioned off to provide toilet and kitchen facilities, and a meeting room, something which has helped to bring the building more into community use.

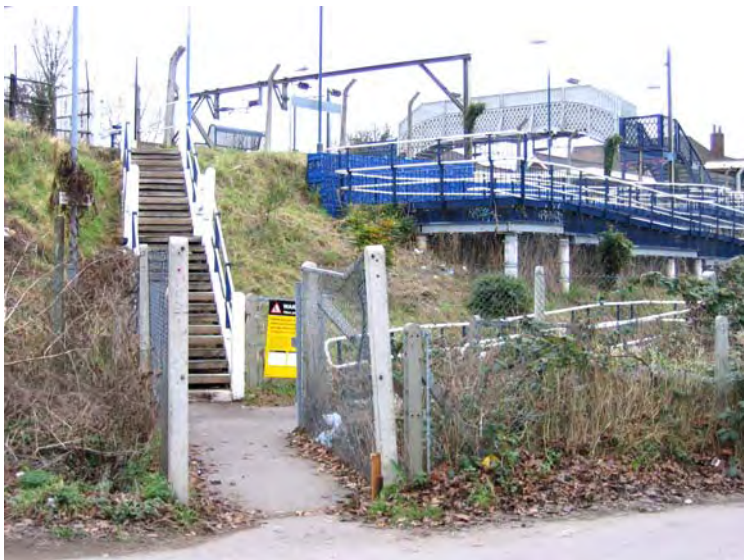
*Fig. 20 Steps and ramp at the west access to Rochford station.*

- 9.13 At the end of the cycle route, a flight of steps ascends the embankment to the west side of the station. The entrance to the steps is through a dilapidated chain link fence, whilst the posts and handrails are painted white and blue, making them excessively visible and an eyesore from a distance (*Fig. 20*). The steps are supplemented by a ramp which tacks up the side of the embankment. These too have unsightly handrails painted blue and white. These features make for an unsightly view at this end of Hall Road, not helped by the use of bright blue plastic reinforcing similar to milk crates used torevet the embankment at this point.

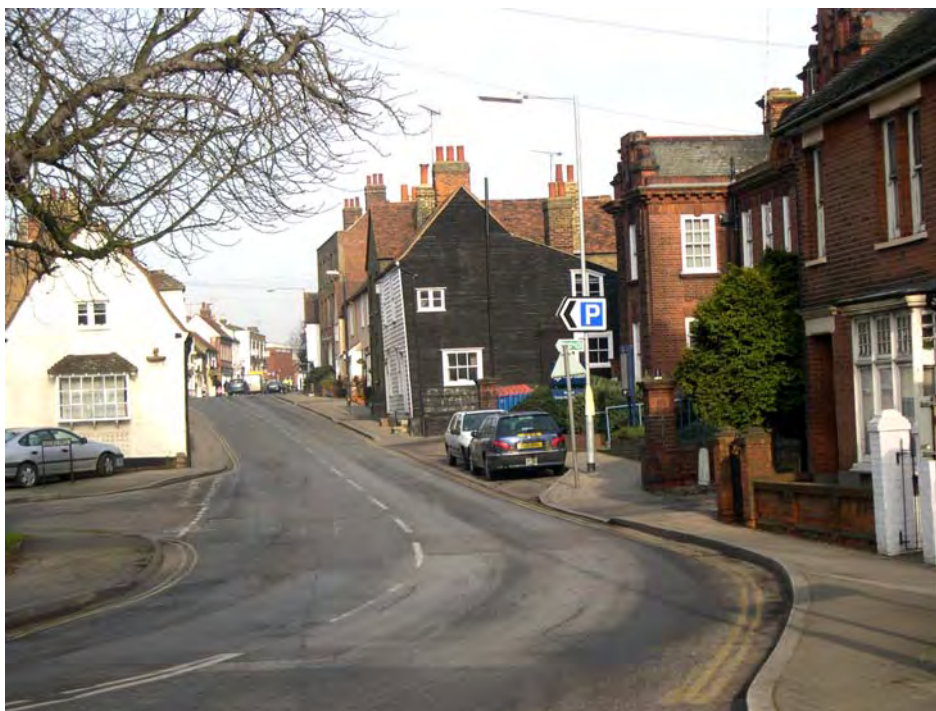
*Fig. 21* View looking north up South Street. No. 47, Police Station and nos 39-41 on the right hand side.

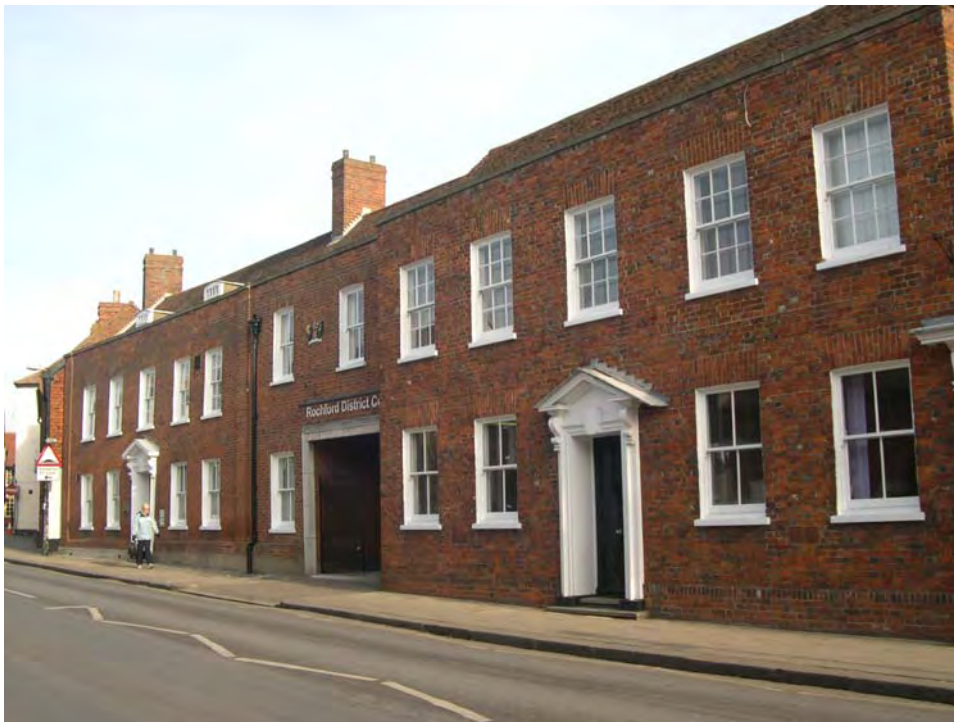
*Fig. 24 North end of South Street, now Rochford District Council offices.*

- 9.33 Behind nos 17 and 15 are attractive gardens maintained by the District Council, with some old red brick boundary walls.
- 9.34 North of Red House were a carriage arch with a projecting 19th-century bay window above, and **nos 9 and 11**, with front doors either side of a three window bay red brick façade (*Fig. 24*). These buildings were remodelled by the District Council in the 1970s. The carriage arch was closed up and three sashes inserted beneath it. Nos 9 and 11 were rebuilt to present a five window bay to match Roche House to the north, with a similar door case. This work has achieved a successful composition such that it is difficult today to work out what has happened. To the rear, these buildings have been extended in two phases, first presumably in the 1970s with an integral extension in a modern unsympathetic style, and then probably in the 1980s with a large free-standing building linked by a first-floor passageway.

- 9.35 **Nos 5-7**, Roche House, District Council offices like previous buildings. Five window bay grade II listed 18th-century red brick house, two storey with attics, parapet to roof, end stacks, pilaster strips at corners, gauged brick arches, doorcase with consoles (*Fig. 24*). To the south, a formerly separate unit with a carriage arch with a moulded stone surround, now incorporated into Roche House, the ground-floor door replaced by a window. Adequate iron gates to arch; unattractive concrete surfacing in archway. The arch forms the main public entrance to the Council offices. Formerly it gave access to car parking, but the car park is now occupied by a temporary reception office, and the whole area has a makeshift appearance quite at odds with the elegant street frontage.

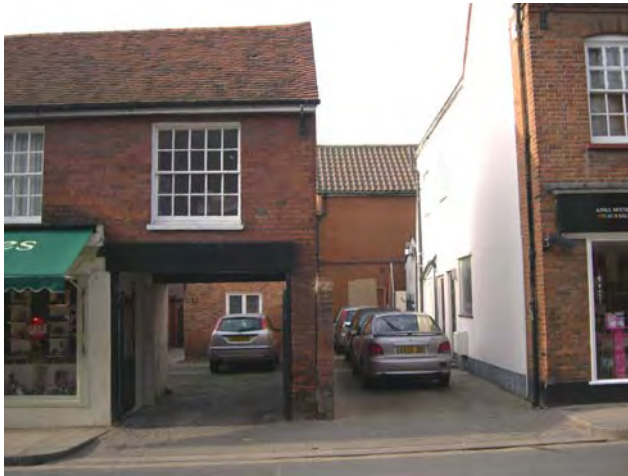
*Fig. 26 South Street, carriage arch on the north side of no. 8.*

- 9.43 Rear of no. 8, the carriage arch leads through to a yard occupied by rear extensions, outbuildings and new development. Although rather crowded, this has been successfully done. **Wistaria House, no. 6**, is an attractive red brick outbuilding converted to a house. It is dated by a graffito on the brickwork: MS 1832. The windows are of rather tall narrow proportion. Two new houses, 6A and 6B, have been shoehorned in further west. The view into the carriage arch, and the space between no. 8 and no. 4, is not enhanced by parked cars (*Fig. 26*).

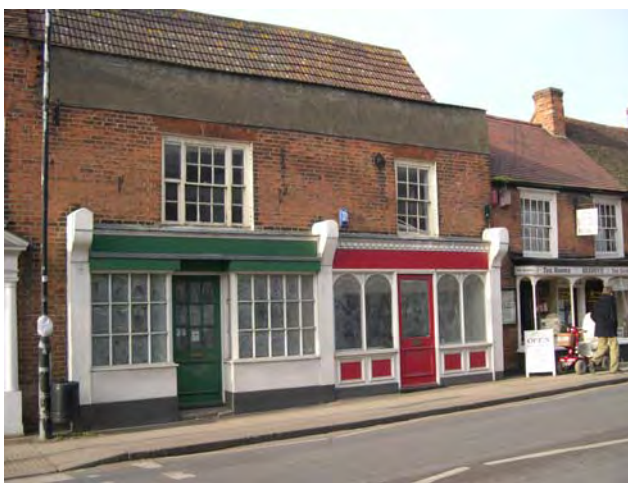
*Fig. 27 South Street, shop fronts at nos 14 and 16, Beehive Tea Rooms to the right.*

- 9.44 **Nos. 10 and 12**, two shops under one ownership and a continuous roof, though no. 12 unfortunately has machine made tiles. Beehive Tea Rooms and Records. Listed grade II, 18th-century but with older timber frame behind red brickwork. Small paned sash windows at first floor. Projecting small pane shop front to no. 10 with door with round arch. Double fronted shop front with segmental heads to no. 12 (*Fig. 27*).

- 9.45 **Nos. 14-20**, long building under single roof with central stack and central door with handsome doorcase with columns, pediment and fanlight. Listed grade II. 18th-century, but possibly older timber frame behind red brickwork. To right hand side, two shops, nos 14 and 16, the fascias and flanking piers old, but the attractive fronts are recent remodelling replacing full height sheet glass. The shops are, however, unlet. To the left of the central door, the ground floor is rendered, covering up former inserted shopfronts (when this part was a bank). Mainly tripartite sash windows to first floor, under gauged arches. Parapet to roof. Right hand part of roof with concrete tiles.

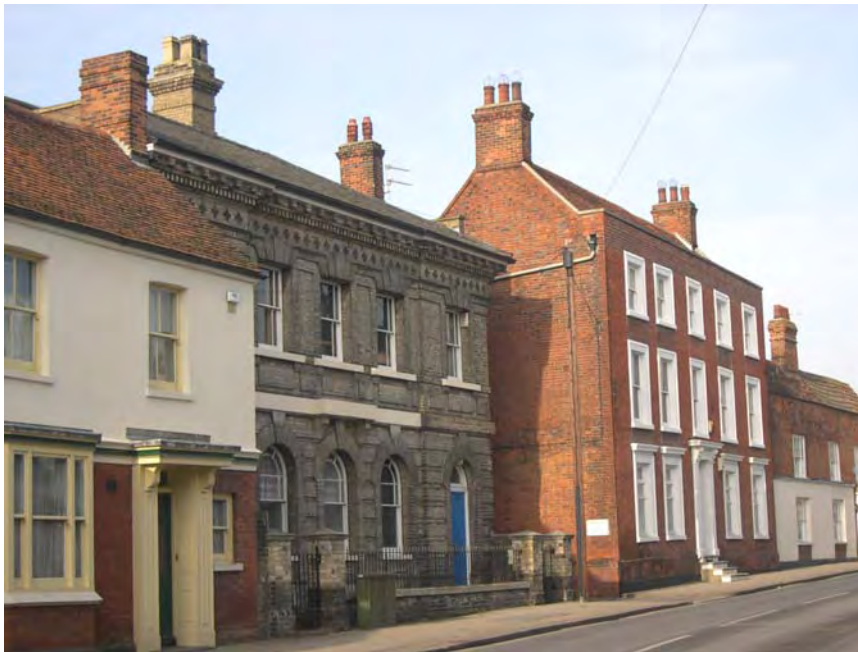
*Fig. 28 South Street, no. 22 and the Masonic Hall, formerly the County Court.*

- 9.46 **No. 22**, tall three-storey house, somewhat out of scale with its surroundings. 19th-century, or perhaps earlier (*Fig. 28*). Listed grade II. White painted stucco surrounds to door and windows, ground-floor windows with cornices, door case with consoles to flat hood. Parapet to roof. End stacks. Red brick, flared headers in side walls. Tuck pointing with black mortar fillets and traces of ruddling, but none of this well preserved. Long been used as offices.

- 9.47 **No. 24**, built as a Court House in 1859, formerly Rochford Rural District Council offices, now Masonic Hall (*Fig.28*). Listed grade II. White or gault brick façade, stock brick to sides and rear, where there is a huge rectangular flat-roofed block which must house the original court room. This is fortunately invisible from the street, but prominent from the car park to the rear. There is also a modern rear extension, recently the subject of an application to improve access arrangements. The detailing of the façade is slightly heavy-handed and very sharp-edged: the ground floor has imitation rustication, with round-arched windows with raised surrounds; the first-floor has gauged brick arches with imitation voussoirs. The sash windows have marginal glazing. The façade is very well preserved, the only significant change being the loss of the original railings to the low brick boundary wall. They have been replaced with unfortunate spindly railings with silvered arrow tips. The appearance of the building would probably benefit from cleaning; white brick usually withstands the process successfully and comes up well.

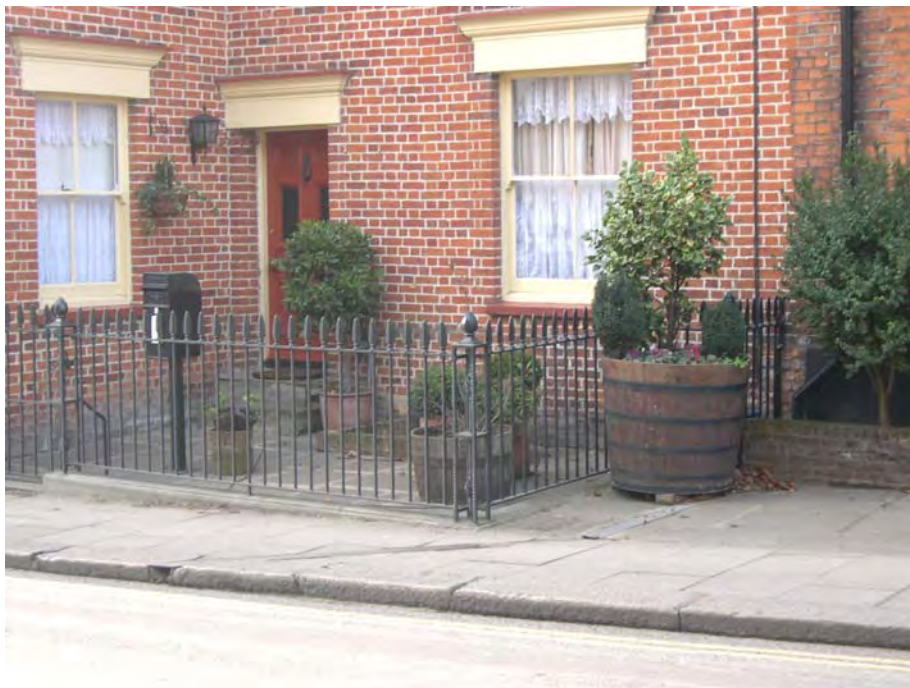
*Fig. 29 South Street, well designed paving and railings at no. 30.*

- 9.49 **Nos 28 and 30**, no. 28, Sydenham House, and no. 30, a small extension to it, were a school in the 19th century. Both grade II listed, and red brick. Sydenham House is 18th century or earlier, no. 30 19th-century. Sydenham House is of three window bays, with tripartite small paned windows, with end stacks. It has a handsome door case with a fanlight. Flat-roofed extension to the rear. No. 30 has stucco cornices to the door and ground-floor window. Brickwork repointed. Small flat-roofed dormer. It has been provided with well designed new railings round the stone paved yard in front of it, a model to be imitated elsewhere (*Fig. 29*).

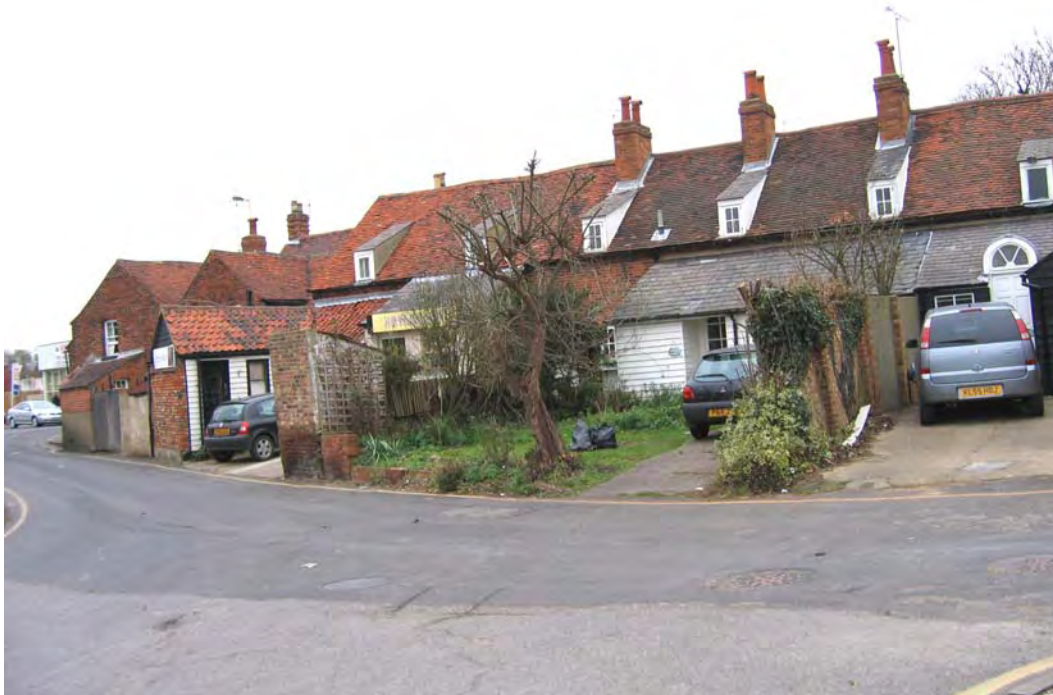
*Fig. 32 Back Lane, rear of cottages at the rear of the west end of West Street.*

9.59 Back Lane, it has been suggested above, has its origins in an infill row on the south side of the market place. The north side of it is occupied by the backs of the properties on West Street (*Fig. 32*). The south side has some buildings which front on to it, but the west end is occupied by the car park. There is great variety down the length of the Lane, of architectural style and scale, of building materials, and of use. Although there may be nothing of individual merit, the views down it are form a composition of considerable visual interest. The backs of the cottages at the west end, with their lean-to and gambrel roofed extensions, are particularly picturesque (*Fig. 32*). The back of no. 43 West Street is notable for a remarkable collection of outbuildings, including a wash house with a chimney.

9.60 The Lane is narrow, its surface patched, and there are no sidewalks. It feels like a pedestrian space, but in fact traffic can drive two ways along it, though access is only possible from South Street. It is generally free from parked cars, but where there is space behind the West Street buildings, there is parking on hard standings or in yards. The gardens of the cottages at the west end have been turned into parking lots (*Fig. 32*).

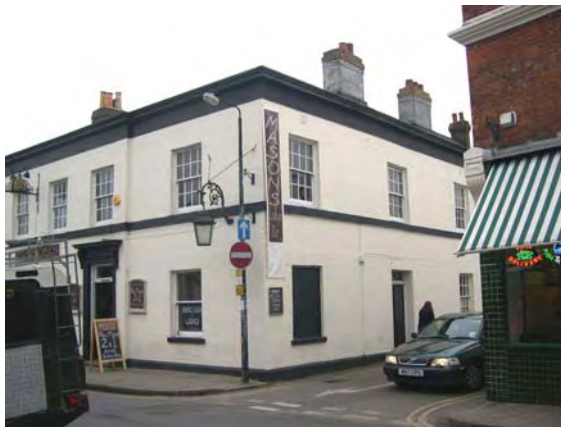
*Fig. 51 North Street, The Old Ship.*

- 9.133 The **Old Ship** public house, listed grade II, 19th-century in appearance, large, imposing and historic but exterior painted leading to a loss of character, abetted by the signage associated with its new identity as Masons Lounge Bar (*Fig. 51*). Of six window bays, the central four projecting forward. Moulded parapet to low hipped roof. Stucco string course. Consoles to the hoods of the two doors. Nice cast iron lamp and bracket at right corner. Well preserved 19th-century rear extension on this side in stock brick. Carriage arch on left hand side. A K6 telephone box stands next to the pub on the north side, where is an old stock brick wall, the back of a lean-to stable, set well back from the frontage; the space in front of it has unfortunately become a hard standing for parked cars. Depressing view into the pub garden through an open carriageway (*Fig. 52*); the front part of it is gravelled and used for parking; the rear, partially screened by evergreens, is a beer garden with a derelict children's play area and three garages. Litter is a prominent feature of this space.

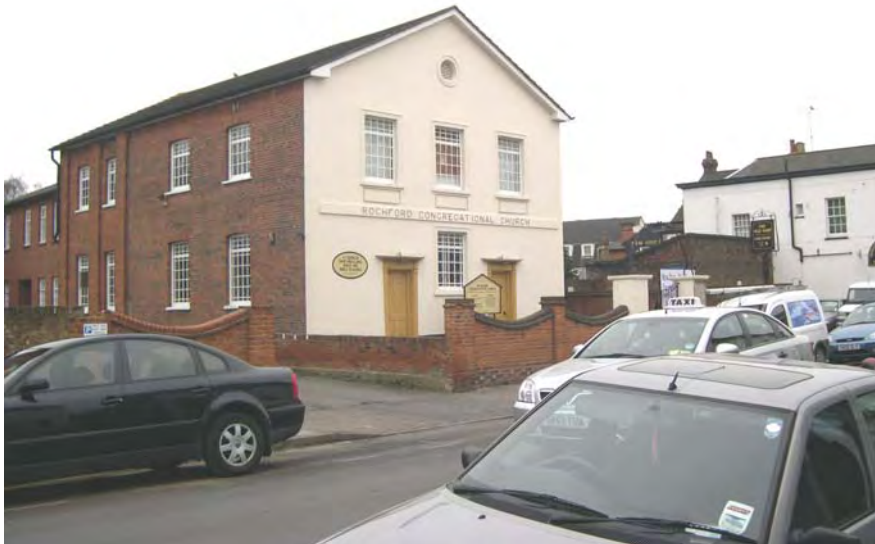
*Fig. 53 North Street, the Congregational chapel.*

- 9.134 **Rochford Congregational church**, a plain gaunt building, the more so because of the sea of asphalt in which it stands (*Fig. 53*). The car park extends right to the back of the plot on the north side. The asphalt covers a burial ground which has been completely cleared. The chapel is a red brick building, but the front is stuccoed and lined out, with two entrance doors. The original building was square in plan, and dated from 1741 (Benton 1888, II, 888; Kaye 199, 62). It was extended by two bays in 1838, at which time the existing galleries must

have been put in. A large extension has since been made to the rear in the late 20th century. The site is enclosed by modern brick walls, but the old stuccoed brick gate posts, with their iron gates and lantern on an iron arch above them, are notable. The setting of this building desperately needs to be softened by some planting. In view of its age, the chapel could be considered for listing. To the rear of the site, there is a nice detached stock brick building of four window bays; UPVC windows to the first floor.

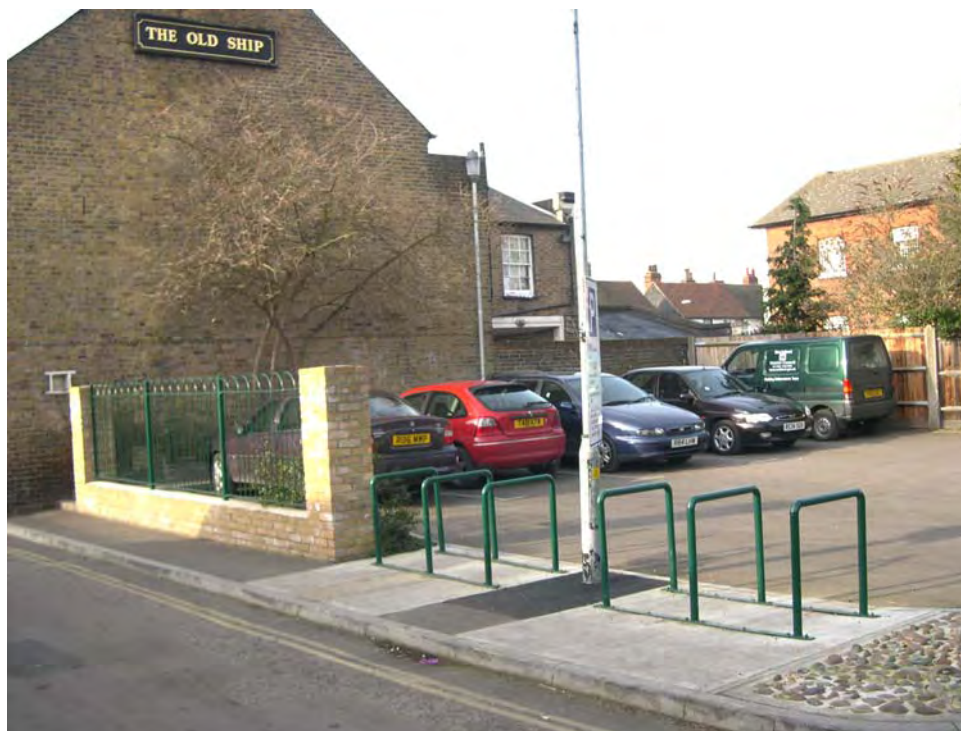
*Fig. 54 Old Ship Lane car park.*

9.142 From North Street, the lane begins well, being enclosed by the buildings to the rear of nos 8-10 and the Old Ship and by stock brick walls with wooden gates. On the north side, however, the sense of enclosure is broken by a newly laid out and very unsatisfactory car park (*Fig. 54*). The boundary to the lane is a low brick wall marred by salt efflorescence, with crude cement flaunching on top of it, above which are spindly hooped railings which have been already vandalised. The effect of this car park is made worse by a degree of visual continuity with the bare asphalt car park to the south belonging to the New Ship. Despite the presence of these car parks, parking is allowed on the south side of the Lane.

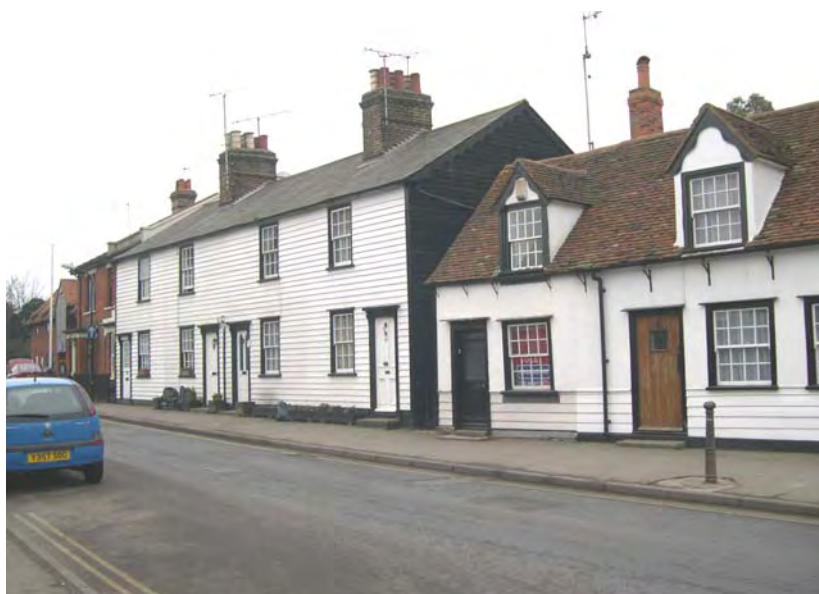
*Fig. 55 Weir Pond Road, cottages at the west end (nos 6-16).*

- 9.146 Four cast iron bollards on the south side of the road are a reminder that this is part of the conservation area. **Nos 2-8** are a row of rendered one-and-a-half storey cottages with dormers with fancy bargeboards. Grade II listed; probably 18th-century. They are a picturesque group presenting a unified appearance, but may not all have been built at one time. They are rendered, white painted with black joinery in the style typical of Rochford. At the bottom of the front walls, there is a weatherboarded skirt or plinth. **Nos 10-16** are another row of low attractive grade II listed cottages, the weatherboarding painted white at the front and black at the sides, the joinery black. Slate roofs and stock brick chimneys, which together with the slack roof pitch indicate a 19th-century date (*Fig. 55*). **Nos 18-20** are a pair of early 20th-century semi-detached houses, with red brick fronts and fletton sides, slate roofs and ground-floor bay windows. No. 18 has UPVC windows and doors.

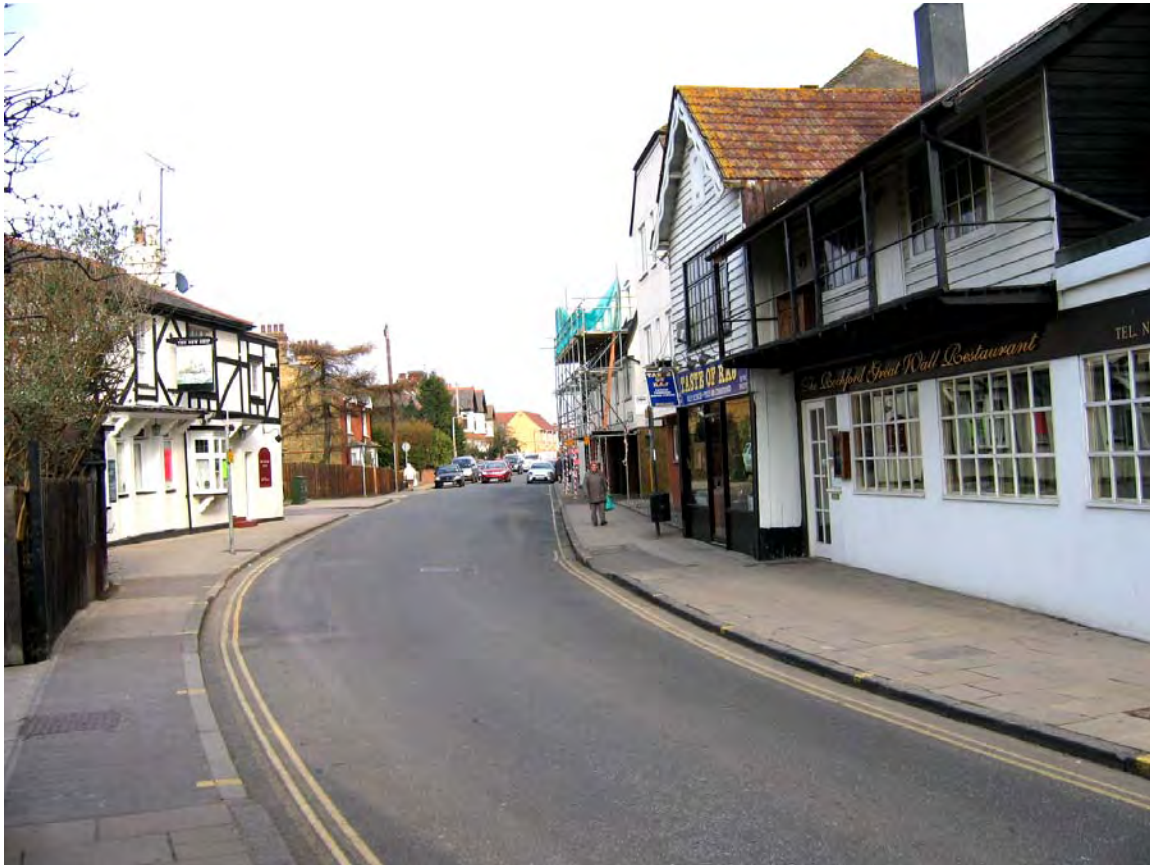
*Fig. 56 East Street, looking east, Great Wall restaurant and Taste of Raj takeaway, the New Ship on the left.*

- 9.152 **Woodys Wines**, interesting late 20th-century block, its corner chamfered to present an aspect across the open space in front of it. It is however rather tall, its brickwork has been painted cream, and the timber windows are of indifferent design.
- 9.153 The **Great Wall Restaurant**, and **Taste of Raj** takeaway, form an attractive group of adjacent timber-framed buildings, of 19th-century or earlier date (*Fig. 56*). Both are weatherboarded at the first floor. The Great Wall restaurant is rendered at the ground floor, and has a slate roof which forms a pentice to a nice wooden balcony, an unusual feature. The Taste of Raj is of cross-wing form; the ground floor is taken up with large plate glass windows and has a rather garish shop sign; the roof has concrete tiles.

- 9.159 The **New Ship** is a 19th-century building given a 20th-century make-over, rendered at ground floor, false half timbering above (*Fig. 56*). Although retaining most of its original windows and joinery, it looks rather unconvincing, probably because its decoration has been oversimplified in recent times. The main central door has been blocked up, which has not improved its appearance. 19th-century buildings to the rear. The New Ship car park is a desolate unenclosed strip of asphalt on the frontage, across which there are views of outbuildings at the rear of the pub (*Fig. 57*).

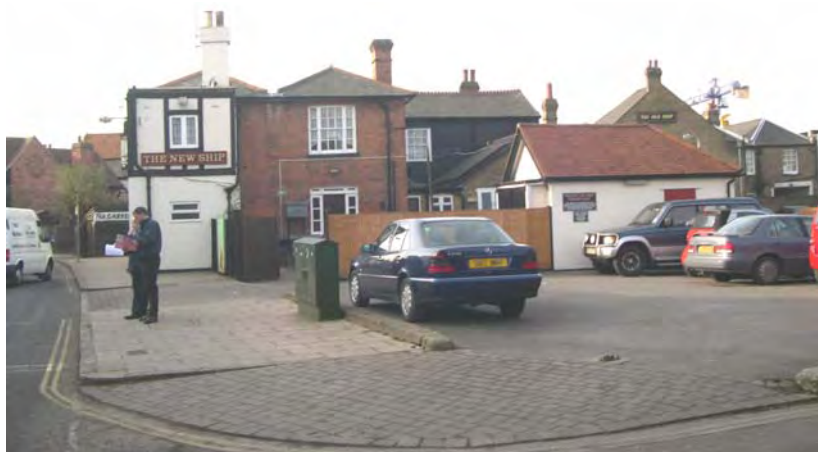
*Fig. 57 East Street, the New Ship car park.*

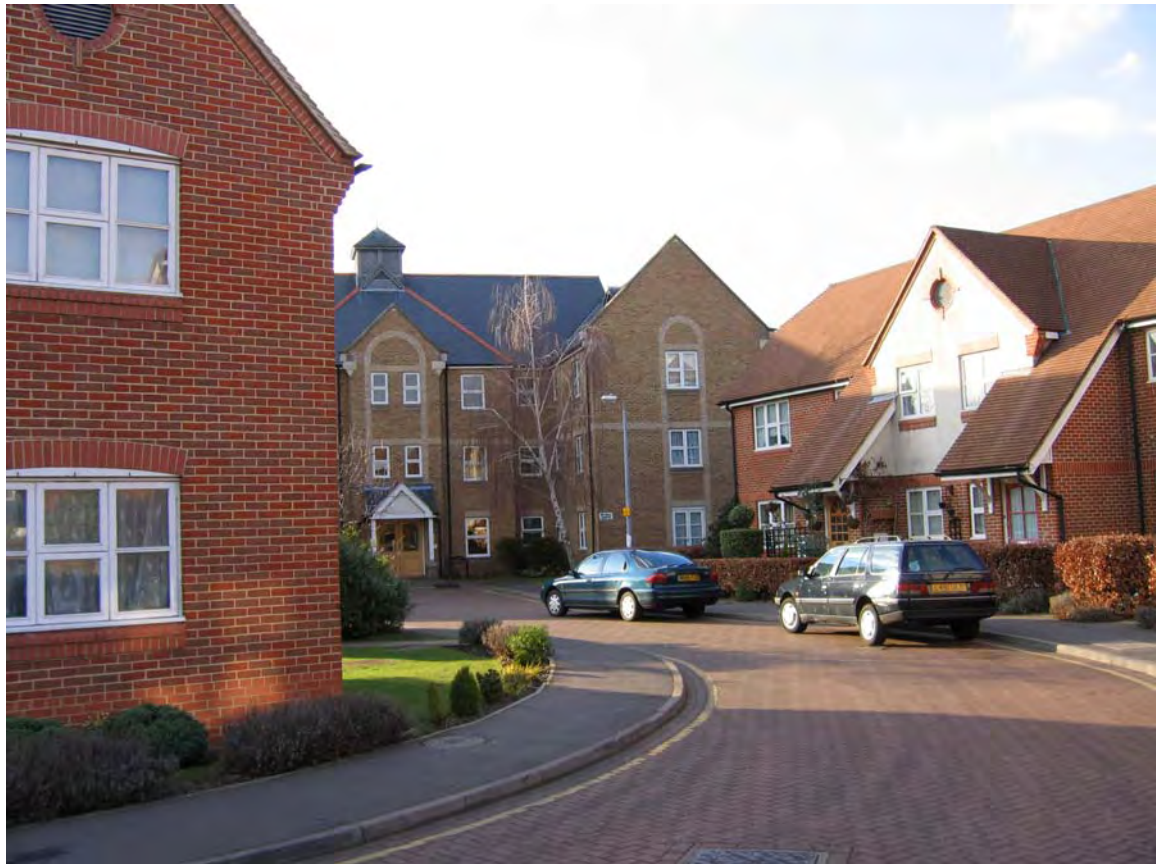
*Fig. 58 Lever Lane and Winnowers Court.*

- 9.164 Within the conservation area are **nos 20-28**, a distinctive row of tall three storey houses in red and stock-type brick, with steeply pitched roofs and integral garages. Lever Lane leads past pleasant terraces of two storey housing to **Winnowers Court**, a three storey block of flats in stock brick with a slate roof (*Fig. 58*). Its height makes it a prominent landmark, both from this side and South Street. Although a satisfactory design, its size and the materials make it slightly forbidding, reminiscent of a workhouse. Lever Lane also gives access to **Millview Court**, a very large block of two storey flats dated 1986 and 1988, and built round a courtyard. It is carefully designed. The first floor has a pargeted finish, the render with the slightly dead look that results from the use of cement. To the south of it, there is a large well kept garden. On the north side, there is an area of car parking which links up with the car park of the Rochford District Council offices. This extensive area of hard standing and brick walls should be softened with some planting and trees.
