Local Development Framework  
Evidence Base

Rayleigh Conservation Area  
Appraisal and Management Plan

LDF Evidence  
Base

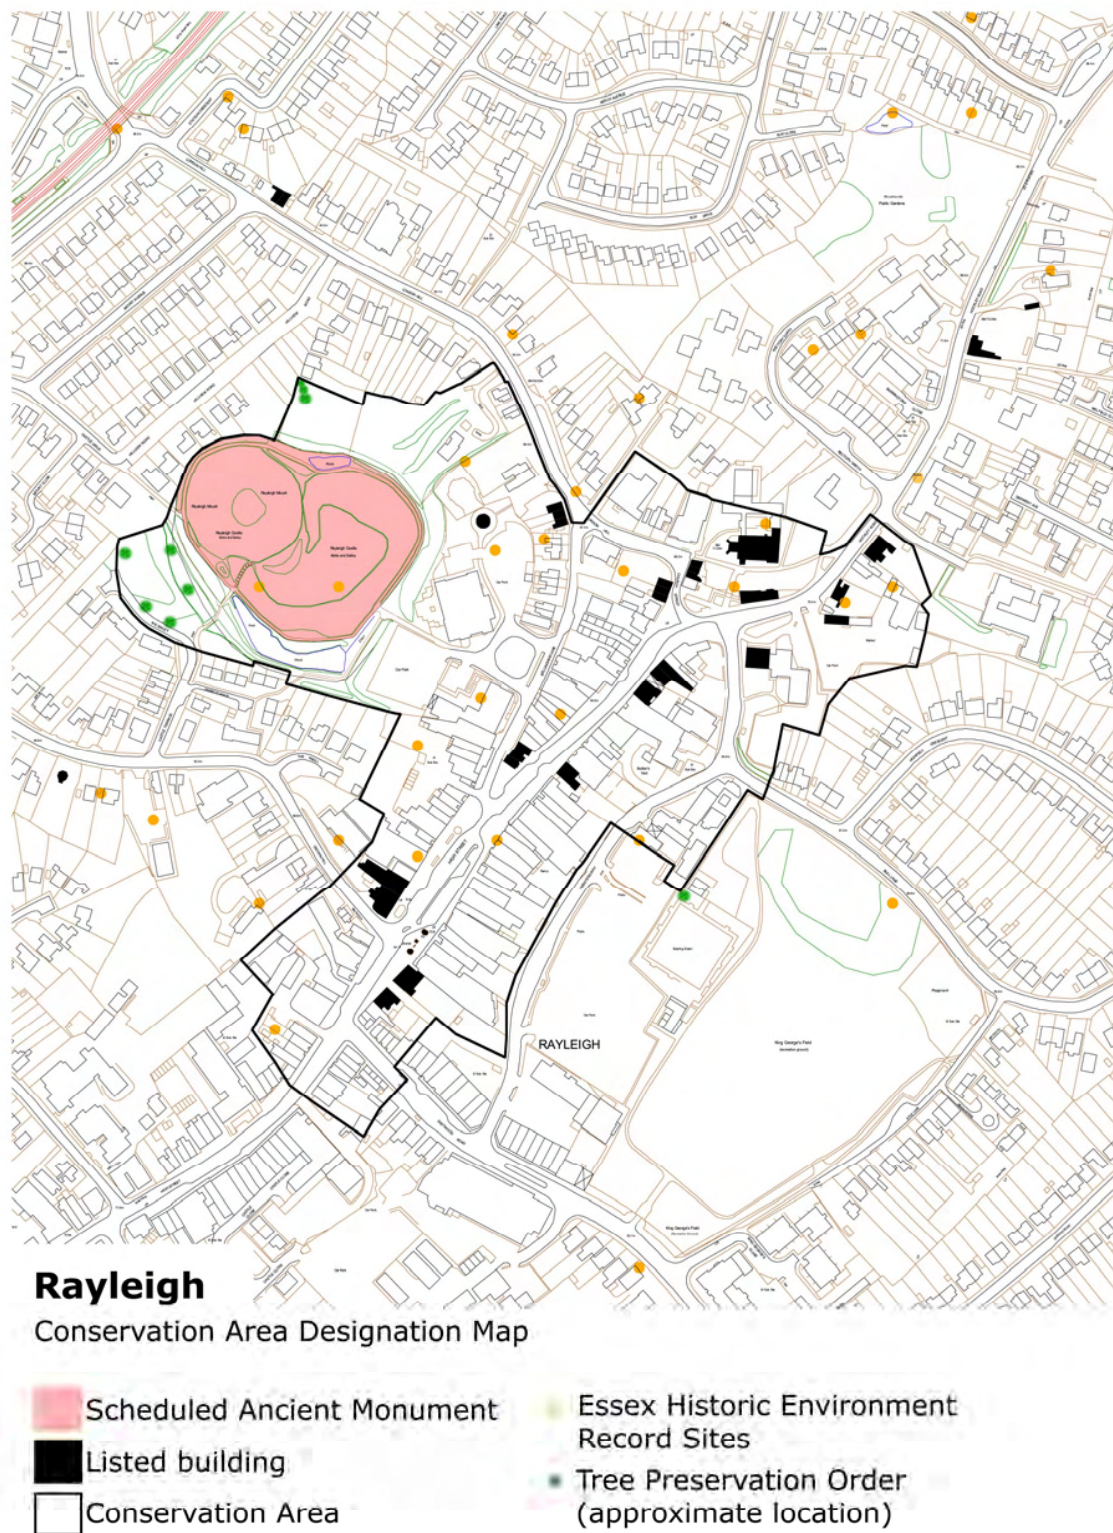
*Fig. 1 Rayleigh town centre, designation map showing conservation area boundary, the scheduled ancient monument, listed buildings, and tree preservation orders.*

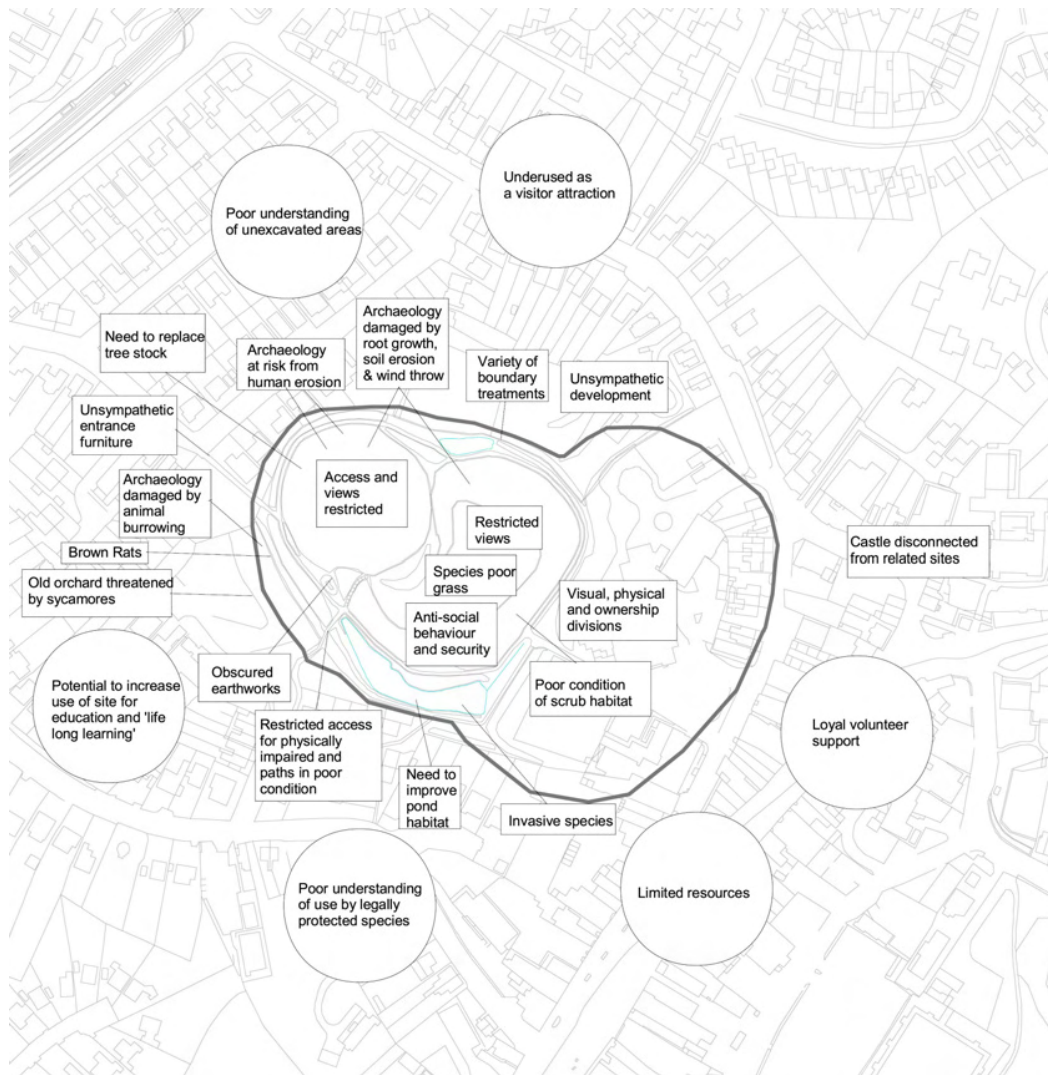
- 5.5 The Conservation Plan divides the Mount into nine character areas, and identifies 72 policies for its better management and enhancement. Management issues are summarised in *Fig. 3*.

*Fig. 3 Rayleigh Mount, management issues identified in the Conservation Plan (Rayleigh Mount Conservation Plan fig. 13).*

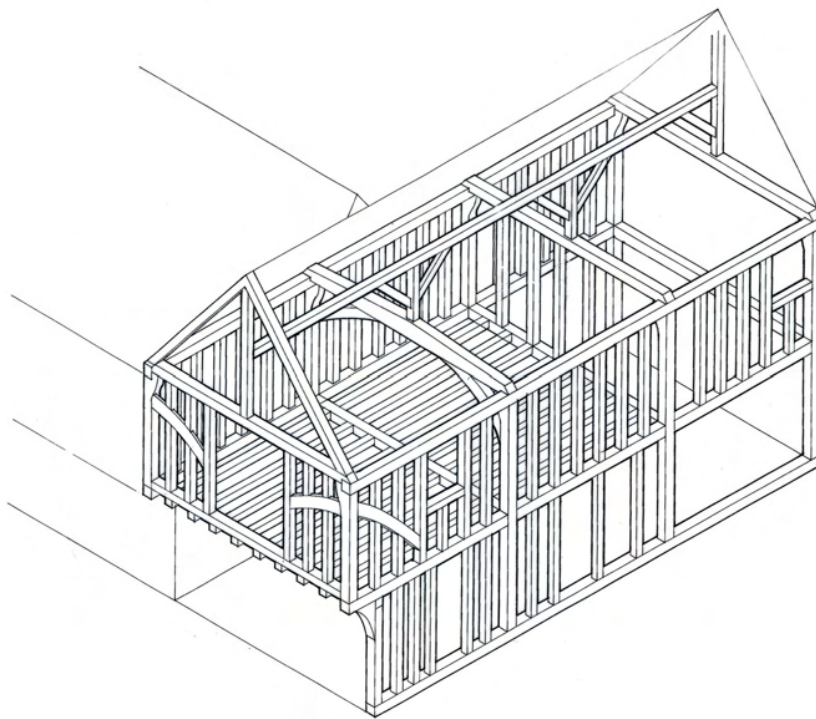
- 7.11 The best preserved late medieval secular building in the conservation area is no. 91 High Street, on the east side almost opposite the Crown (Crump 1991). Refurbishment in 1989 revealed a jettied late 15th-century three-bay cross-wing at right angles to the street (*Fig. 6*), and an adjacent 17th-century three-bay building parallel to the street. The cross-wing was probably a shop. These are standard buildings of their time and there must once have been many of them in the High Street. The only other known timber-framed buildings of the 16th century or earlier are the Spread Eagle next to no. 91, nos 9 and 11 (La Romantica and Squires) on the east side of the north end of the High Street, and nos 40 and 42a at the south end of the junction with Bellingham Lane.

*Fig. 6 The 15th-century timber frame of no. 91 High Street (after Bob Crump).*

- 10.41 The southern end of this side of the street has escaped modernisation, and has buildings of a variety of dates, of traditional form and scale. **No. 91** is the oldest known building in the High Street, datable to the 15th century (*Fig. 6*). Its restored exterior is recognisably late medieval. However the timber shopfront would look more attractive if it were painted, not stained. To the side of it, there is a lane through to Websters Way: poor boundary treatments and parked cars present a dismal view which contrasts with the two good buildings which frame the entrance to it (*Fig. 31*). Next is the **Spread Eagle**, a grade II listed building of medieval appearance though nothing visible externally is of that date. Inside three bays of a timber frame dated to the late 16th century have been identified. It presents an attractive composition of gables and clay tile roofs, wooden pilasters and fascia at the ground floor, cream-painted render and black-painted joinery. First Choice and the next-door barber's shop (**nos 97-99**) are a 19th-century two storey building with false timber-framing and sash windows at the first floor. On the corner with Eastwood Road, there is a pair of single-storey flat-roofed shops (Space Communications, a shoe repairer's) of a traditional sort built out in front of older buildings on high street frontages. In Eastwood Road, the conservation area includes a 1930s parade of shops on the north side (**nos 3-11 Eastwood Road**), typical of their period, white painted render lined out in imitation of ashlar with a parapet roof and a strong horizontal emphasis to the fenestration, though the windows are now UPVC, not metal.

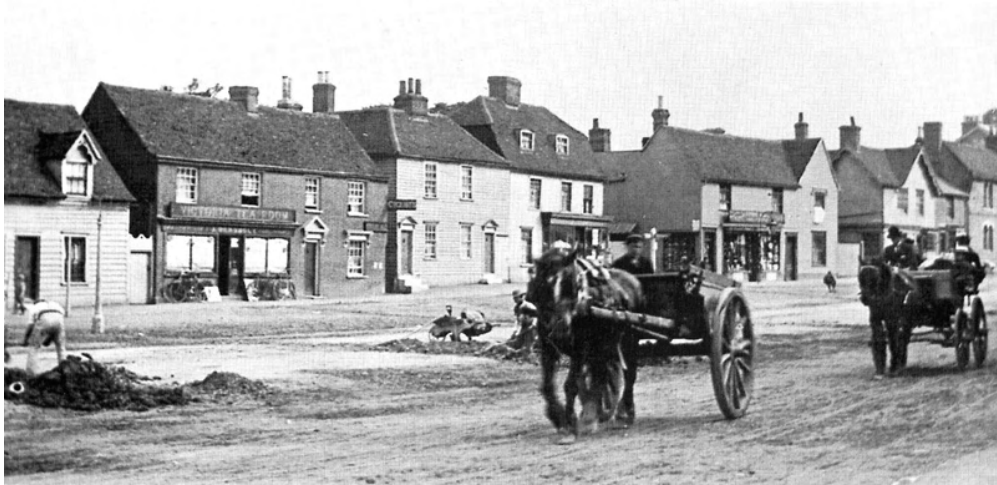
- 8.1 Old photographs show that many of the High Street buildings were timber-framed and rendered, often with pebbledash, or clad in weatherboard (*Fig. 12*). The latter, a feature of south Essex towns and villages, has today all but vanished, though it can still be found in some backlands situations. No. 91, probably the oldest building in the High Street, was formerly weatherboarded; its flank wall still is. There is a weatherboarded barn behind no.7 High Street. Yellow-brown stock brick was characteristic of 19th-century buildings (*Fig. 13*). It was made locally, as were red bricks.<sup>5</sup> The latter, more expensive, were used for the cottages and villas of the suburban expansion that began at the end of the 19th century. Thus the Dollmartons buildings at the south end of the High Street are of stocks, whilst the slightly later villas in Bellingham Lane have red brick detailing and in one case a red brick façade. The 20th-century buildings are mainly of stock-type bricks or textured brown fletton brick, painted render, and concrete, with flat roofs.

*Fig. 12 Rayleigh High Street early in the 20th century.*

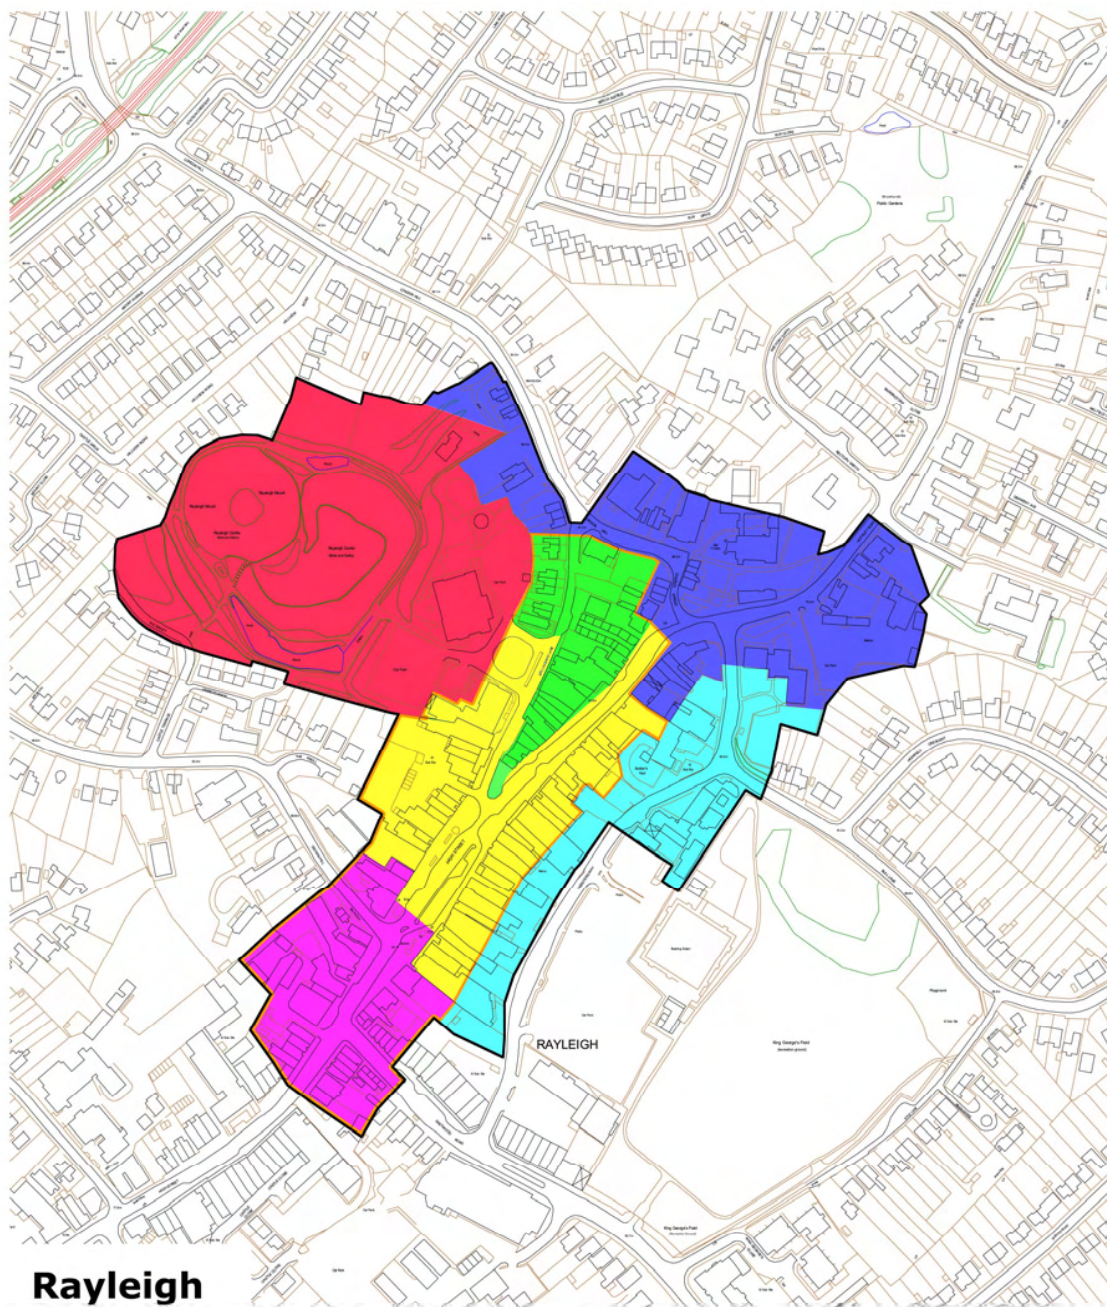
Fig. 14 Character zones identified in the Rayleigh conservation area.

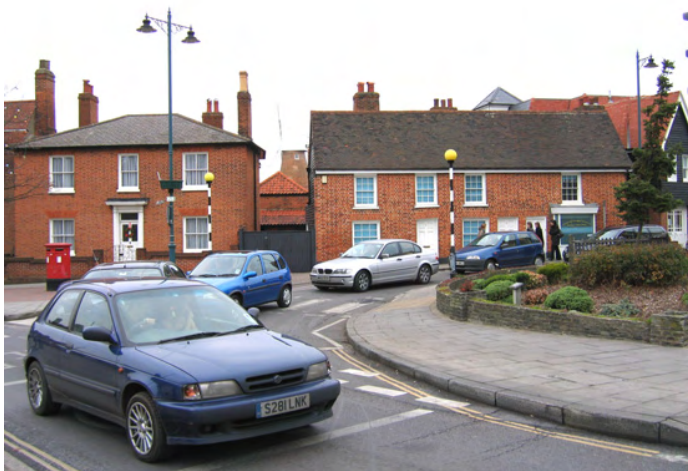
Fig. 17 The junction of High Street, Church Street and Hockley Road has good views and buildings but is adversely affected by traffic. In the background Wearn Cottages and no. 4 High Street.

- 10.12 Opposite no. 2 are **Wearn Cottages** (nos 1-5), a terrace of three attractive low two storey cottages which are grade II listed (*Fig. 17*). They are timber-framed and thought to date from the 17th century, though they were given a brick façade in the late 18th or early 19th century. Their side walls are weatherboarded. They were restored in 1988/89 and their brickwork and pointing still look in very good condition. The roofs have machine made tiles. They are used as offices.

- 10.43 **No. 4** is a nice double-fronted 19th-century house with a red brick façade, sash windows, a hipped slate roof and end stacks (Fig. 17). It complements Wearn Cottages to the north. **No. 6** (Rona Estate Agents) was similar inasmuch as it is double-fronted with a brick façade, but the latter has been rebuilt and all the windows renewed, so that the detailing does not fit with the architectural style of the building. In the left hand side there is now a large shop window, and above it a first floor bow window. A double pile building, the front part with a parapet to a gambrel roof, it probably dates originally from the 18th century

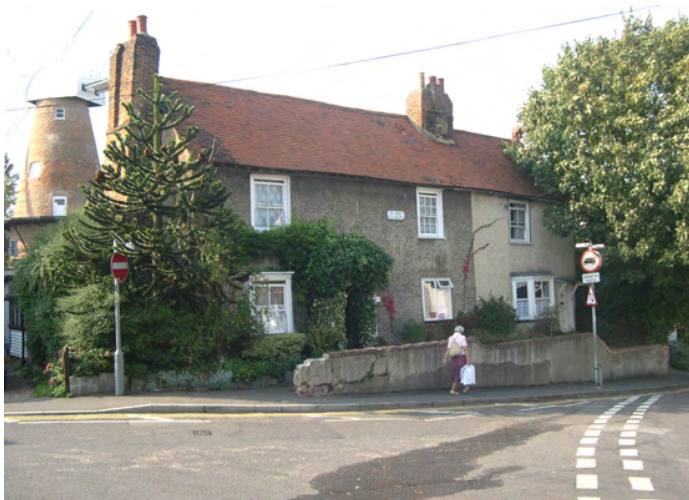
- 10.5 There is a terrace of three grade II listed 17th-century cottages (**nos 13-17**) at the junction with Bellingham Lane (*Fig. 19*). They are rendered with rough-cast pebbledash, the right-hand one painted. A two-pitched roof covers all three, with a catslide over a rear outshot. The middle cottage has a hole in its roof. Set high above the road, they form a picturesque group.

*Fig. 19 Nos 13-17 London Hill, with the windmill in the background.*

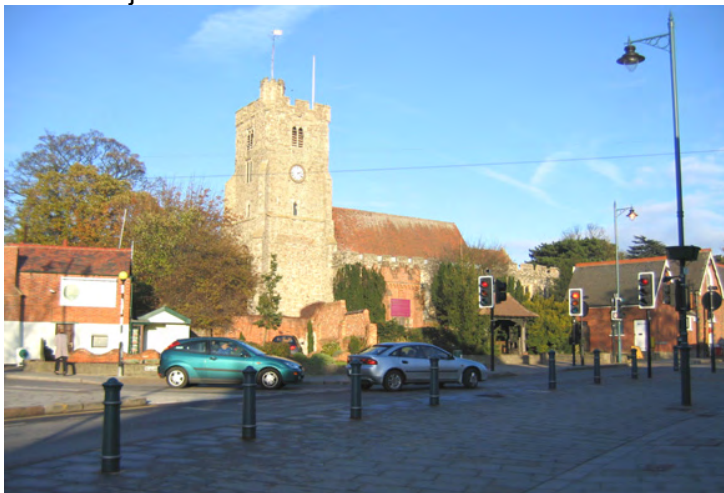
- 10.13 The **church** (*Fig. 21*) is a large building (nave, aisles, chancel chapels, vestry and porch) with a prominent tower and a large 1990s extension, probably the largest church extension in the Chelmsford diocese. It is built mainly of Kentish Ragstone, but the pretty crenellated 15th-century porch and the extension are of brick. The chancel is thought to date from the 12th century on the evidence of Roman brick quoins, but most of the fabric is 15th-century. The 16th-century Alleyn chapel has Ragstone and knapped flint chequerboard masonry. There was a major restoration of the church in 1912. The church is in good condition.

*Fig. 21 Holy Trinity church seen from the High Street, Hockley Road junction.*

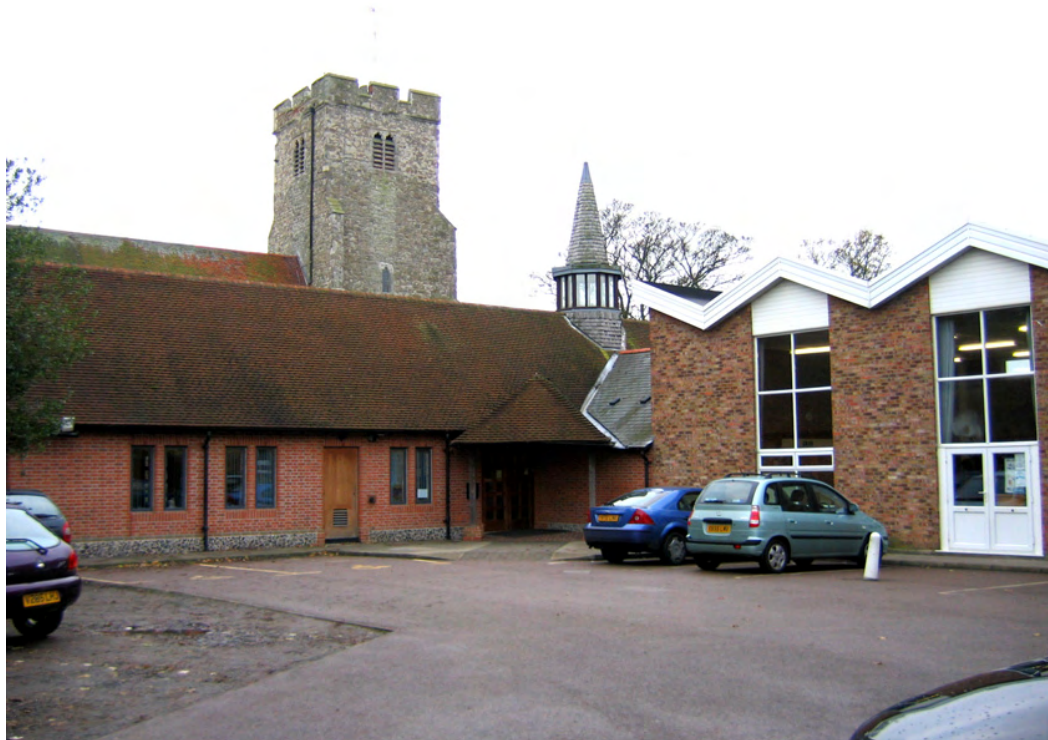
- 10.14 When the former National School and parish room on the south side of the churchyard was declared unsafe for use, the parish in 1976 built a modern meeting hall to the north on land that had been part of the rectory garden, its design hardly in keeping with its setting. When this became inadequate for their needs, an **extension** was built on to the church in 1993 (*Fig. 22*). This encloses a small cloister area on the north side of the church. The extension has been successfully designed to fit in with the church. These buildings are busy during the week and have an important community use. The car park area on the north side would benefit from landscaping.

*Fig. 22 The extension to Holy Trinity church.*

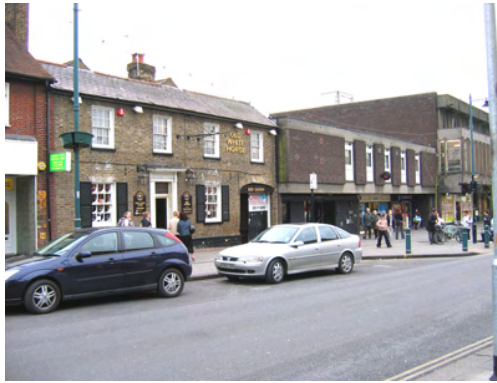
- 10.35 The **Old White Horse** is an isolated survivor of the old High Street (*Fig. 28*), a stock brick double-fronted two-storey public house with a carriage arch through to a paved beer garden enclosed by a close-boarded fence with concrete posts, and beyond that car parking on Websters Way. It is grade II listed.

*Fig. 28 High Street, The Old White Horse, and beyond it nos 45-47 and 55-55a.*

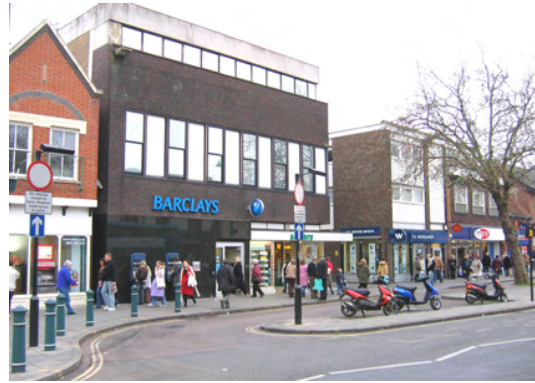
*Fig. 29 High Street, Barclays Bank, a problem of scale. In front of it, the taxi rank.*

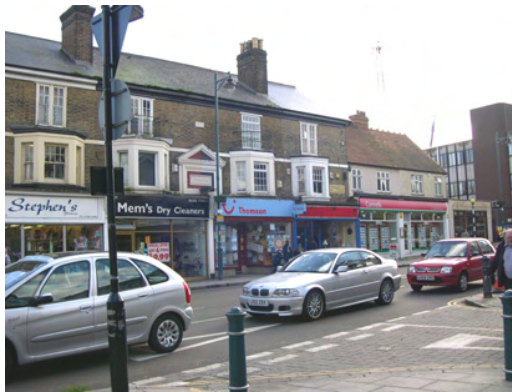
- 10.42 On the other side of Eastwood Road, there is a three-storey stock brick building (Fig. 32) with a name '**Dollmartons**' in a pedimented surround and a date plaque '1881' (**nos 105-111**). At the ground floor there are four shops. It was quite a grand building in its day, with stucco surrounds to first-floor bay windows, but it suffers from poor maintenance and is not enhanced by the shop fascias. Half the original sash windows have been lost, and the most southerly property has been re-roofed in artificial instead of natural slate.

Fig. 32 High Street,, nos 105-111, the Dollmartons building.

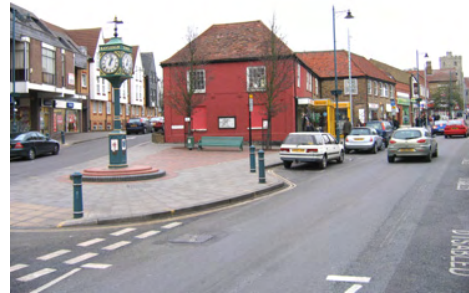
*Fig. 35 High Street, Manns Corner.*

- 10.48 **Nos 38 and 40a** (Elan and Top Kids) occupy a deceptive stock brick building (*Fig. 35*) designed to look old but in fact dating probably from the 1970s. Old 20th-century maps show this to have been a vacant plot. It has been built of reused stocks, with sash windows and a clay tile roof, so that it blends with nos 40-42b to the south. This it does quite successfully, but some of the windows at the first floor have been replaced in UPVC.

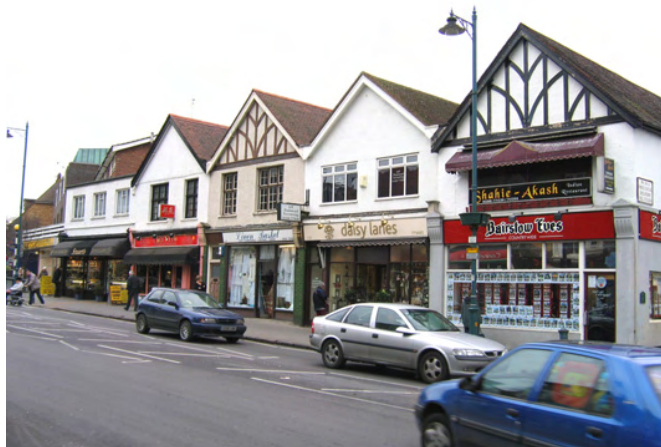
- 10.60 **Nos 110-120** are a row of 1920s or 1930s buildings with gables to the street, which illustrate how good traditional forms can look despite successive alterations (*Fig. 41*). Only two of them preserve false half timbering in the gables, and only the southernmost two have their original windows. One of the other two has UPVC windows. The large first-floor window and sun-blind at the first-floor of no. 110 are particularly to be regretted. The last building in the conservation area on this side, Stewarts Jewellers, is plain, rendered, with Crittall windows and a parapet roof.

*Fig. 41 High Street, nos 110-120.*

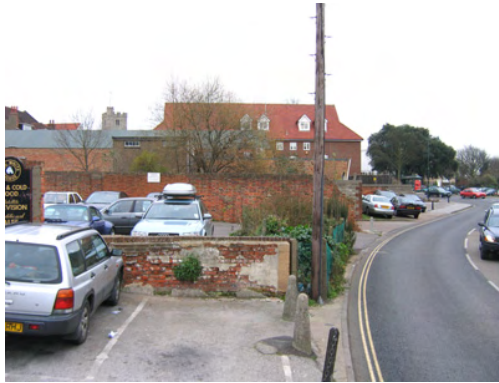
*Fig. 44 Websters Way, Burley House and unattractive backland area to the south.*

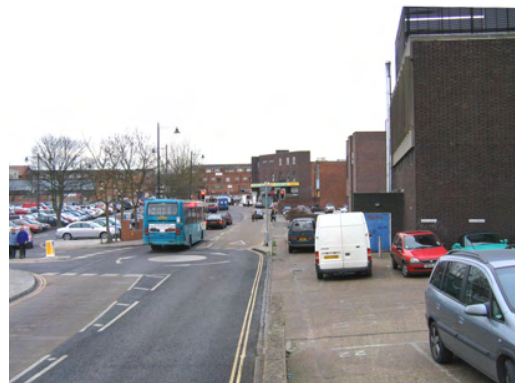
*Fig. 45 Service buildings in the south part of Websters Way present a contrast with the landscaped car park on the east side of the road.*

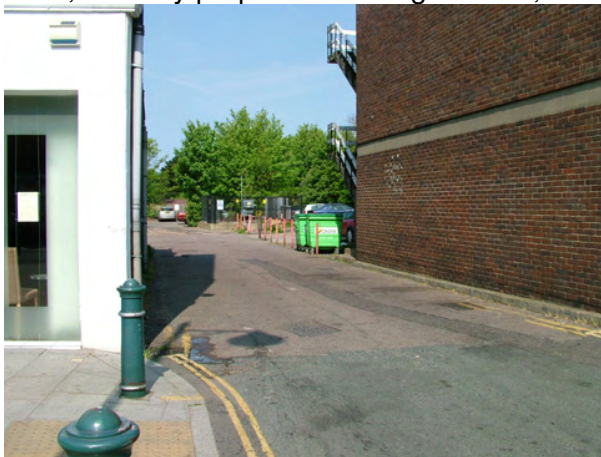
- 10.50 To the south of the Bellingham Lane junction, the High Street is exceptionally wide, a legacy of its former marketplace function. Opposite Manns Corner are **nos 44-50** (Rosebys, Rayleigh Hi-Fi, Traveline, HSBC, and Watch Shop), an interesting modern two-and-a-half storey development with a pitched slate roof with recessed dormer windows (*Fig. 36*). The façade is in part deeply recessed with concrete jetties, presumably in an attempt to achieve interest and drama, but scale remains a problem and the building is rather intimidating. Down the side of this building is a lane through to a large area of backland parking: the view into it is unattractive (*Fig. 49*).

*Fig. 49 View into the backlands between nos 50-52 on the west side of the High Street.*

- 13.12 There are two types of backlands spaces: those open to the highway (Bellingham Lane, Websters Way) and those which are enclosed (west side of the High Street). The former impinge directly on the townscape; the latter do so when there are views into them, as for instance between nos 50 and 52 on the west side of the High Street (*Fig. 49*). The condition of the backlands is thus a material factor in the appearance of the conservation area, and the way they are used, and any proposals relating to them, need to be considered with great care.
