## **LITTLE WAKERING – KIMBERLEY ROAD**

### **Report on flooding issues for the Flood Forum following a site visit on 12/5/2021.**

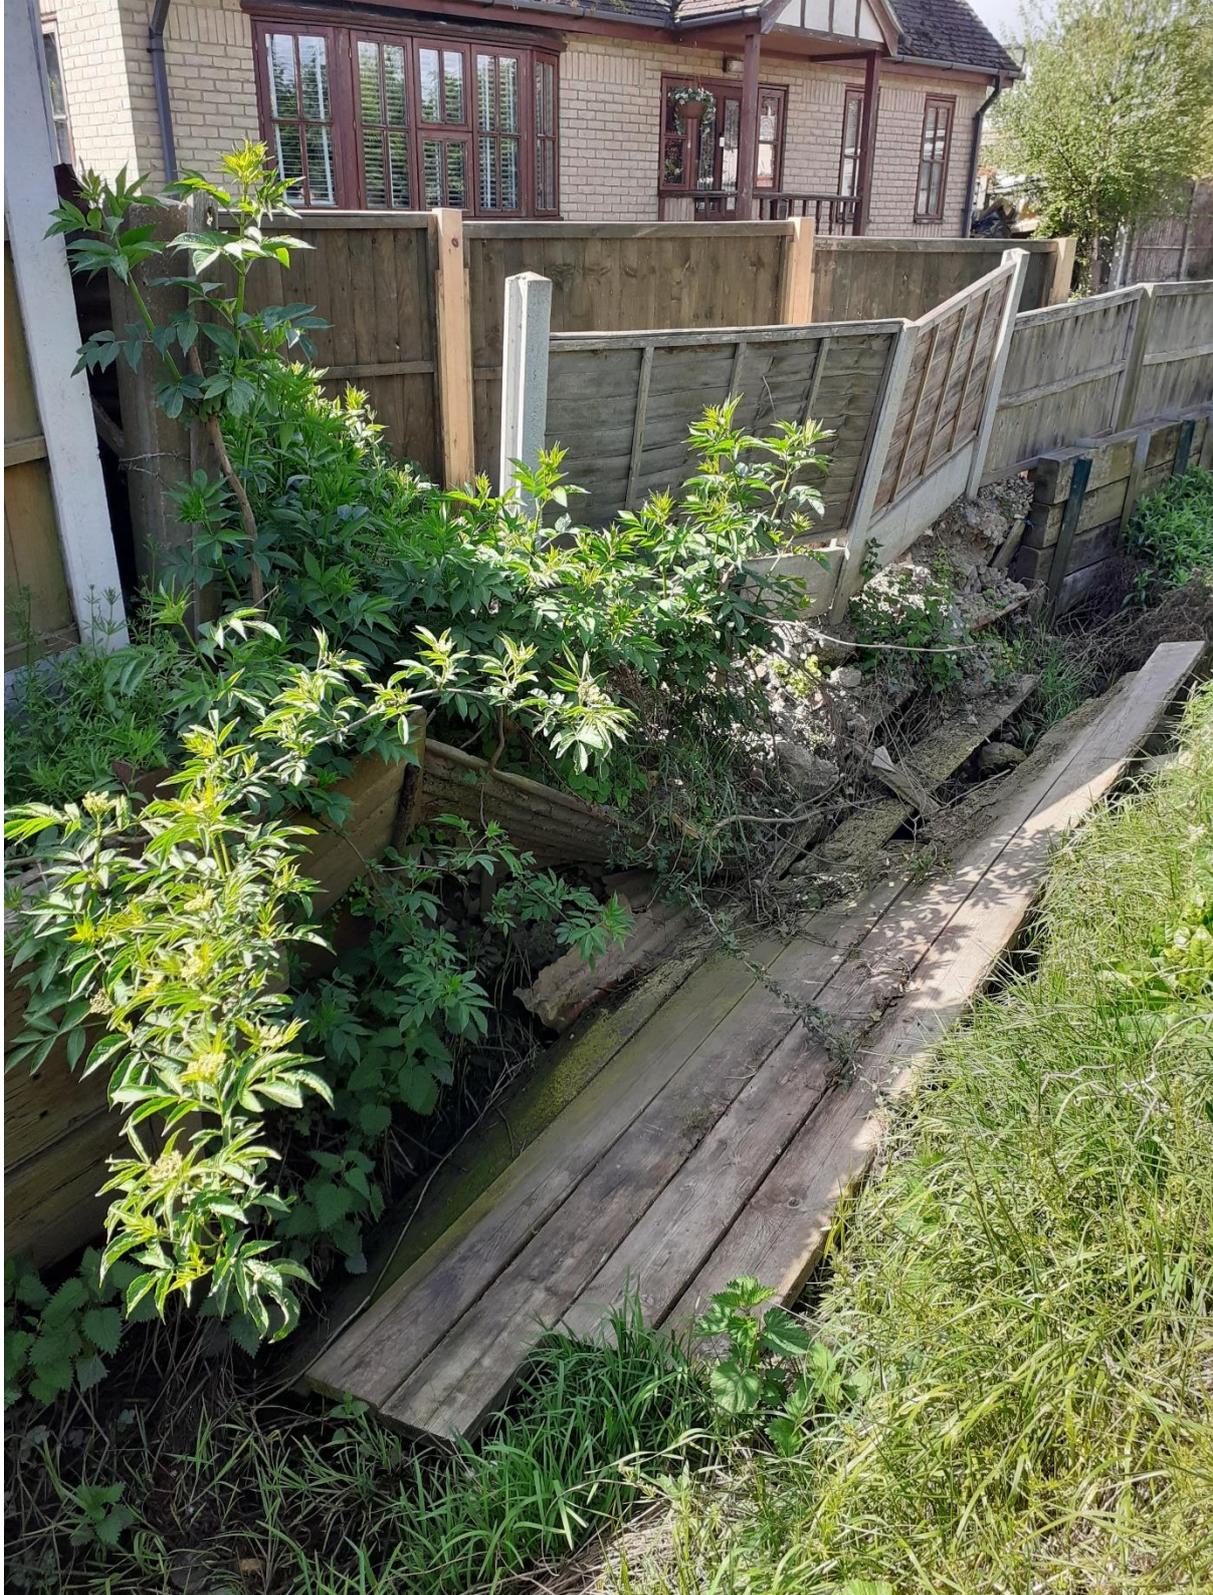
**5 DRIVEWAY BY THE DITCH**

The ditch has been narrowed to create a driveway to a newer property, 344A Wakering Road. The side of the ditch supporting the roadway is formed of railway sleepers and supported in places by scaffolding poles. In some areas this construction has collapsed into the ditch.

To advise residents of 344A that in the opinion of the Flood Forum, the maintenance of the ditch on the side of their drive is their responsibility.

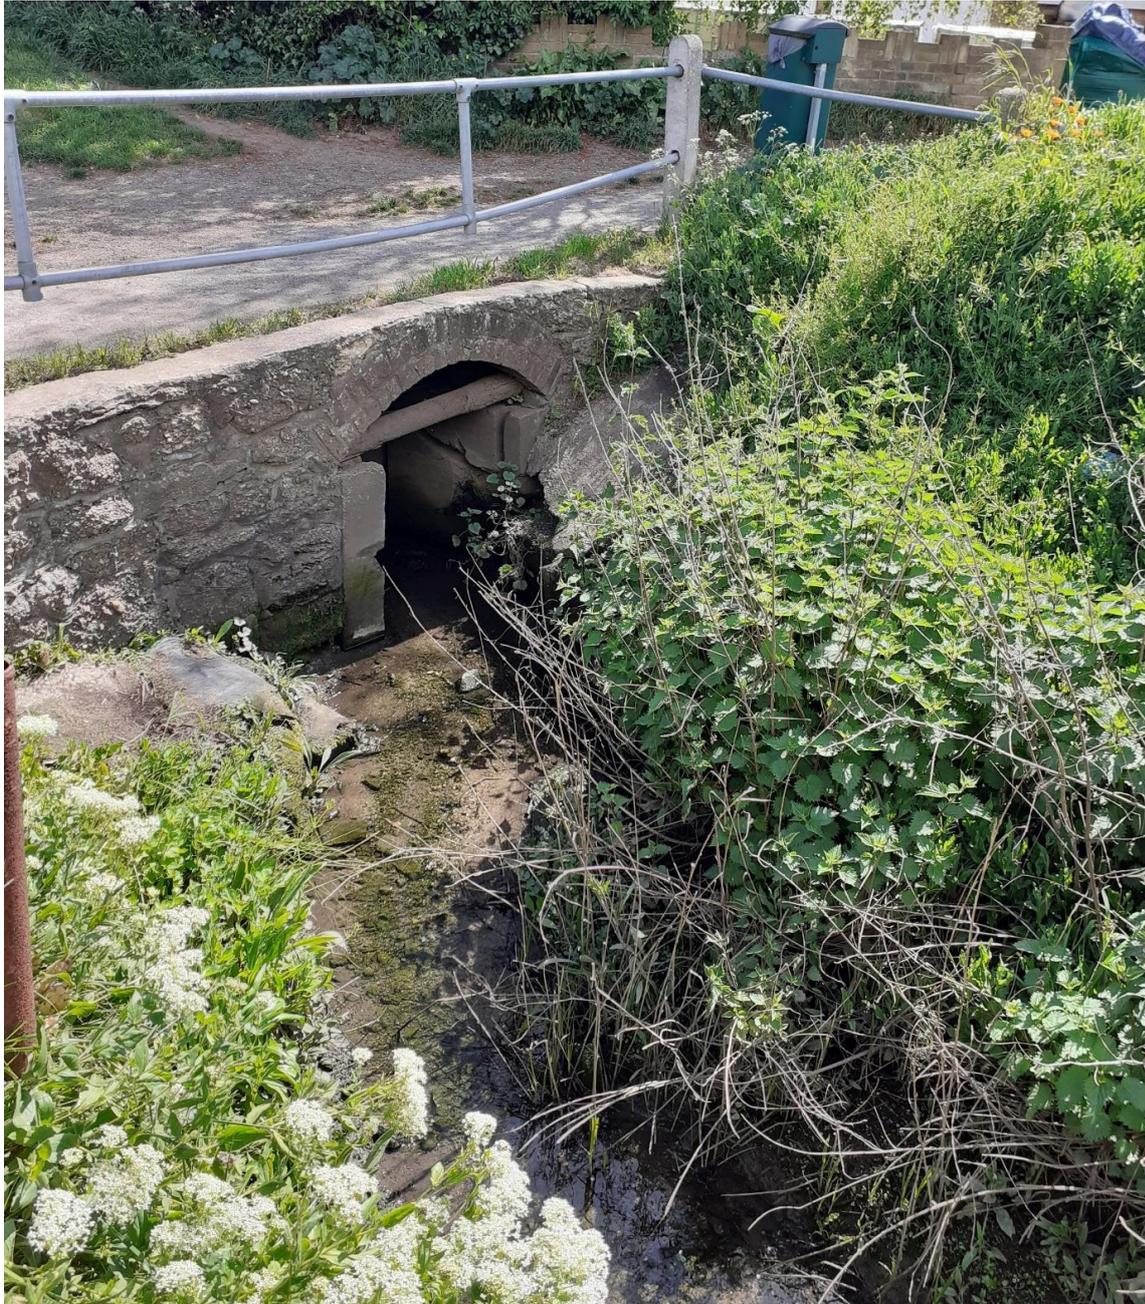
**6 ENTRANCE TO THE CULVERT**

This currently has no grill or other protection to prevent debris from building up in the culvert and potentially affecting the operation of the Duck Bill Flap. Provision of a grill has previously been discussed with Rochford District Council Officers, but this was not actioned. The installation of the grill is complicated by a turn in the ditch just before the entrance to the culvert and the presence of a drain flap to allow water from Kimberley Road to run into the ditch.

Given the relatively short run of the ditch there is limited capacity to generate debris, but a bottle was observed.

To take Agency Partners' views on the need for a trash screen on the culvert. If required, agree a specification, and look at options for funding and instal and maintain.

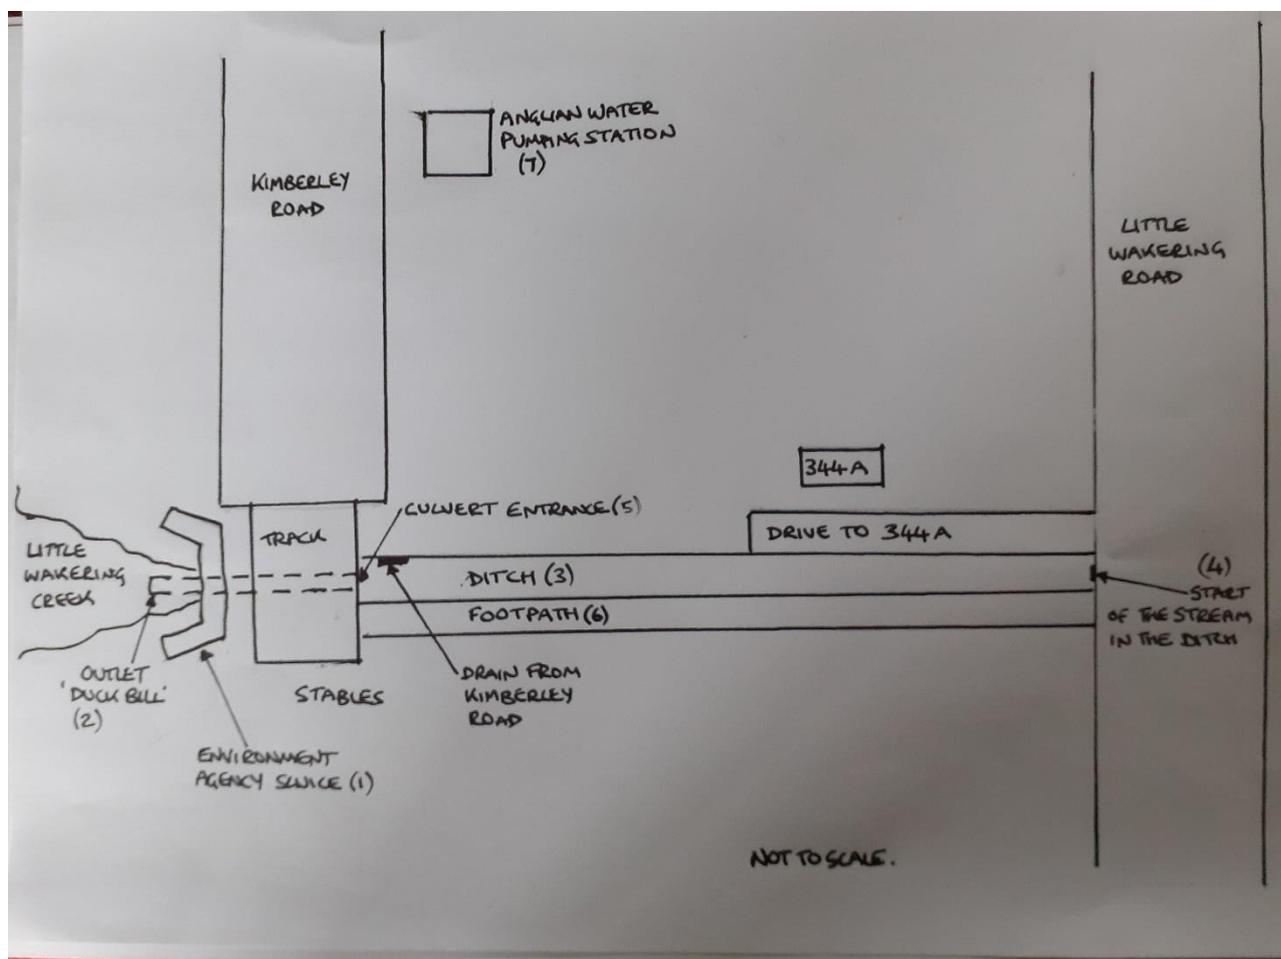
## 8 PUMPING STATION

There is an Anglian Water pumping station in Kimberley Road. This collects foul water from the area and pumps it away for disposal. There is a history of this flooding and sewerage collecting in the surrounding low-lying areas, in particular an infill property built behind the pumping station. There are local reports of tankers on the site to pump out the building early every year.

The Maintenance Manager for the pumping station advises that the pumps there have been replaced with two brand new pumps. Their performance has been monitored in adverse weather and were able to cope with the incoming flow.

To remove the item relating to the Pumping Station in recognition of the improvement works completed and observations in adverse weather.
